# *OH Coil Cooling Tube Arc Failure New Designs and Re-commissioning*

**2015/05/28**

# Scope of this Presentation

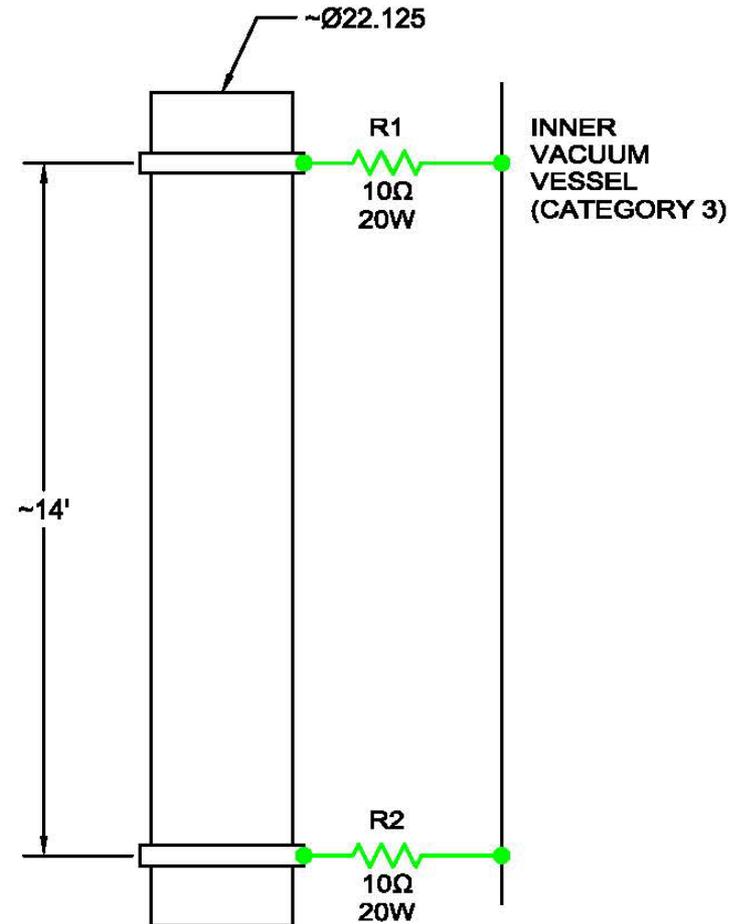
# Item 1 - OH Ground Plane Grounding

- The OH ground plane grounding scheme has been re-envisioned with the following design criteria:
  - Provide grounding points at both ends of the ground plane.
  - **NO CONTINUOUS LOOPS**
  - At the top end, use a modified version of the design that worked for NSTX.
  - At the bottom end a new concept is being developed.
  - Both ends will be grounded to a single point (through resistors) to the inner vacuum vessel.

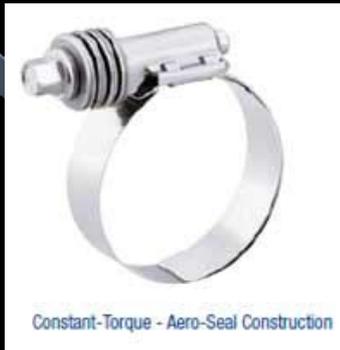
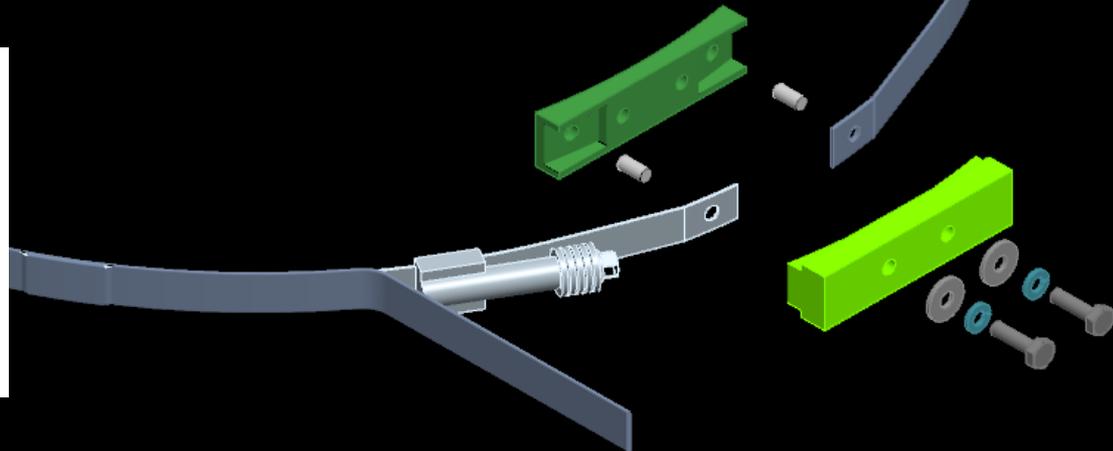
# Item 1 - OH Ground Plane Upper Clamp

*This is essentially the same clamp used for the original OH coil. Ground Braid, which is a flattened tube, can be slipped over the hose clamp and positively secured.*

*Modified "Breeze Constant-Torque, heavy duty clamp". The tightening mechanism is spring loaded. Needs to be lengthened via welded extension section.*

*Electrical Break. G-10 with SS pins to restrain hose clamp*

- The OH ground plane top clamp is being redesigned with the following design criteria:
  - Maintain tension during the OH temperature fluctuations.
  - Provide a 4” wide electrical break
  - Secure the ground braid (nickel plated copper, flattened tubular braid). The ground braid will slip over the hose clamp and will not be long enough to form a conducting loop. (will not span over the hose clamp’s electrical break)
  - Single point ground through resistor to the inner vacuum vessel.
- New drawings almost done – pending review/approval
- Materials needed are in-house.
- Peer Review planned for next week
- Procedure being developed

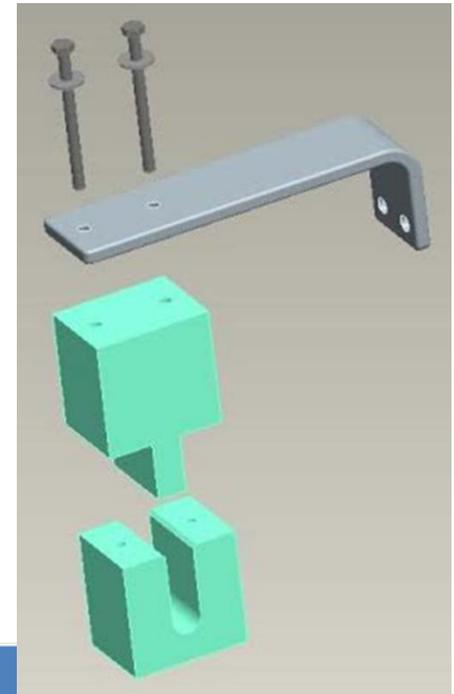
# Item 3 - Redesigned OH Cooling tube support clamp details

Cooling tube no closer that 1.25” from grounded components

- The New clamp drawing - E-DC1943
- Installation/assembly dwg - E-DC1944
- Sample clamps were fabricated and passed 26 KV hi-pot test

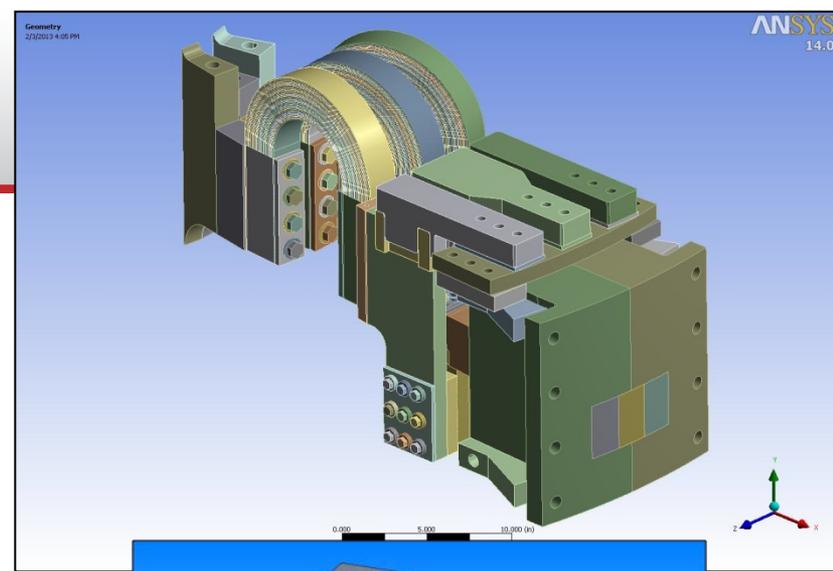
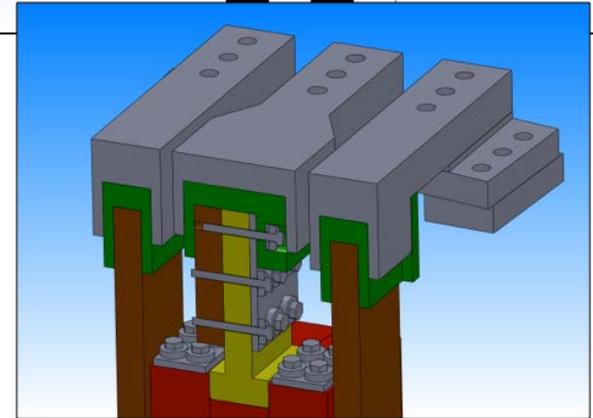
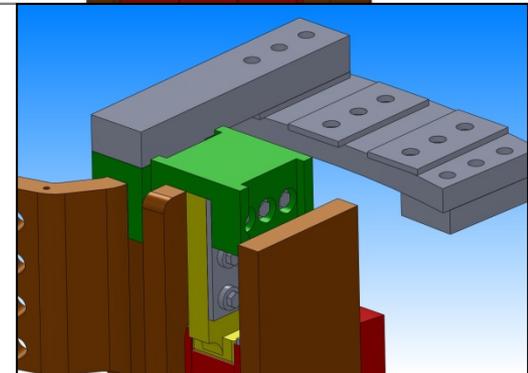
# Inconel TF flag supports

- TF flag supports are required to prevent electromagnetic loads from transferring to the outer TF leg flag braze joints.
- Design intent required elimination of gaps - structural gap filler was specified.
- Specified structural filler was unavailable – Hysol/glass bead slurry was substituted, but abandoned for hard shimming when the fit between parts was deemed acceptable during field inspections.
- At disassembly four (of 72) G-10 isolators were found to be cracked. It is difficult to ascertain whether stack-up of tolerances, installation technique or gaps between parts were the cause of the cracks.
- Specified structural filler has recently become available, has been ordered and received.
- Bench trials have shown that the filler applies easily (does not run or drip) and can be disassembled readily (mold release applied).

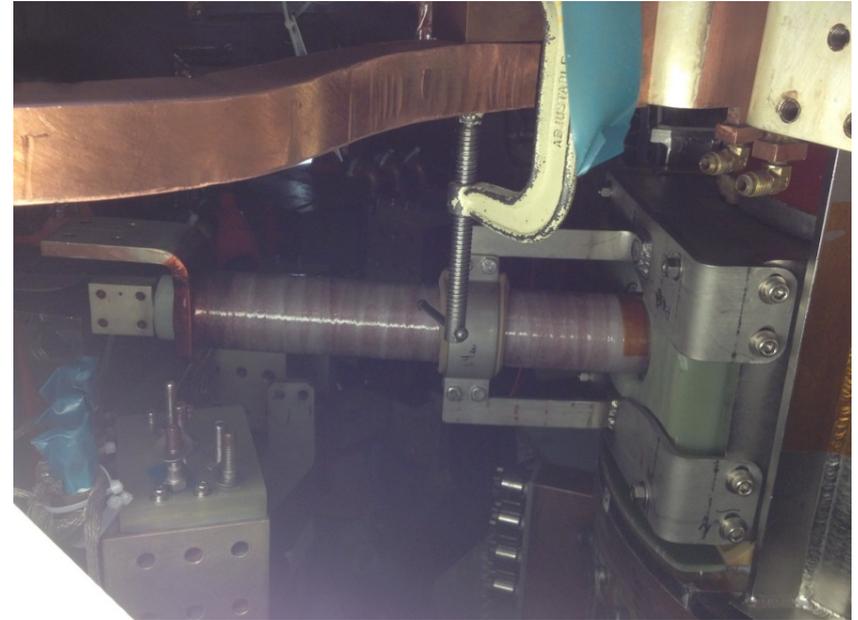
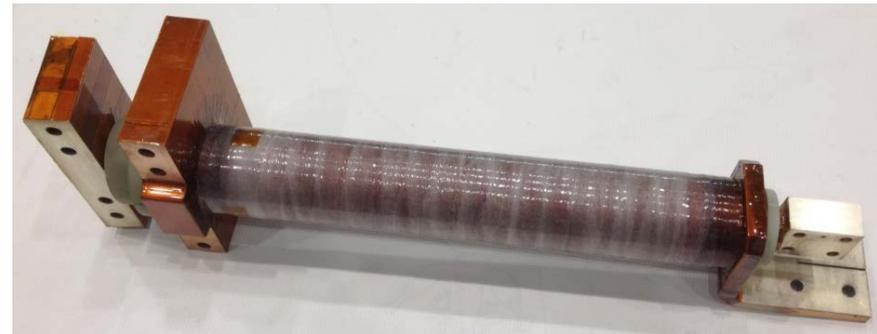
# OH Coaxial Feedthrough

- Clearance between the OH coax inner/outer conductors is required for the initial installation! The current design provides .010" radial clearance between the G-10 and the inner/outer conductors.
- The G-10 insulator between the OH coax inner/outer conductors shall be modified so that it conforms tightly to the inner conductor. Clearance between the G-10 and the outer conductor shall be adequate to ensure proper mating of electrical joints.
- While on the bench and disassembled, epoxy fill holes shall be made in the outer conductor shell.
- After installation, epoxy shall be injected into the void between the G-10 and the outer conductor.
- Trial fitting indicate that the in-situ potted coax will be removable.
- Bench testing of epoxy backfill process is underway.
- Modified drawings and Peer Review to follow successful trial.

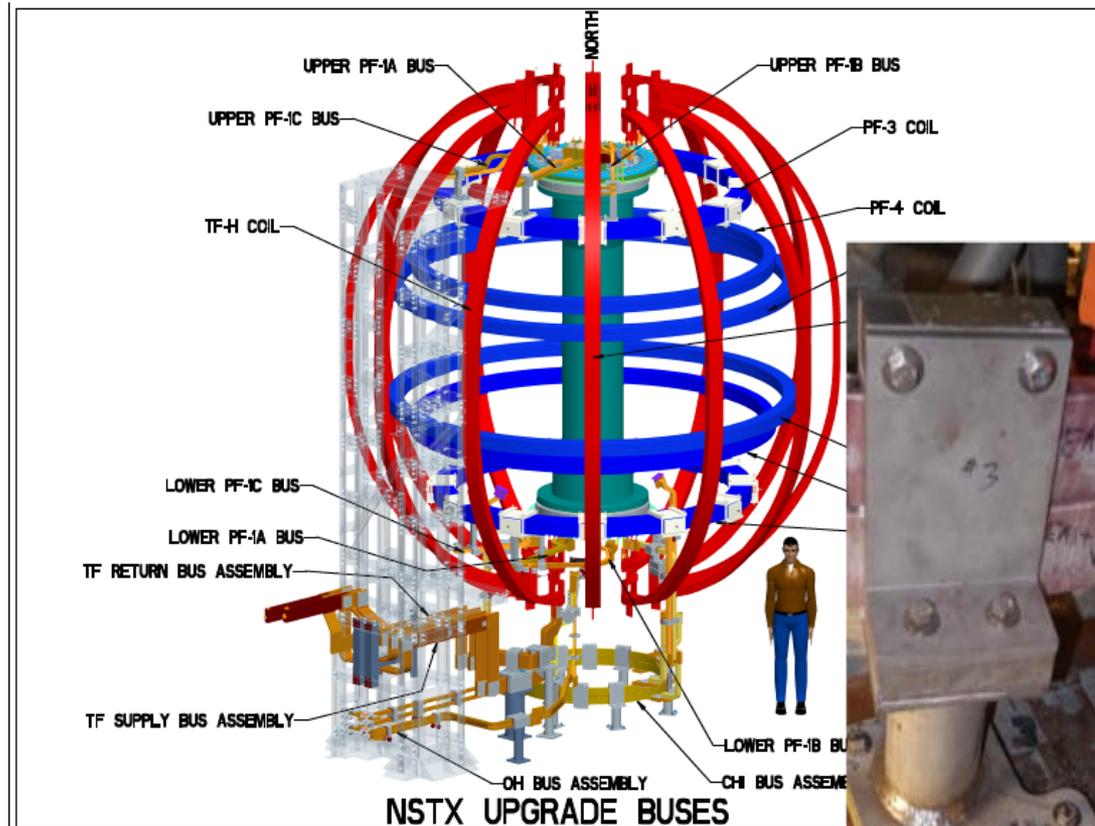
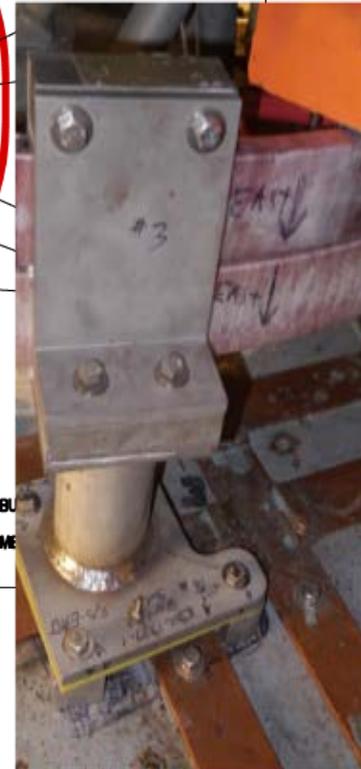
# Grounding the Bus Support Brackets

- The bus supports to the ground were not grounded appropriately.
- Details will be coordinated with electrical engineering group.
- Drawings being generated for the installation of grounding cables which will connect these supports to the proper category ground.

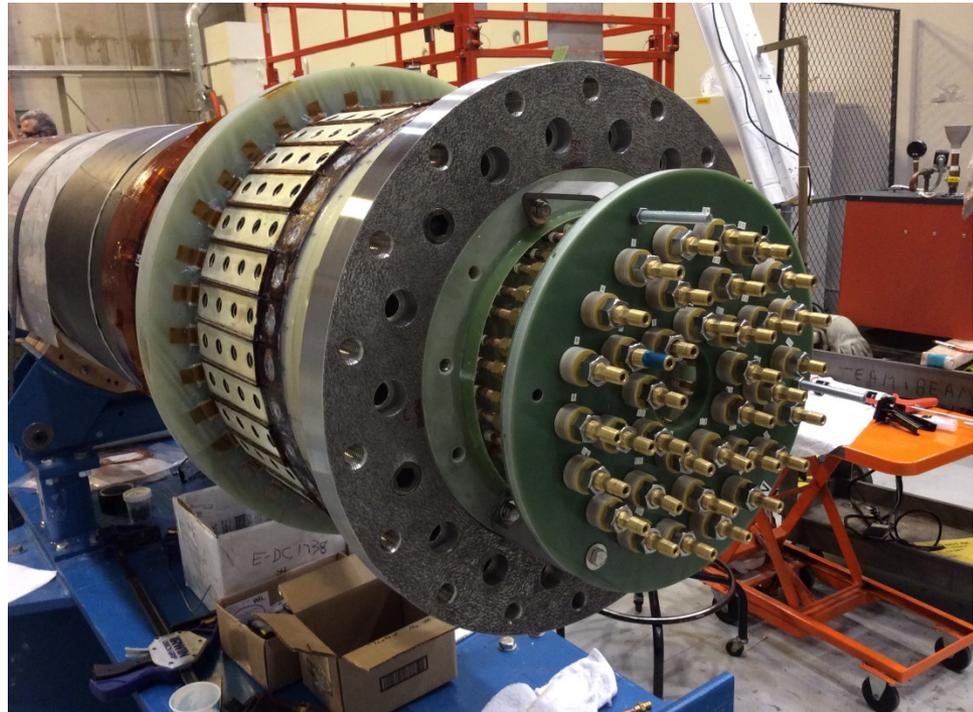
# Grounding the TF cooling tube bulkhead brackets

- These brackets support a G-10 plate that supports the 36 TF inner leg cooling tubes and were not grounded.
- Top side brackets will be referenced to outer vessel ground.
- Bottom side brackets will be referenced to building steel ground.
- Details will be coordinated with electrical engineering group and documented on new drawing.

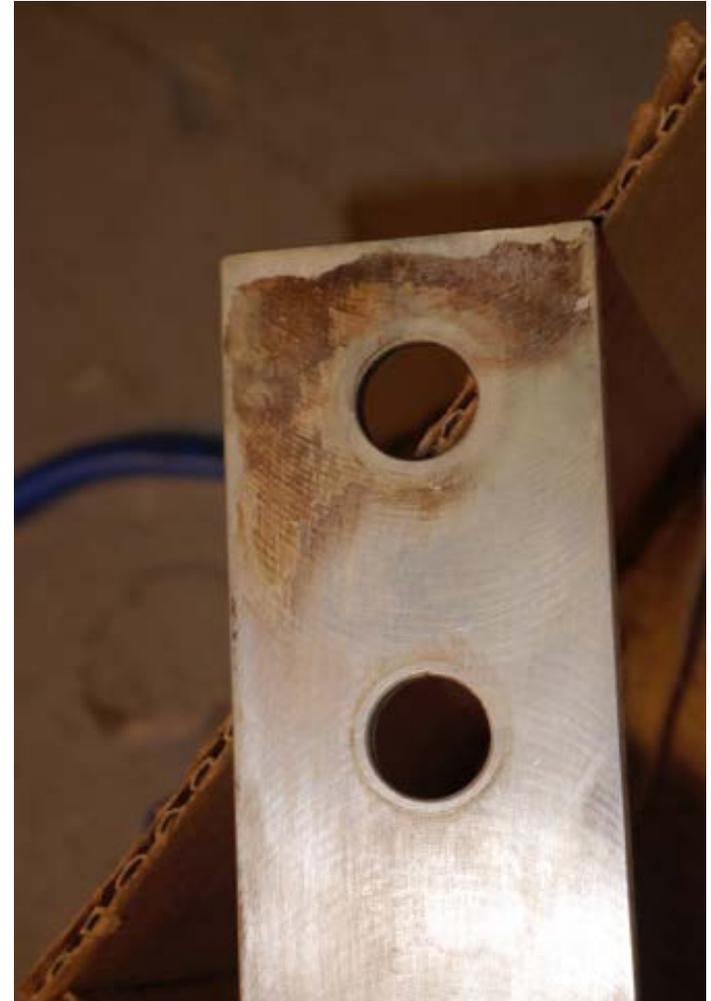
# Tarnished Silver Plating on Electrical Contact Surfaces

- Stains found on silver-plated TF joints
- Stains appear to be silver tarnish.
- Present on significant number of joints.
- We have experienced two events with water spraying onto these areas. Likely caused by water entering joints through capillary action or by exposure to air.
- Surfaces have good flatness – most have measured flat to within 0.001”
- Have price quote from local tester to perform analysis to confirm that it is tarnish.

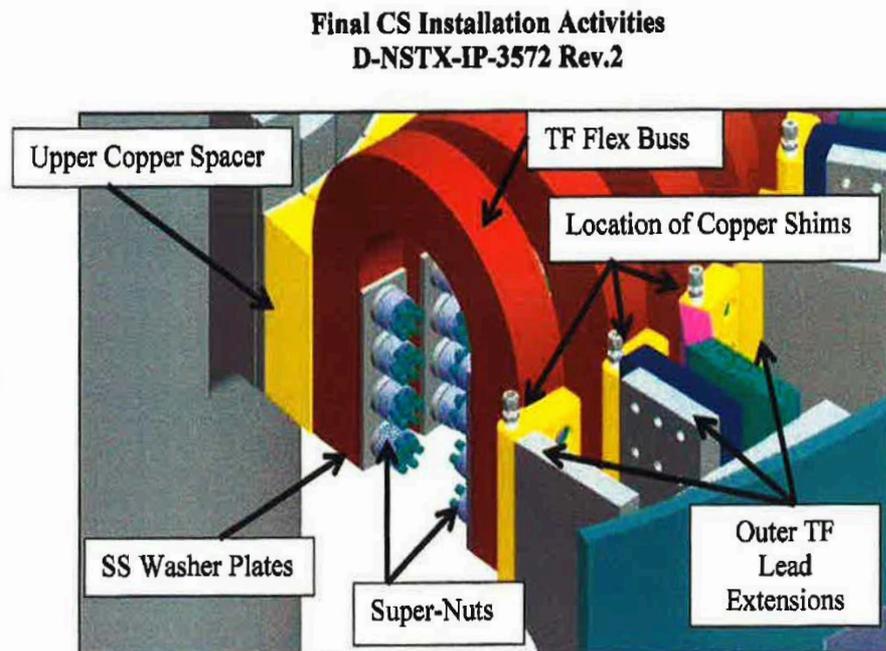
**Figure 7- Typical TF Flex Bus Assembly**

- Resistance measurements of electrical joints were made with Biddle instrument.
- Many joints could not be directly measured due to access restrictions – measurements across multiple joints were taken instead.
- We are evaluating the recommendations from electrical engineering to provide better resistance measurements for all bolted-up electrical joints.
- Techniques from electrical engineering shall be incorporated into the re-installation procedure(s).
- Plan to expand the use of temperature stickers to better monitor electrical joint temperatures. We'll need an plan for inspecting the hard-to-see stickers.

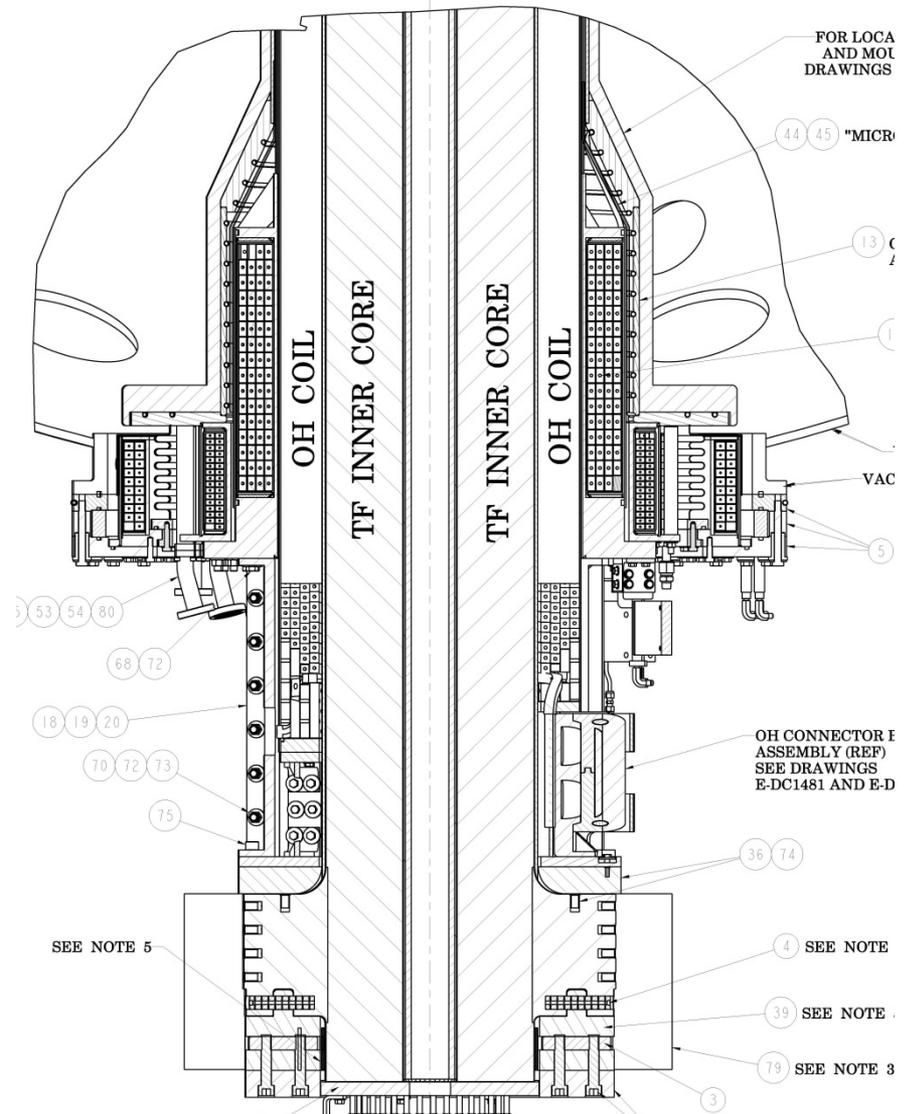
# Divertor Bake-out Options

- During the mini bake-out, it was realized that the tiles in the divertor region were not achieving desired temperature.
- There are copper cooling lines embedded in the centerstack case that are there for cooling Inner PF coils 1A and 1B.
- We are extending the cooling tubes to the outer edge of the umbrella, where they will be available for “alternate” plumbing configurations in the future.
