# NSTX-U OH Fault Report on Extent of Condition

J. Hosea (chair), R. Ellis, N. Greenough, D. Mueller

NSTX-U Arc Fault External Review  
May 28, 2015

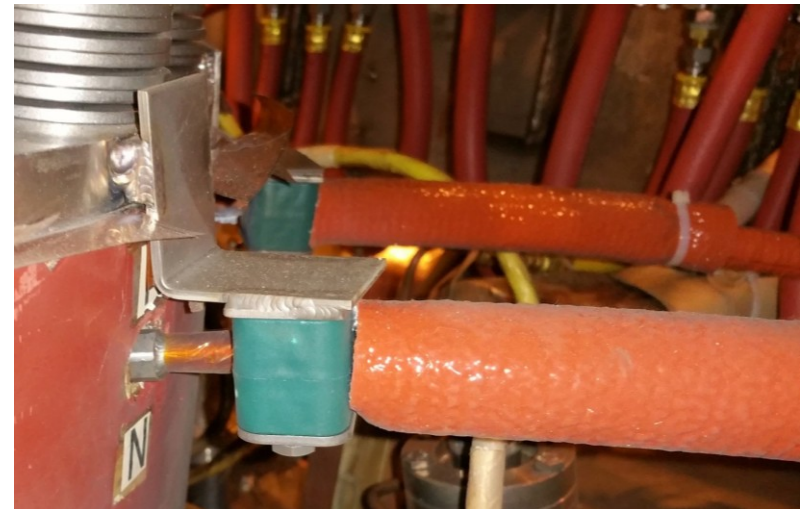
- Need an approved design with proper insulation - underway .
  - Original parts were field fit.
  - New design must have electrical engineering input to insure proper high voltage insulating techniques - underway.

Original implementation of OH water connections

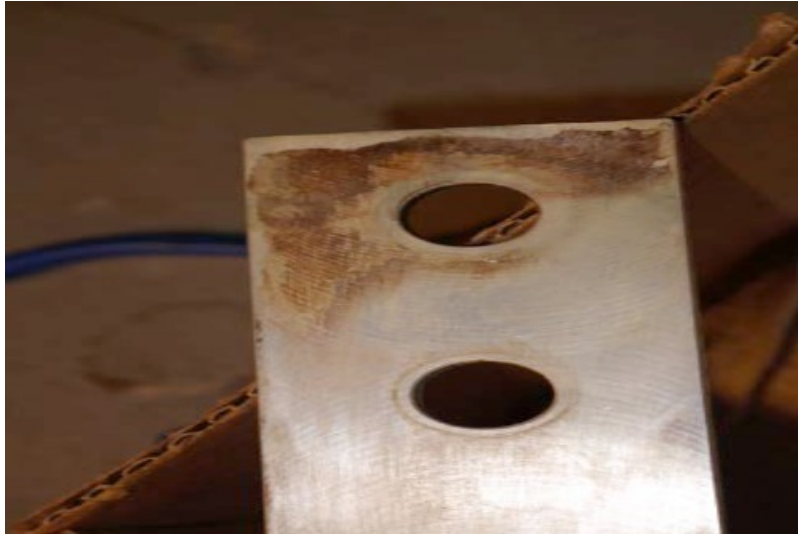
- Improve quality and uniformity of silver plating of contact surfaces.
  - Tarnishing of some of the silver plated areas has been observed.
  - Variable thickness, observable by eye, of silver plating?
- Cracking of G-10 spacers observed on some of the TF connector restraints
  - Structural adhesive will now be used to fill joints to prevent gaps causing stress. Tests for using adhesive with teflon mold release have been successful.
  - Any analysis on the expected performance of the adhesive?
- Use temperature stickers, monitor with a borescope or camera/fiber optic bundle.

Tarnish on silver plated connectors

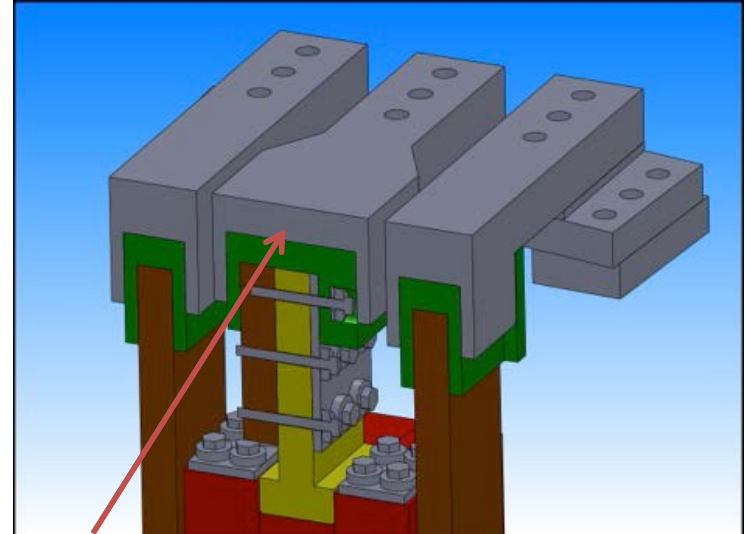
G-10 caps that cracked → improve contact with structural adhesive??

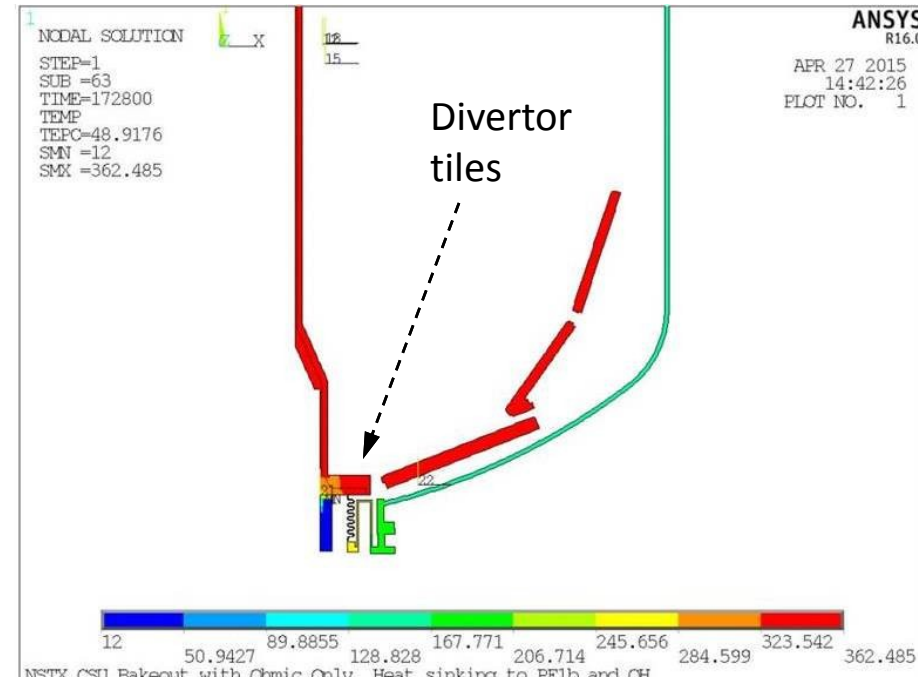
- Failure to reach desired 350C bakeout for divertor tiles is predicted.
  - Refer to PF-1A, B, and C considerations
- High temperature is needed for bakeout of divertor plates to provide for good plasma performance.
- Preparations need to be made to add hot He gas heating to the divertor plates to reach desired temperature of 350C.
- Discoloration of CHI leads after Center Stack bake.
  - Need to understand the cause

- Heating of graphite tiles is adequate with He heating of divertor plates
- But PF1B G-10 spacer and wrap get too hot
- Also the welds taking up launching loads may be over stressed
