NSTX-U Startup Arc Fault Technical Explanation

M. Williams (AD Engineering and Infrastructure)
Stefan Gerhardt (NSTX-U Research Operations)
NSTX-U Engineering Team

OH Arc Fault External Review
May 28, 2014

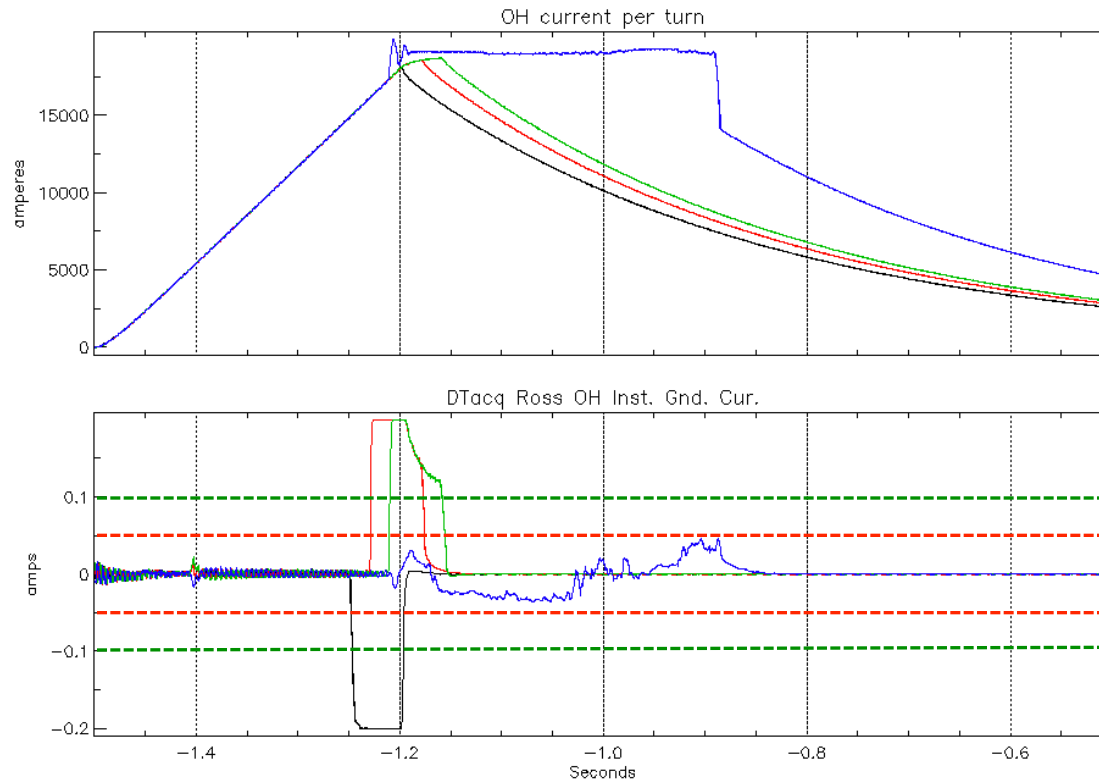
Shots:
200185
200187
200189
200190

Ground Currents Were Much Different on 200190

- Ground currents noticed during forensic analysis following the arc
- 200190 had different characteristics than the previous ground fault trips.
 - Less ground current, but much more damage.
- Instantaneous ground fault detector would not have detected any problem or terminated the shot.
 - Hence, removal of that instantaneous GF detector cannot be blamed for the damaging arc.
 - Again, the inverse-time GF relays were always present.

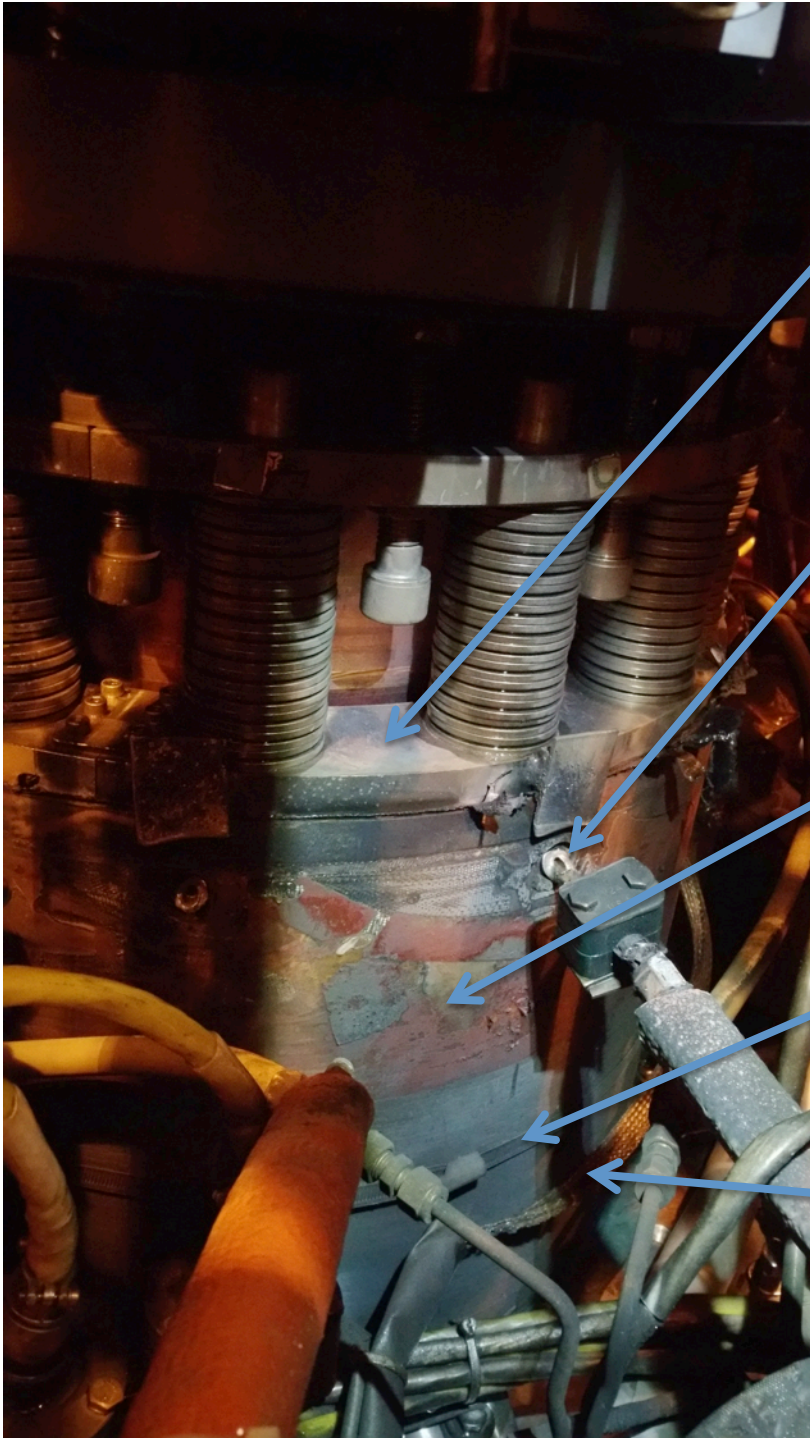
Electrically floating OH Preload Assembly

Damaged water fitting and strain relief bracket (4 places)

OH ground plane reference conductor clamp

OH ground plane reference conductor (loose, and note rest position)

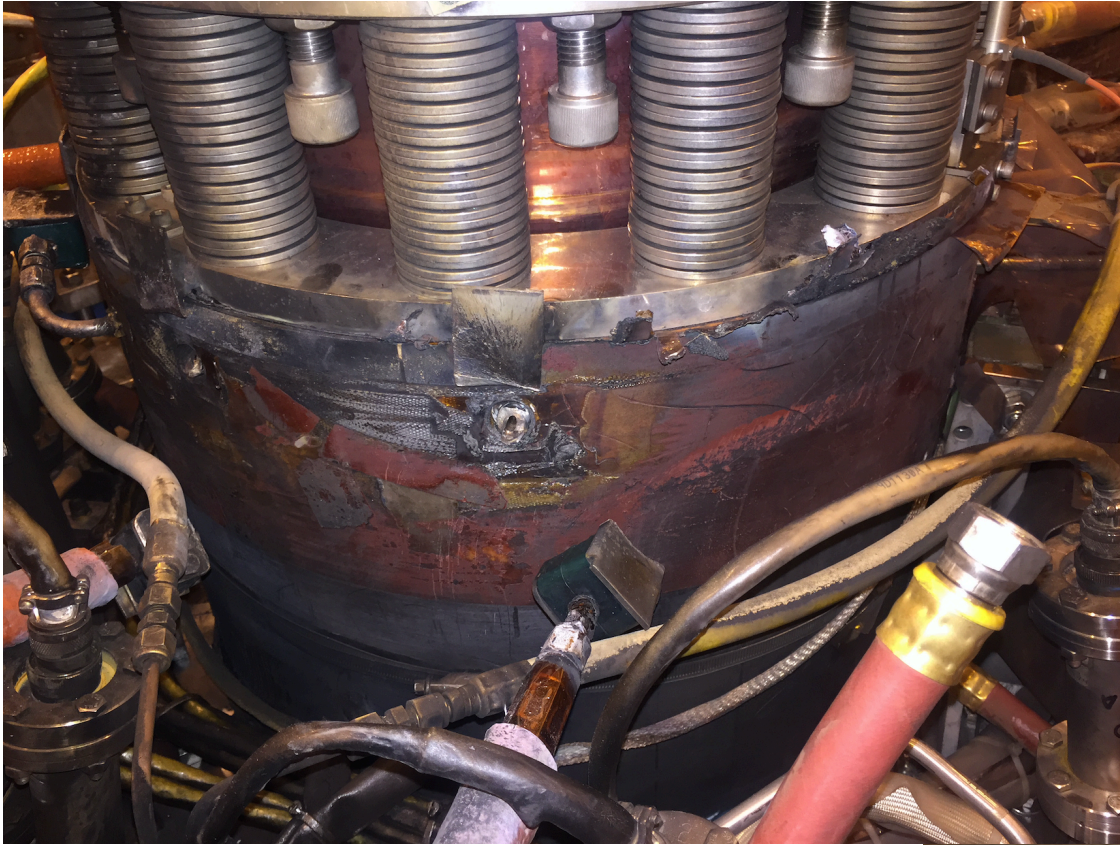
- The braid pulled away from its clamp and touched ohmic heating coil water coolant tubes initiating an arc.
 - The braid was improperly installed and formed a continuous current loop.
 - Loop reacted to ohmic heating coil flux swing & magnetic field.
 - This creates a vertical $J \times B$ “launching” force.
 - The conducting braid had worked loose of its clamp, and was free to move vertically over part of its toroidal extent.
 - Differences in the vertical motion of the braid resulted in different current/fault characteristics on consecutive shots.
 - Between-shot electrical tests didn’t identify this issue.

Rest position is well below the location of the largest arc damage, but braid damage was observed.

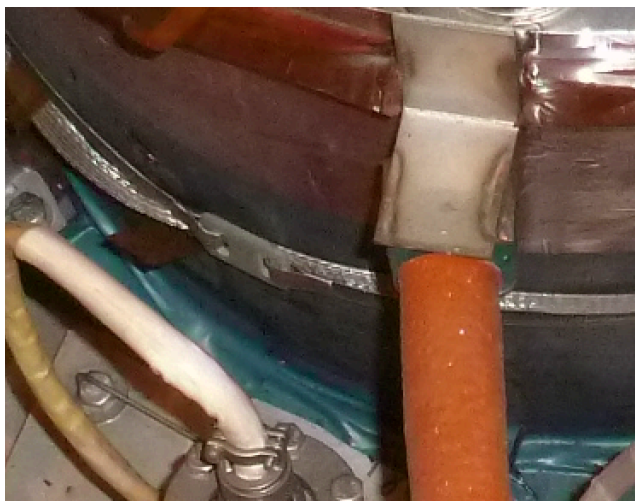
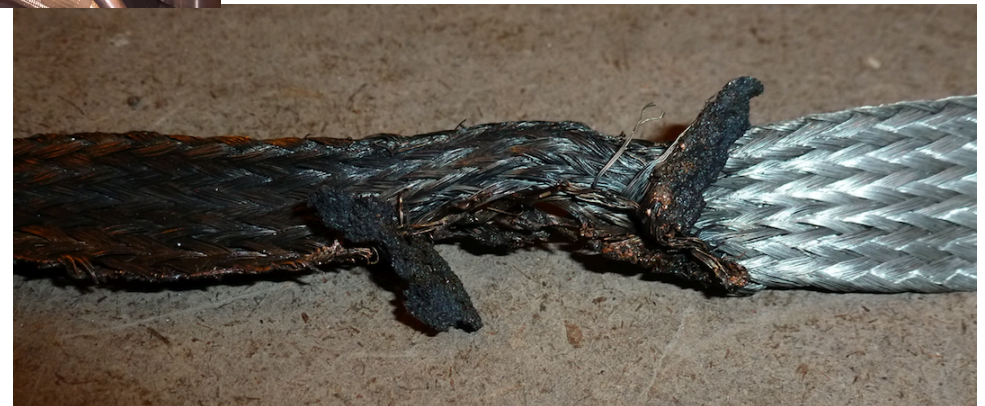
Braid bridged the insulating break in the clamp, but was restrained at that location, ~180 degrees from the fault area

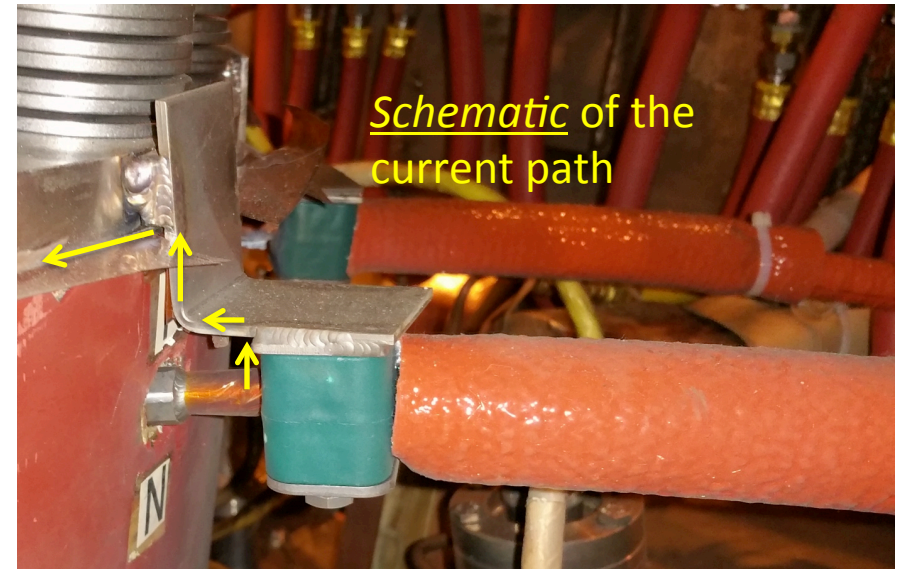
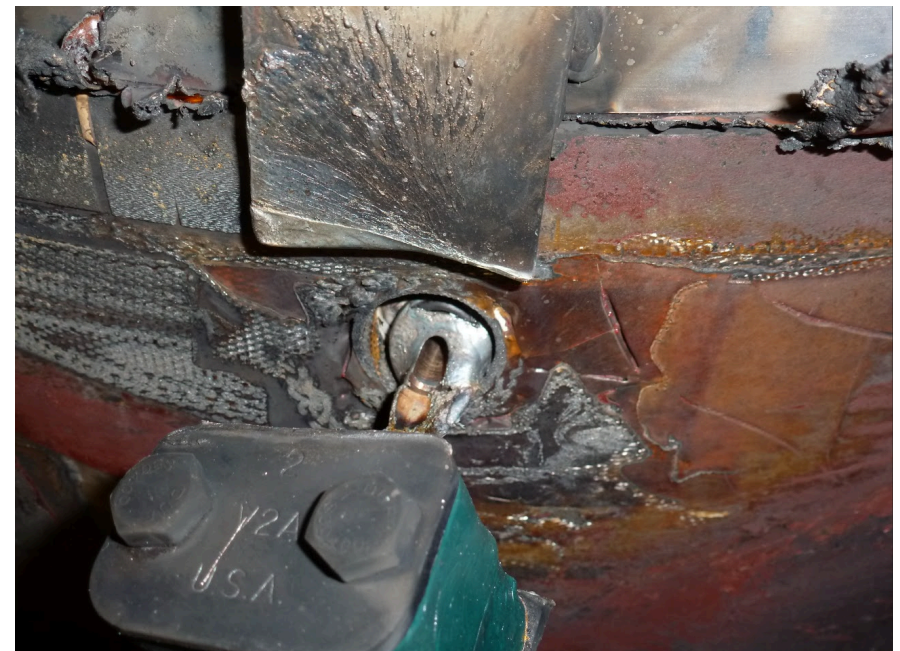
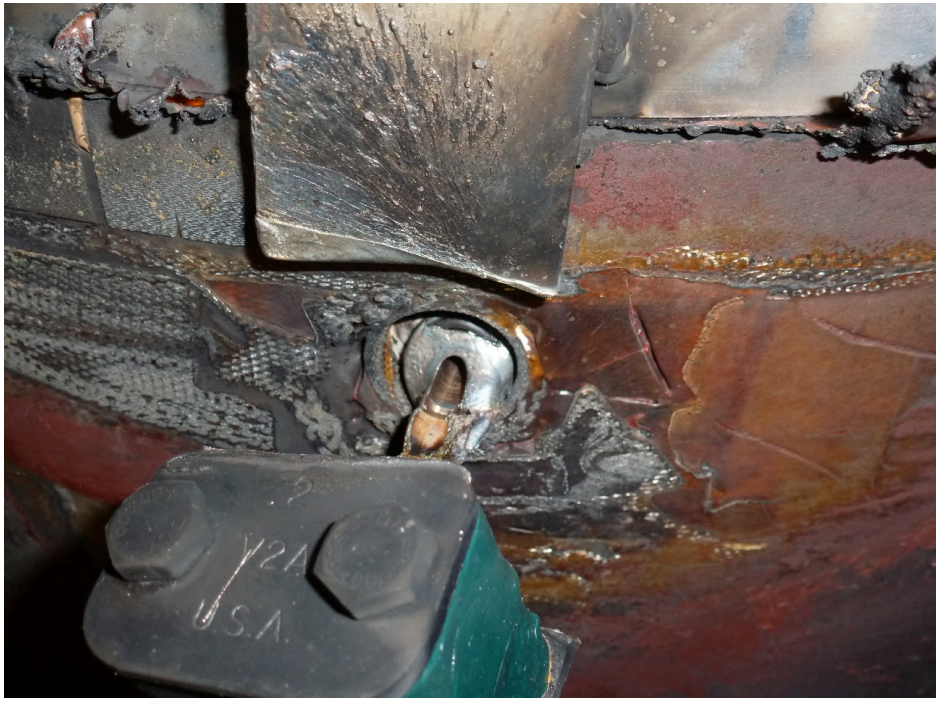
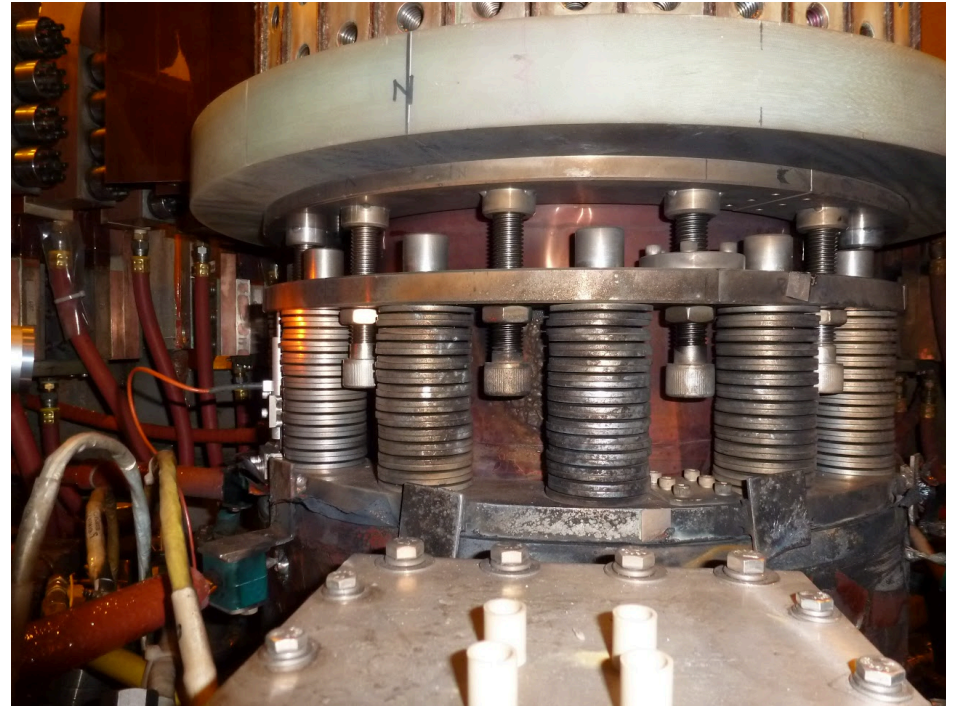
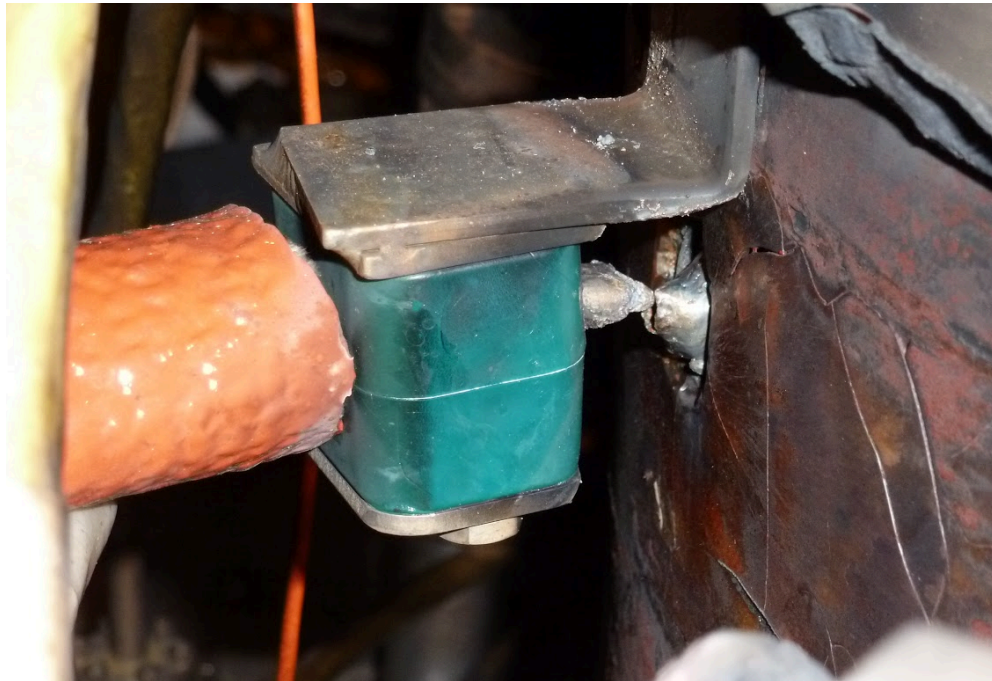
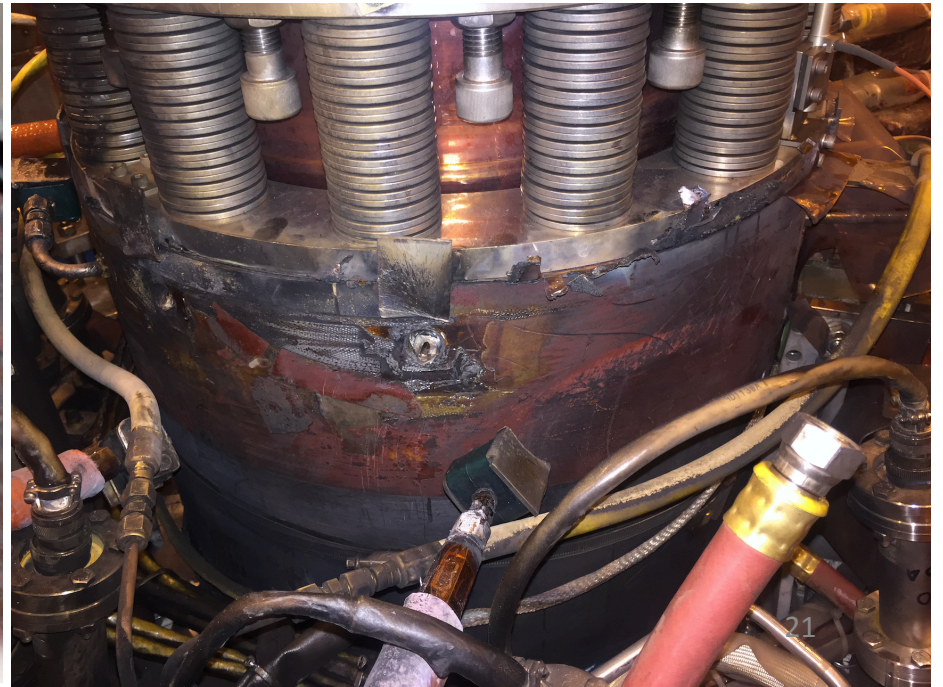
- The arc engaged the *ungrounded* preload-assembly and was sustained for about 300 milliseconds.
 - the OH Preload Assembly was not electrically referenced to the NSTX-U inner vacuum vessel, and therefore:
 - did not produce a OH circuit ground current trip, and
 - High-pots of the OH coil system could not detect communication between the coil and the washer stack.
 - the OH coil water cooling tube strain relief assemblies were compromised due to the initiated arc

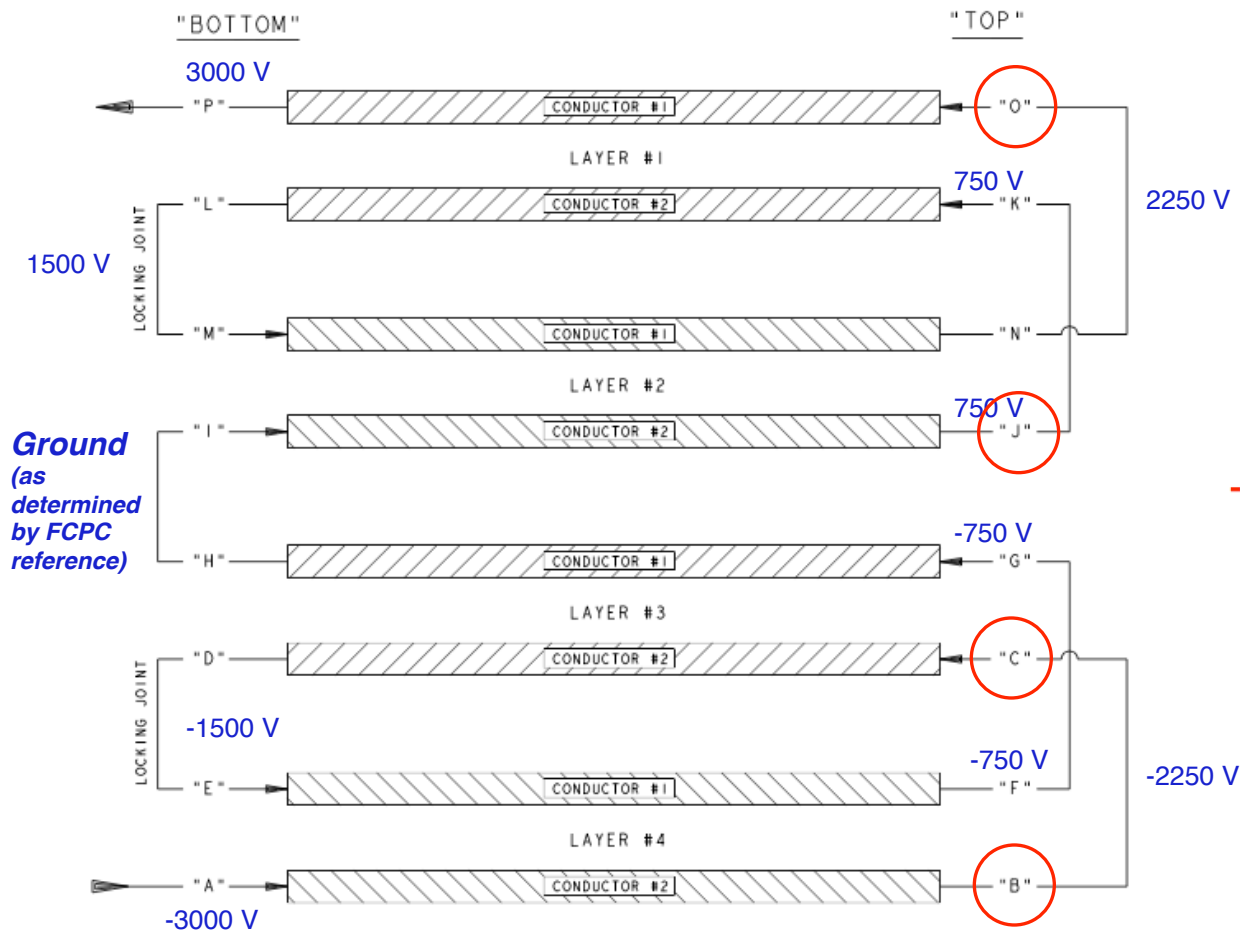
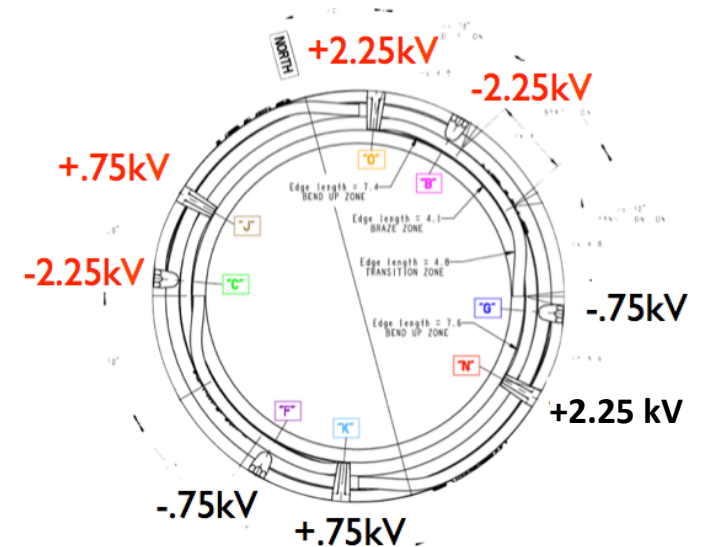
The Arc Included the Two Highest Voltage Water Feeds

Red indicates where there was damage

Conceptualize the arc as shorting out $\frac{3}{4}$ of the length of the coil.

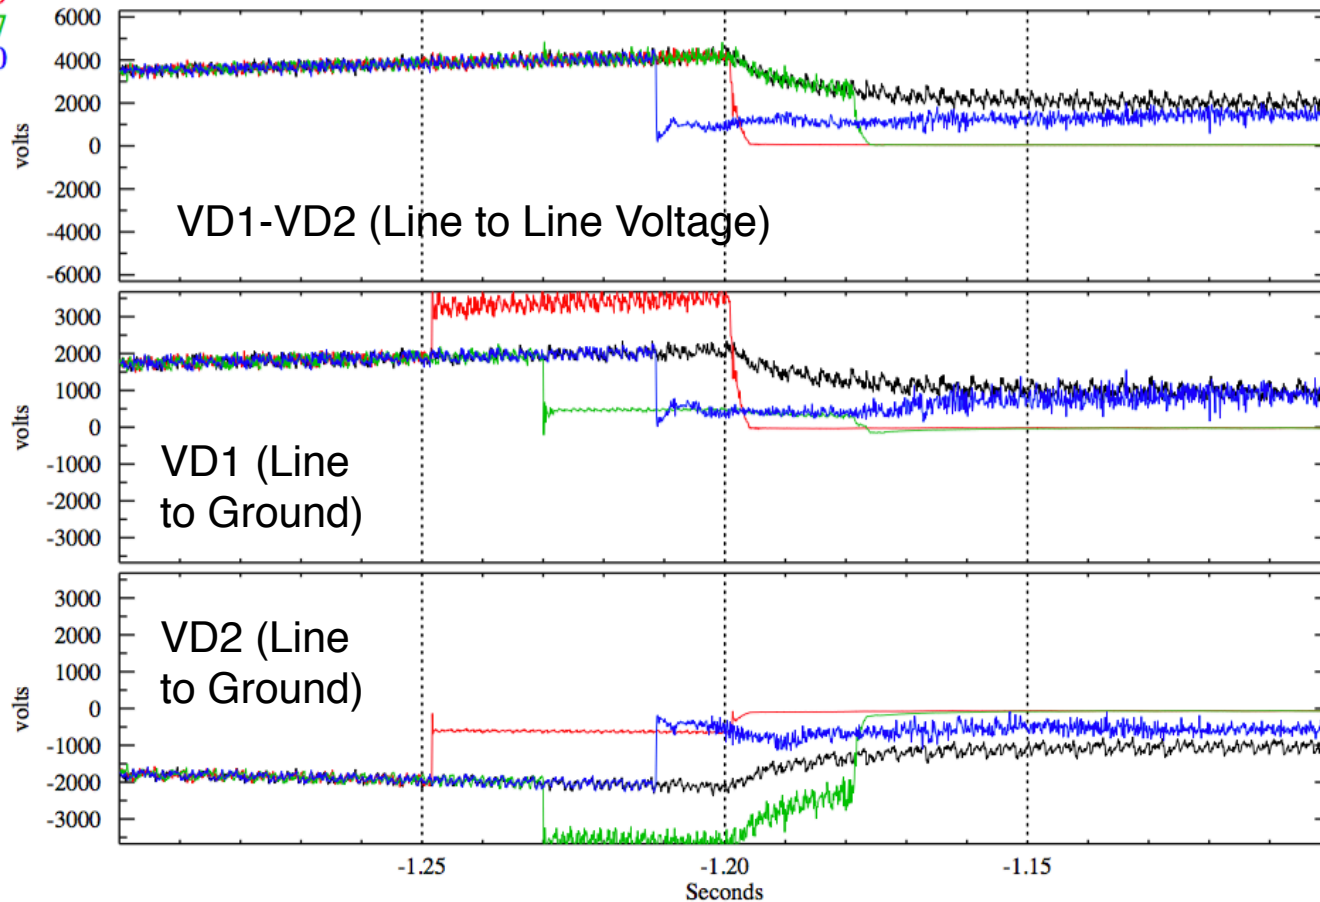
Shots:
200157
200185
200187
200190

Changes in the Line-Ground Voltage Go With Changes in the Ground Current

200157: Good 100% shot from ISTP, Symmetric

200185: Ground Fault
VD1 goes to 3200V,
VD2 goes to ~600 V.
600 V / 3800 ~ 1/8 of total coil voltage.

200187: Ground Fault
VD1 goes to ~500 V.
VD2 goes to -3400.
500 V / 3900 V ~ 1/8 of coil

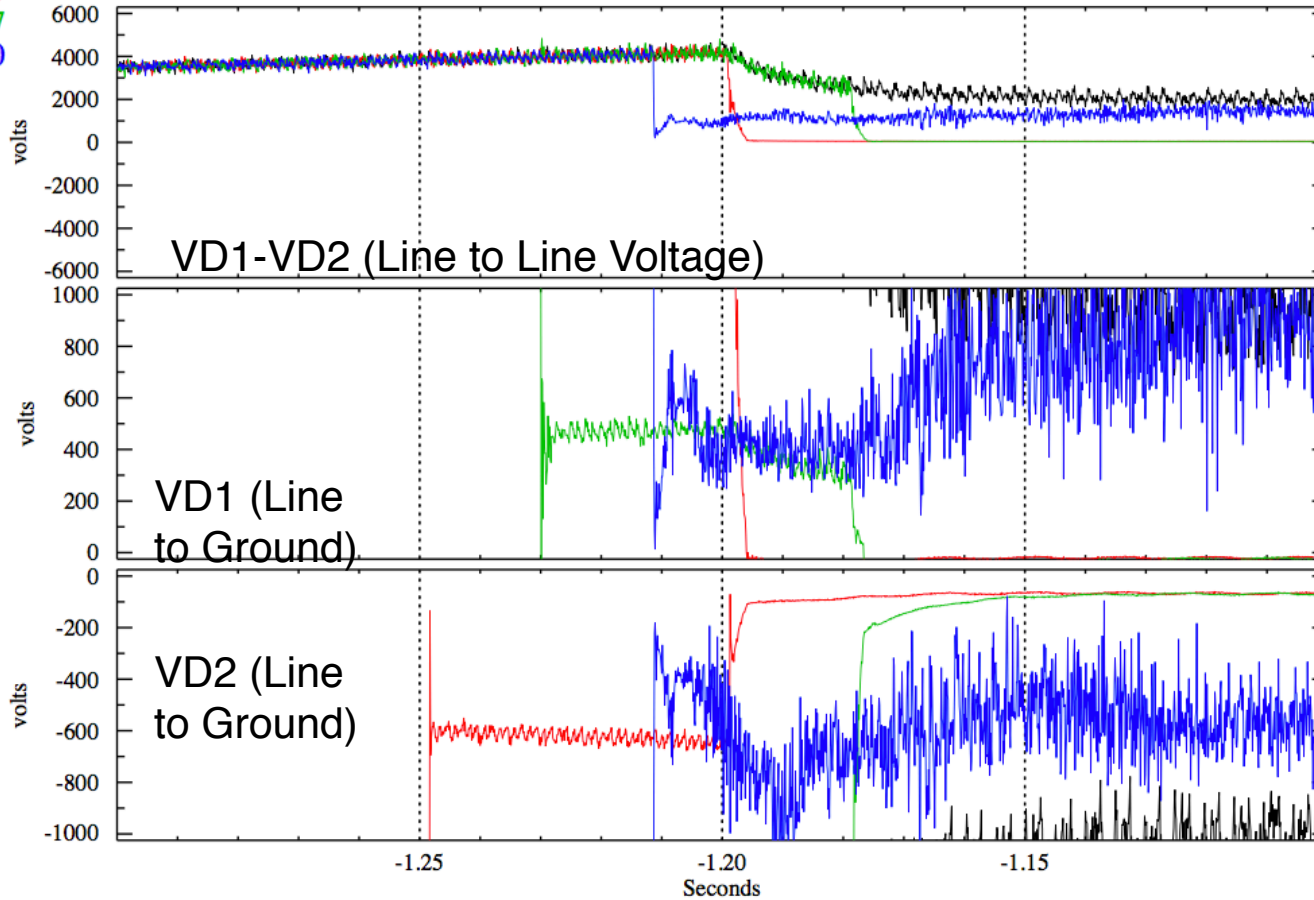
Shots:
200157
200185
200187
200190

Line-To-Ground Voltages Drop On Both Sides During Final Arc

200190: Large Arc at $t = -1.21$ s
Both sides dropped to similar level.

(and thus no ground current)

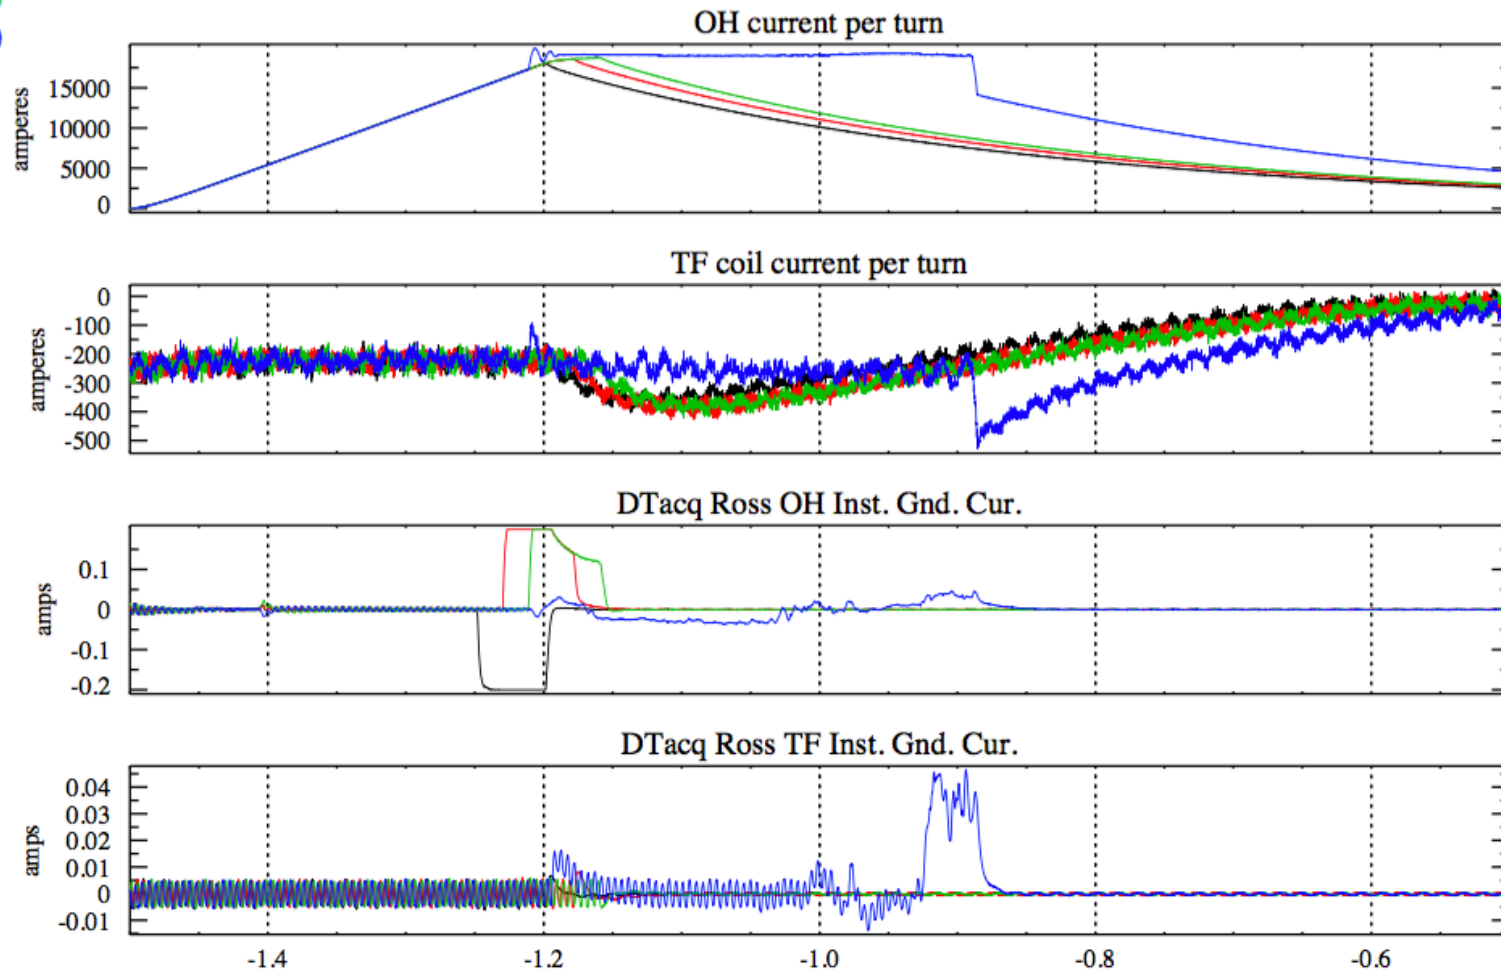
Shots:
200185
200187
200189
200190

The Final Shot Tripped Off on TF Ground Fault Warning

Note: No TF Ground Currents Observed on Any Previous Shots
