Extent of condition reference materials

Meeting with engineers to determine their concerns for extent of condition 5/19/2015

EXTENT OF CONDITIONS

NSTX-U OH Fault Extent of Condition Review

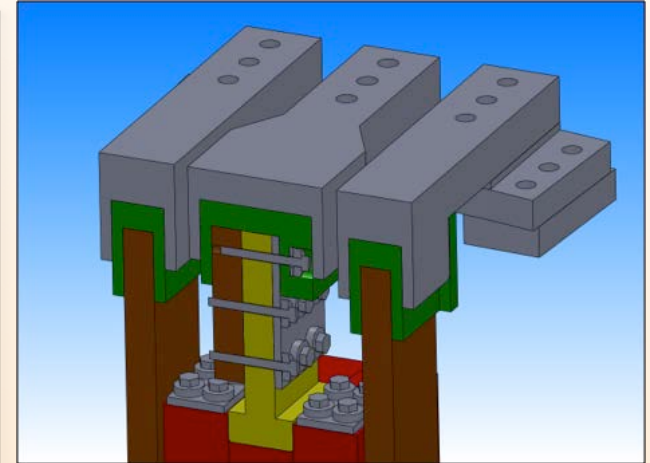
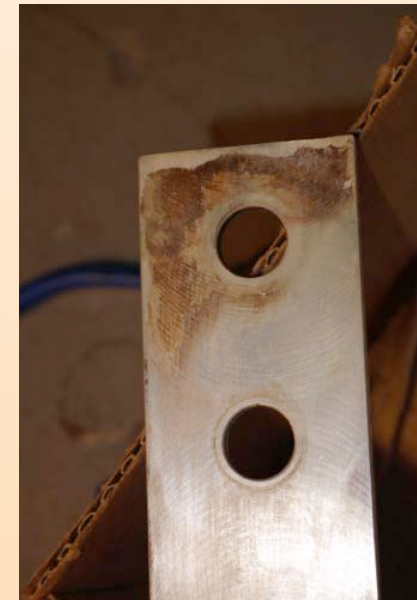
-OTF Finger Supports (Sibilia)

- ◆ Newly identified cracking of G10 cups.
- ◆ Adding structural adhesive should eliminate the problem but will make future disassembly more difficult

-Electrical Contact Surfaces (Sibilia)

- ◆ Stains found on TF joints
- ◆ Have price quote from local tester to perform analysis

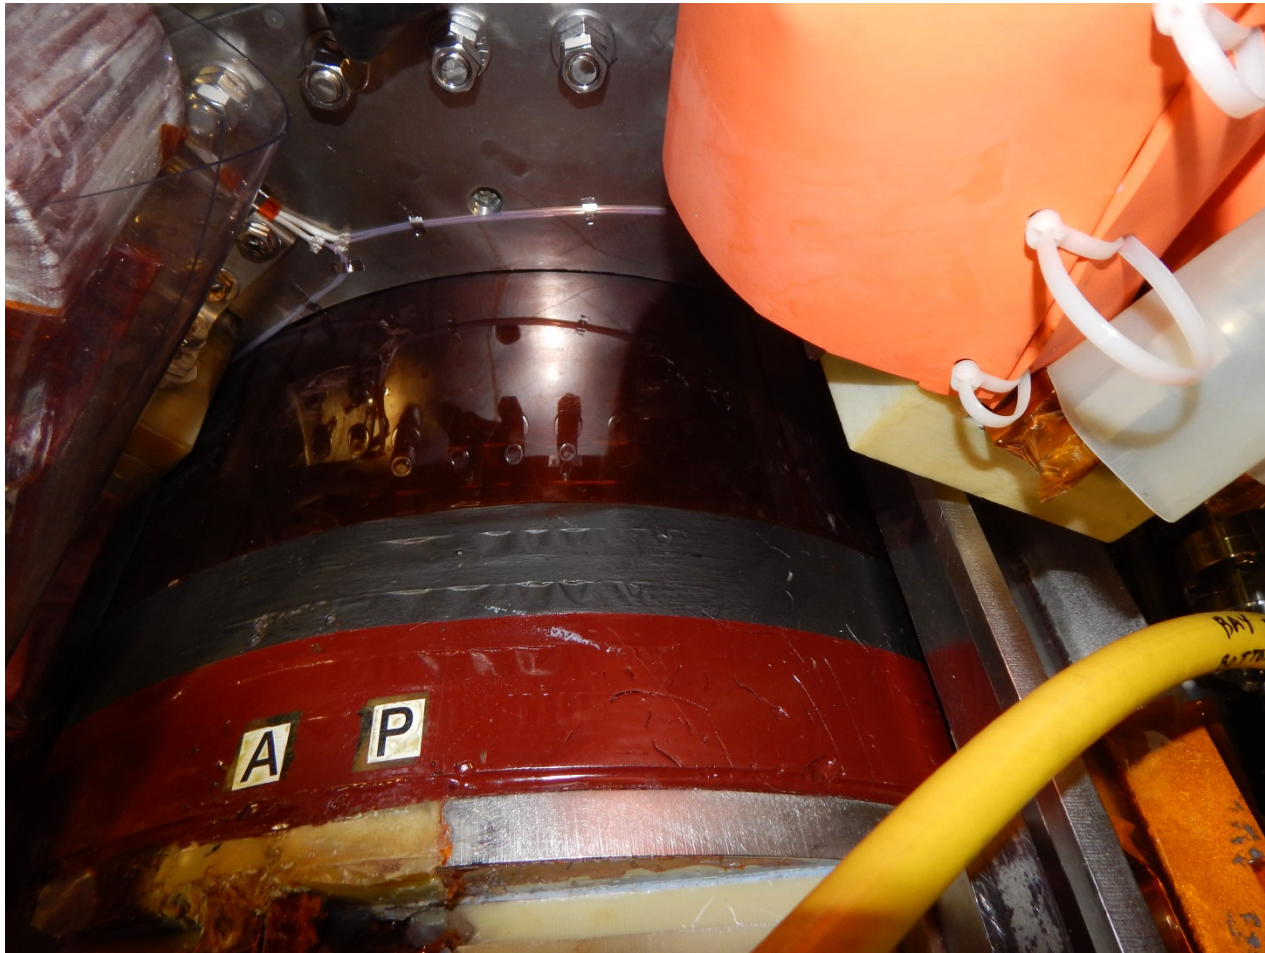
OH Ground Plane Lower Grounding option

- OH ground plane - lower grounding point.
 - Has benefit, however the installation of a lower grounding location is not without risks. Many energized components in the area (PF-1A and PF-1B leads are to the left/right and the OH coax is below the only location that we can add a lower grounding point.

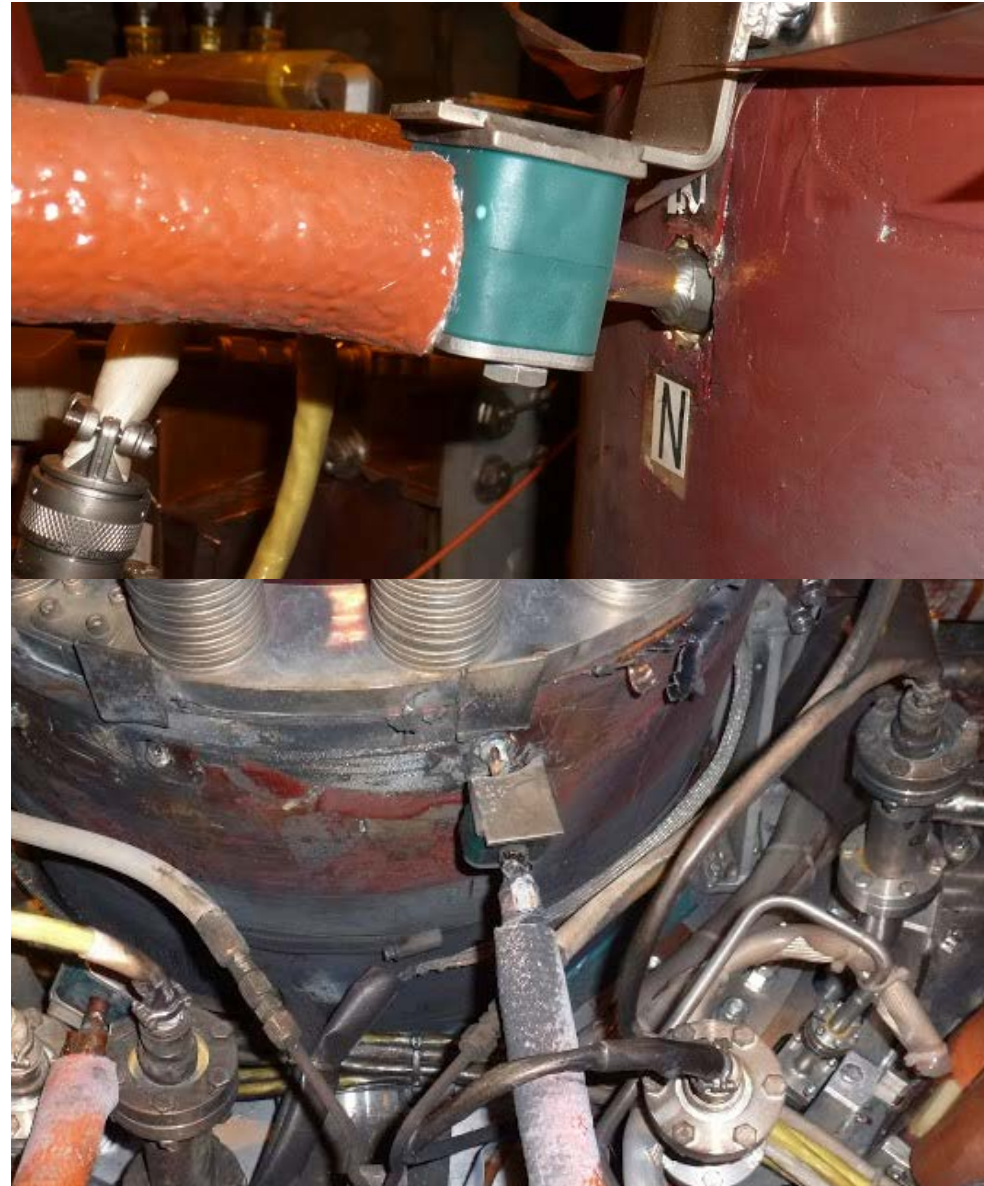
- Four of the eight Upper OH Coil Fittings were burned during the recent incident related to the OH Grounding Cable.
- The clamps which was holding the fittings were also damaged.
- The SS Braided hoses were intact.

- Inspections and leak tests proved that no damage occurred to the OH Coils
- Hydrostatic test was performed and the coils passed the test
- New clamps are being designed
- The new clamps will replace all existing ones

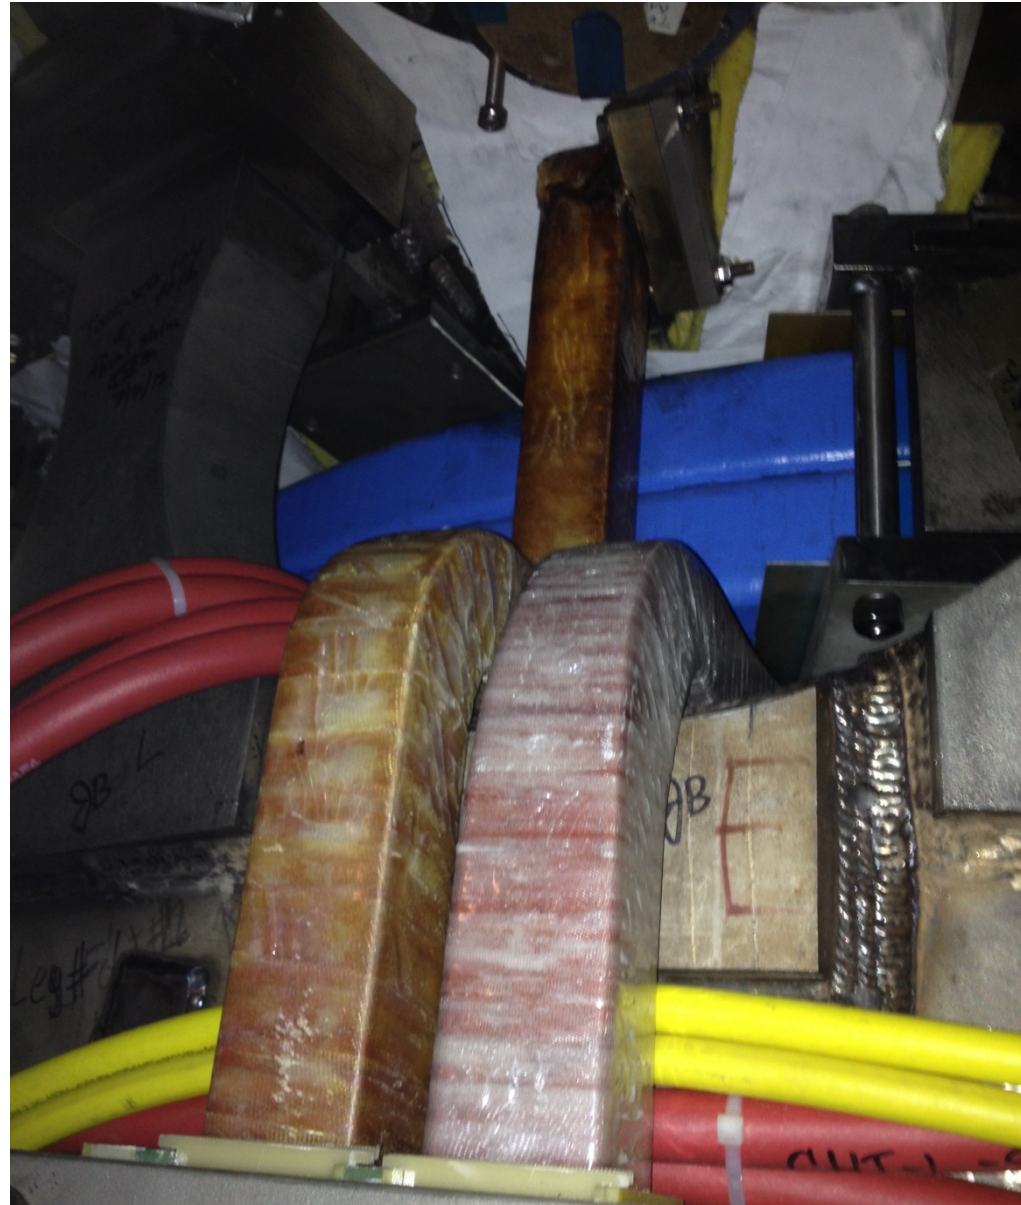
- The insulation on the Outer CHI Bus Bars changed color.
- Discussions were held between EEs, MEs and construction personnel.
- It was discovered that bakeout was done at 8 KA. Bakeout usually done at 4-6 KA
- The plan is to install temperature stickers and measure how hot the conducts get.
- If necessary, the insulation can be replaced with high-temperature materials.

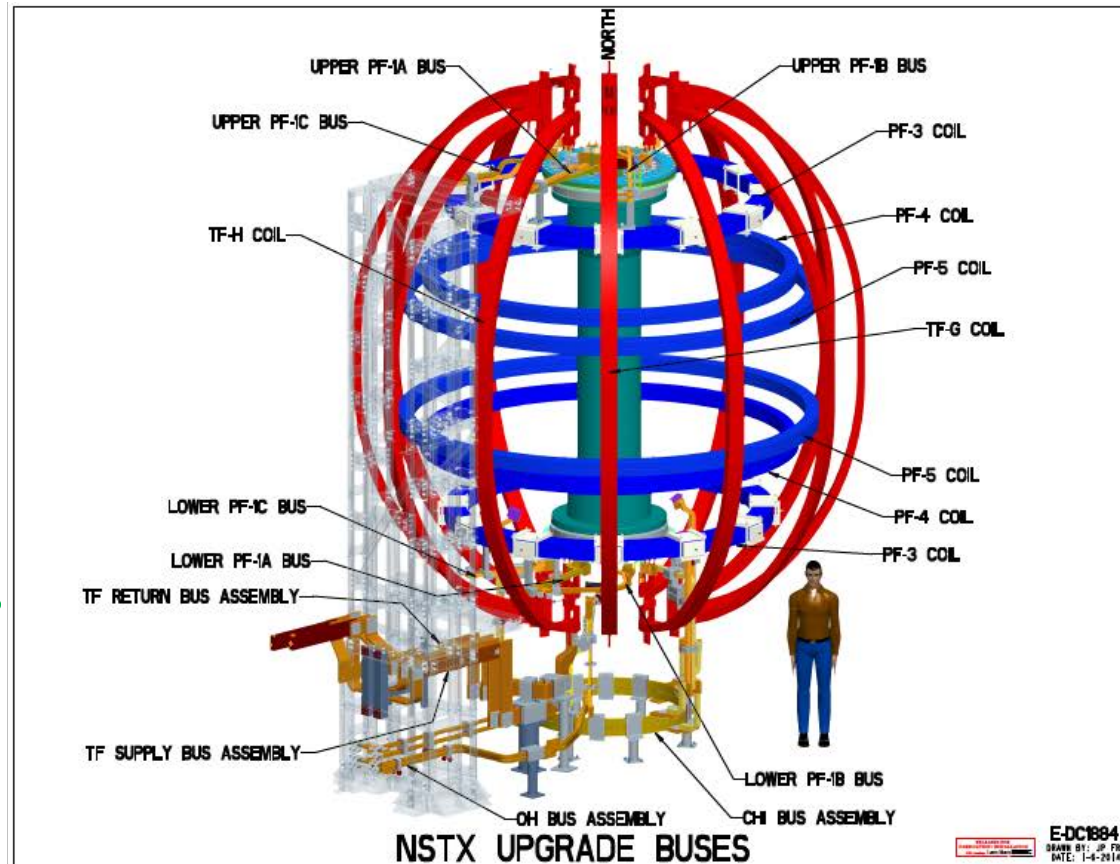
- The bus supports to the ground were not grounded appropriately.
- Discussions were held between EEs, MEs and construction personnel.
- There is work going on to generate electrical drawings and install grounding cables which will connect these supports to the umbrella structure.

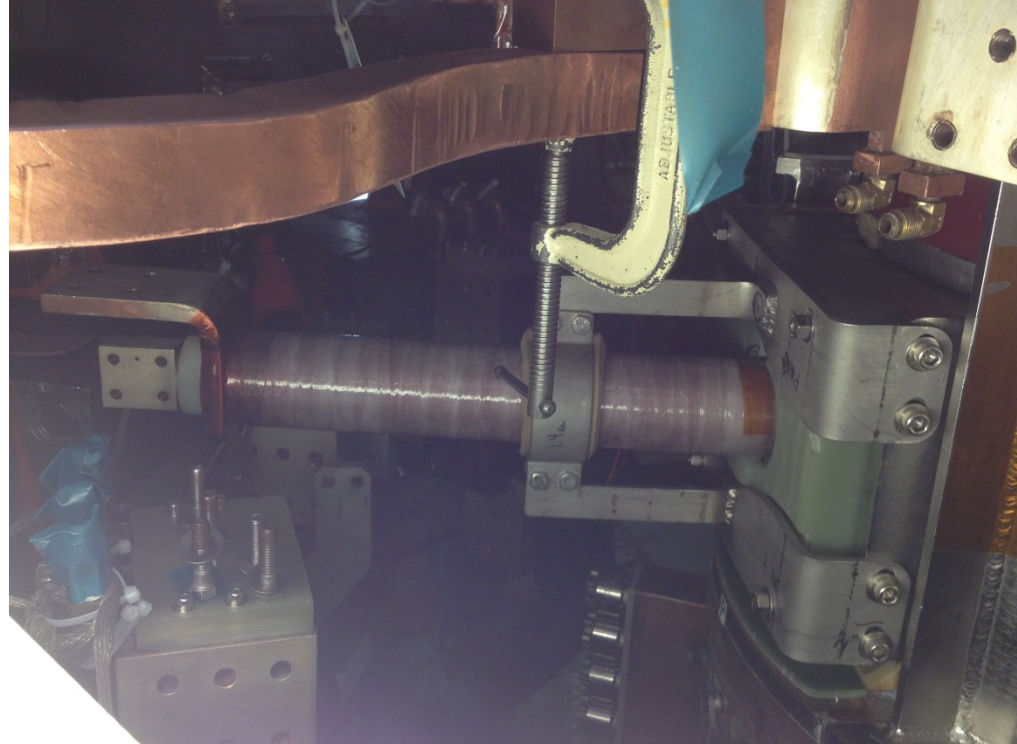
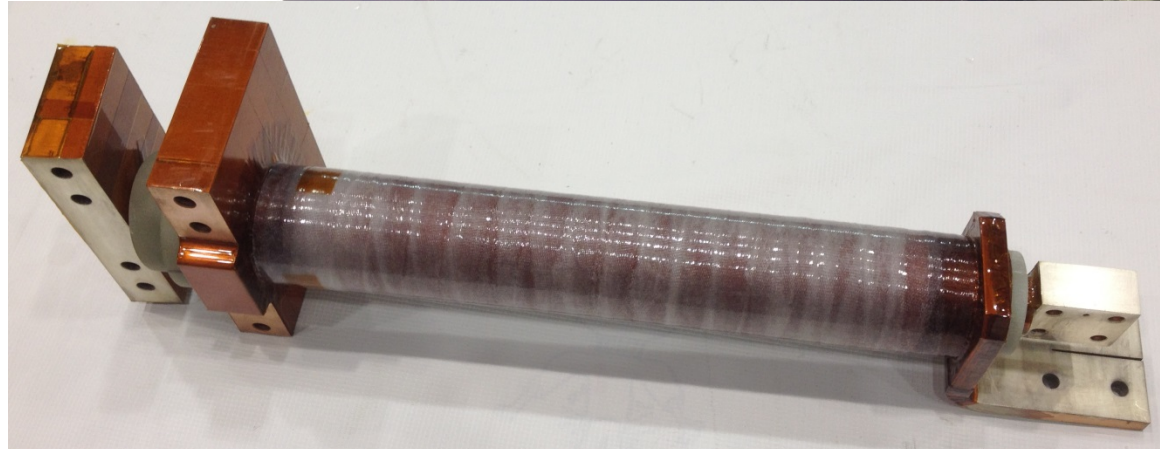
- The OH Co-Axial Bus was not filled with Epoxy as the parts were needed to be removable. #E-DC1750
- The radial clearance between mating parts was 0.01"
- Discussions were held regarding the need to fill the gap.
- The detail will have to be worked out, but there is a plan to fill the gap with epoxy in the field.

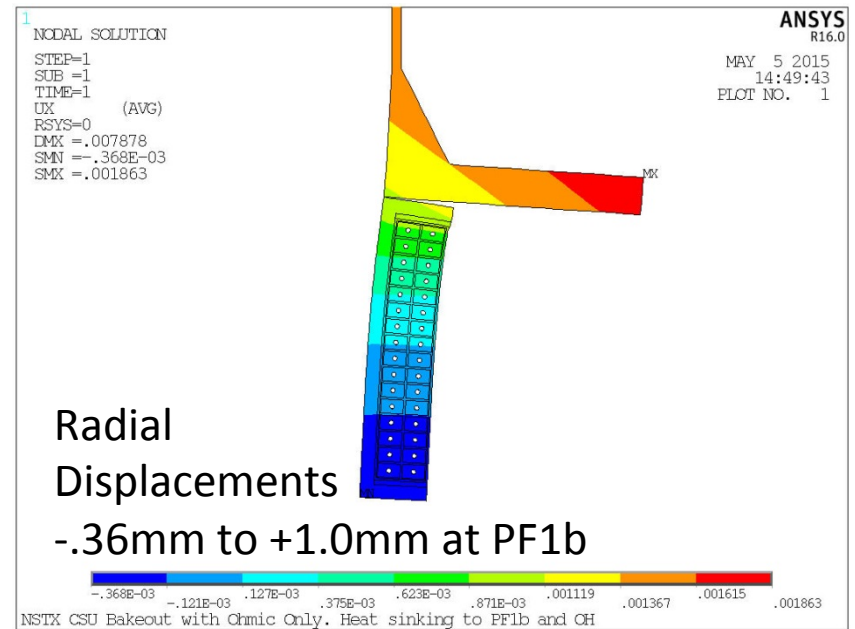
Shear At Weld from Thermal Growth

Weld Shear from Thermal Growth	
Radius	0.381 m
Weld Depth	0.003175 m
Weld Fraction	0.5
Weld Area	0.0038 m ²
Radial Force, 360deg	1.75 MN
Shear	460.49 MPa

460 MPa is taken as a limit on weld shear stress bases on (limited) testing

All options meet this limit except last (next slides)
