# NSTX-U OH Fault Report on Extent of Condition

J. Hosea (chair), R. Ellis, N. Greenough, D. Mueller  
May 26, 2015

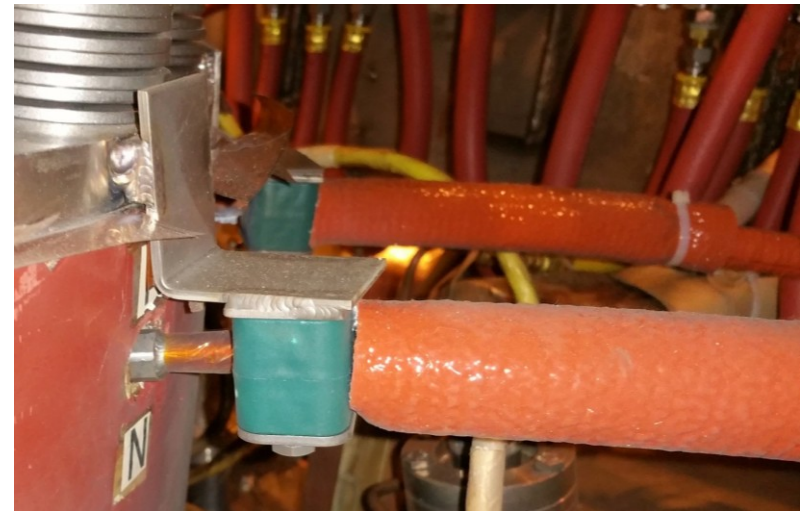
- Need an approved design with proper insulation - underway .
  - Original parts were field fit.
  - New design must have electrical engineering input to insure proper high voltage insulating techniques - underway.

Original implementation of OH water connections

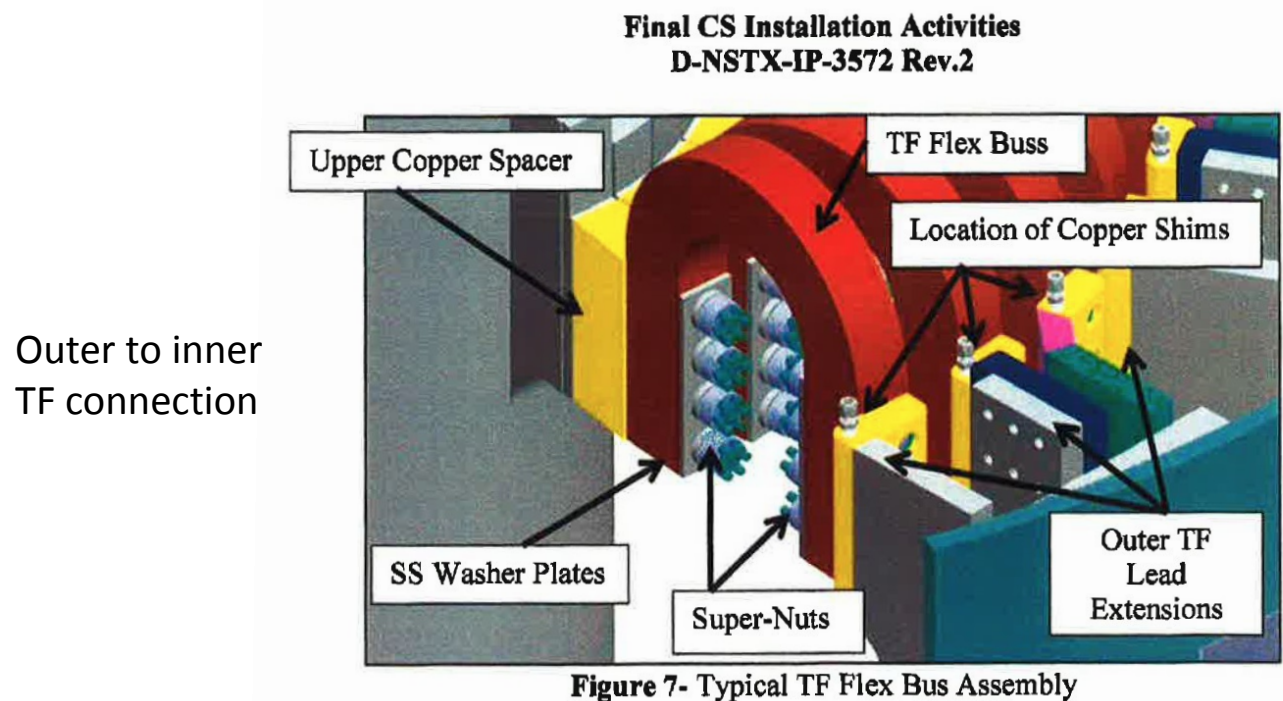
- Critical connection with several elements in series.
  - Fit-up is critical.
- Accurate joint resistance measurements are required.
  - NSTX-U has relied on purely mechanical measurements of joint characteristics. [torque, feeler gauges]
  - Investigate if techniques exist for proper measurement of joint resistance. Voltage across the TF inner leg connection can be measured via the water connection with current running through the connector assembly and the leg

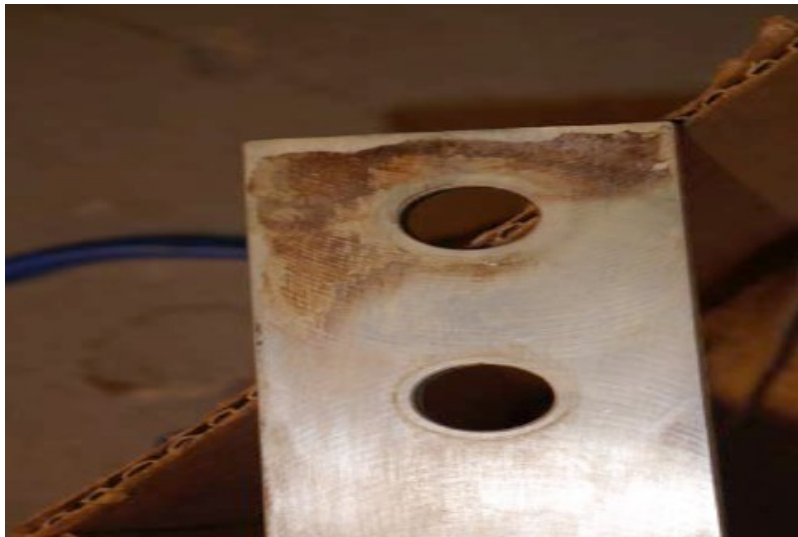
Tarnish on silver plated connectors

- Improve quality and uniformity of silver plating of contact surfaces.
  - Tarnishing of silver plated areas has been observed.
  - Variable thickness, observable by eye, of silver plating?
- Cracking of G-10 spacers on TF connector restraints
  - Structural adhesive will now be used to fill joints
  - Any analysis on its performance?
- Use temperature stickers, monitor with a borescope or camera/fiber optic bundle.

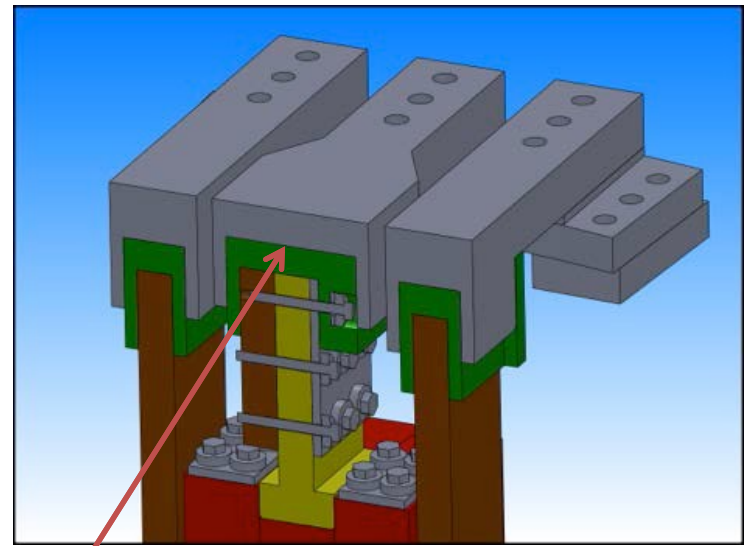
G-10 caps that cracked → improve contact with structural adhesive??

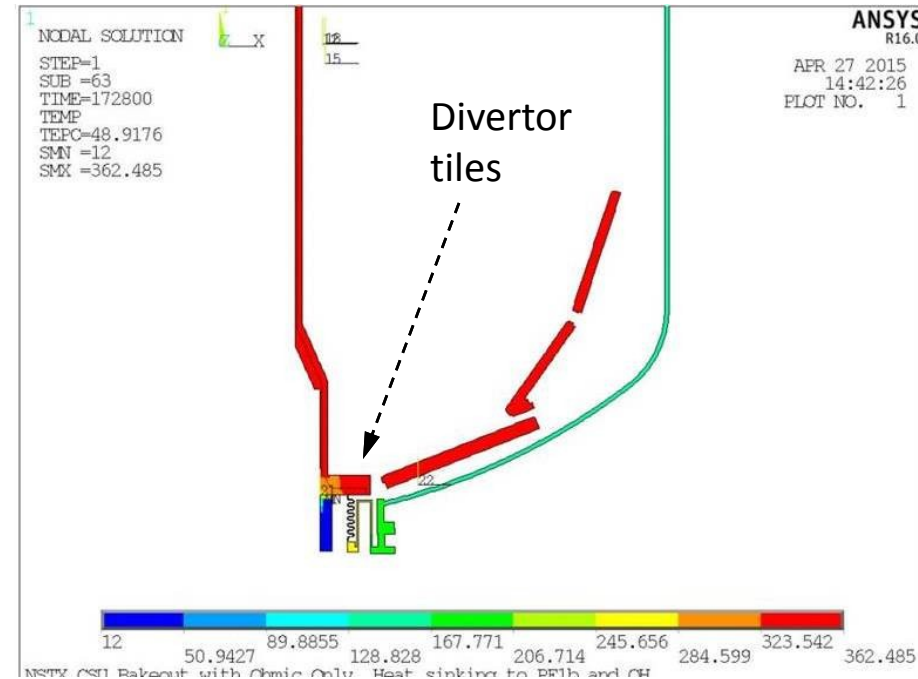
- Failure to reach desired 350C bakeout for divertor tiles is predicted.
  - Refer to PF-1A, B, and C considerations
- High temperature is needed for bakeout of divertor plates to provide for good plasma performance.
- Preparations need to be made to add hot He gas heating to the divertor plates to reach desired temperature of 350C.
- Discoloration of CHI leads after Center Stack bake.
  - Need to understand the cause

- Heating of graphite tiles is adequate with He heating of divertor plates
- But PF1B G-10 spacer and wrap get too hot
- Also the welds taking up launching loads may be over stressed
