Executive Summary

On April 24th, 2015 during the execution of the coil power tests the NSTXU OH circuit suffered arc damage from a short created by the movement of a grounding conductor on the OH Ground Plane across energized OH water connections. The arc damaged the conductor water connections, caused a water leak and tripped off the power supplies. The cause was identified as a grounding conductor on the OH ground plane that was installed without the required electrical break. The resulting circulating currents in the conductor interacted with the OH field propelling it into the water connections. The lack of a proper ground on the OH compression ring to which the water connections were mounted was identified as a contributing cause. Subsequent inspection and investigation identified the cause as well as other areas of the design that can be improved to avoid a recurrence of the fault. These items include redesign of the grounding clamp on the OH ground plane, grounding of the OH compression ring, and redesign of the water connections on the OH coil. Disassembly and inspection of all of the TF and OH components in the upper and lower umbrella identified other areas that can be i

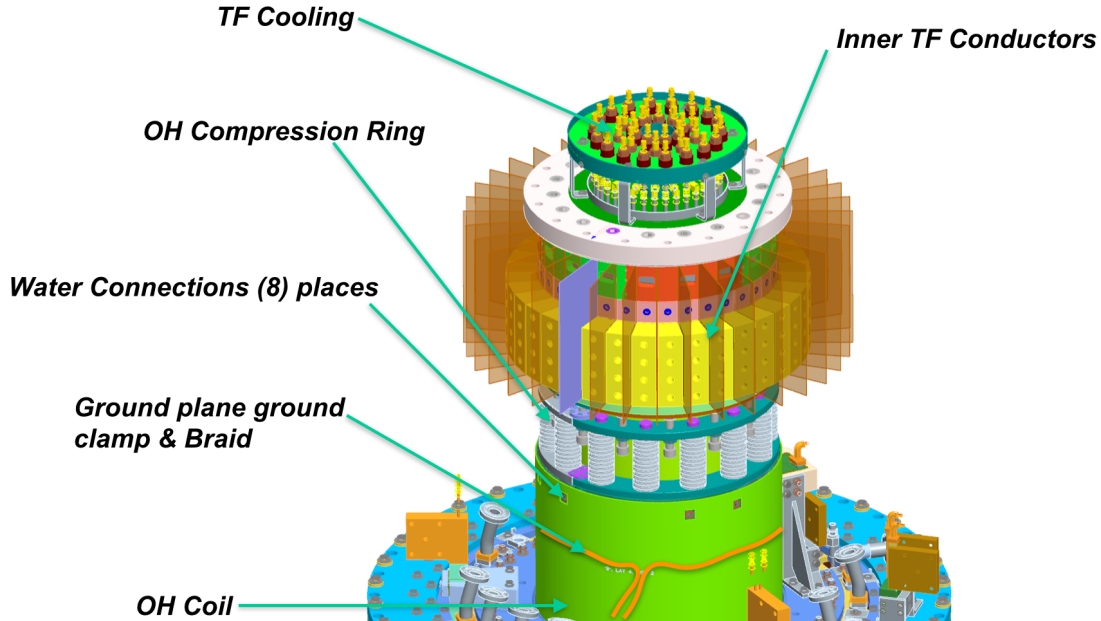
The OH coil and surrounding hardware at the top of the NSTXU is shown in Figure 1. The OH coil shown at the bottom is cooled by water cooling passages in each layer of the conductors. The cooling water exits through 8 ports near the top of the coil just below the OH compression ring. The OH compression ring provides a minimum 20,000 lbs. of downward force to the OH coil against the electromagnetic launching loads and thermal bakeout dimensional excursions. The OH compression ring was not grounded at the time of the event. The ground clamp and conductor (braid) shown several inches below the water connections provides a grounding path for the painted ground plane on the outside of the OH coil. Figure 2 shows an undamaged OH water connections supported by an insulating clamp to the OH compression ring.

Figure 1 OH Coil, Water Connections, Ground Clamp and Compression ring

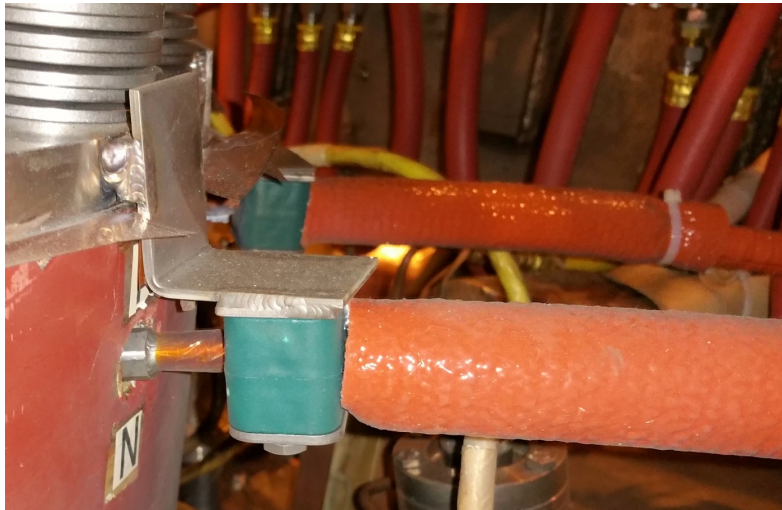
Figure 2 Photo of an undamaged hose connection to OH water passage

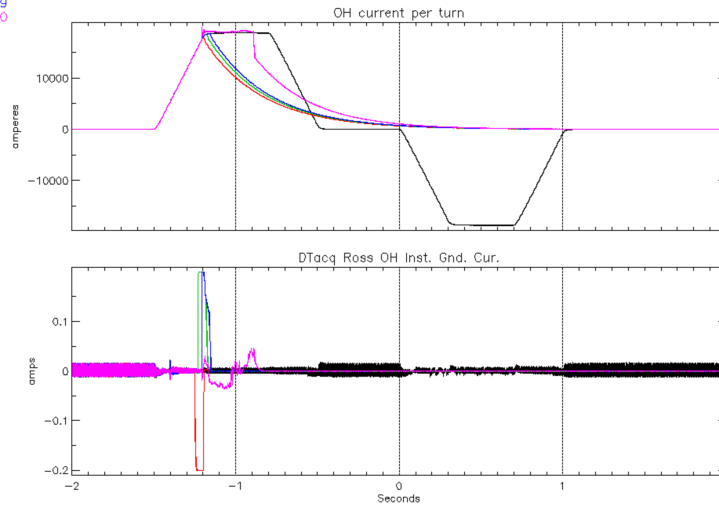
Figure 3 OH Coil Current (top) and ground current (bottom) for the final shot of the ISTP (200157), three shots with trips on 4/24/2014, and the shot with the damaging arc (200190)

Shot 200185 was the first attempt at the 100% test shot on April 24th, as well as the first ground fault trip, and was accompanied by an inner to outer vessel loop fault that developed during the shot. A controlled access to the NSTX-U test cell (NTC) was made, where the source of the loop fault was found to be the OH ground braid. This braid had been connected to the outer vessel (Cat. 4), while a higher impedance path from the ground plane to the PF-1aU coil mandrel was likely completing the circuit causing the loop. The braid was moved to an inner vessel (Cat. 3) connection, clearing the loop fault.

Once personnel cleared the NTC, a low-pot of the OH coil was performed from the rectifier room. The leakage current was found to be the same during the morning low-pots. Shot 200187 was then a repeat of the 100% test shot attempt, and also succumbed to a trip due the OH ground currents. The trip level on the ground current on the instantaneous relays was then raised from the previous 50 mA to 100 mA. The 100% shot was then repeated as shot 200189; this shot again tripped the OH ground fault relays. At this point, the instantaneous ground fault relays were removed from the protection circuit; note that the inverse time relays were NOT disabled, and were still part of the rectifier/machine protection system. The next shot, 200190, was a fourth attempt at the 100% test shot; it is also shown in Figure 3. The damaging arc occurred on this shot. This arc was supported for approximately 300 ms, and the shot was tripped off by a TF ground current trip.

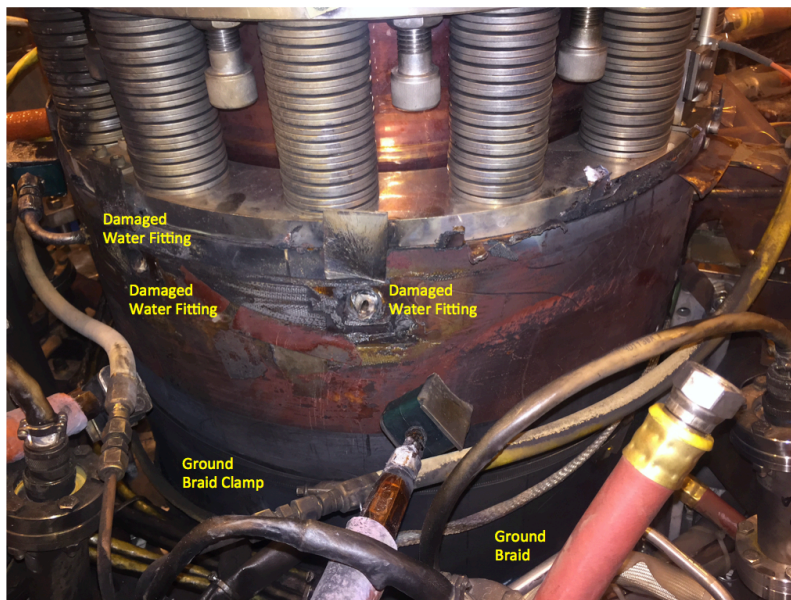
Inspections during the hours and days immediately following the fault showed that the damage was restricted to an area at the top of the OH coil, within the upper structure; see Figure 4 and 5 for examples of this damage. Most clearly obvious was the damage to four of eight upper water feeds. In some cases, the stainless steel brackets that supported the water feeds off the Belleville spring stack were disintegrated by the arc. The water fittings on the coil were badly damaged in other cases. All four of these failures resulted in water flowing out of the coil and throughout the upper umbrella structure. Some other water-cooling hoses within the umbrella were also damaged, though none badly enough to result in water leaks. The arc also distributed soot over many components within the umbrella.

Figure 4 Image of the damaged area with labels on some key features

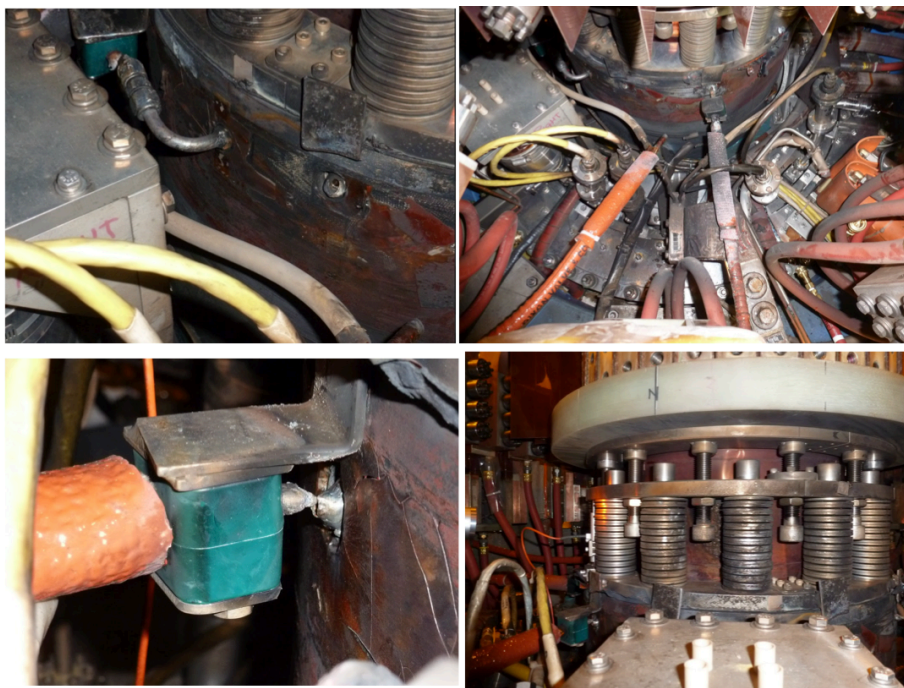
Figure 5 Additional images of the damaged areas

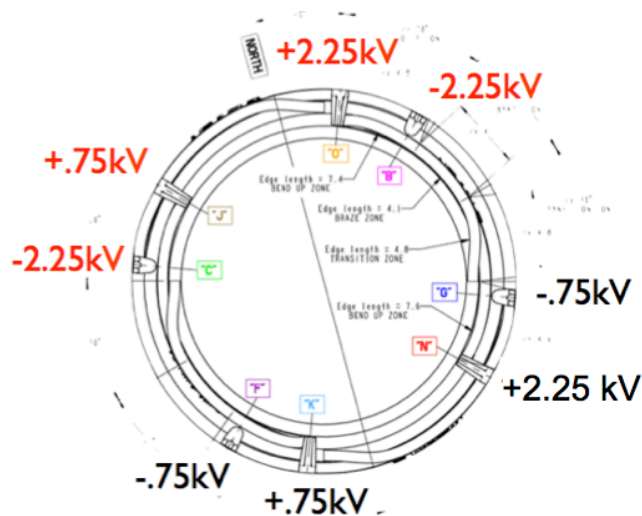
Once the braid had worked sufficiently free of its clamps, it was able to come in contact with different water fittings. As can be seen in Figure 6, both the +2.25 and the -2.25 kV water fittings are in near proximity to each other, such that small variations in the vertical travel could result in different fitting coming in contact with the braid. This can explain the observed changes in the sign of the measured ground current between 200185 and 200187 in Figures 3 and 6, when the braid comes in contact with fittings at different voltages, causing different ground current signatures.

Figure 6 Potentials on the various water feeds at the top of the NSTX-U coil. The red labels indicate the four feeds with damage during the arc on shot 200190

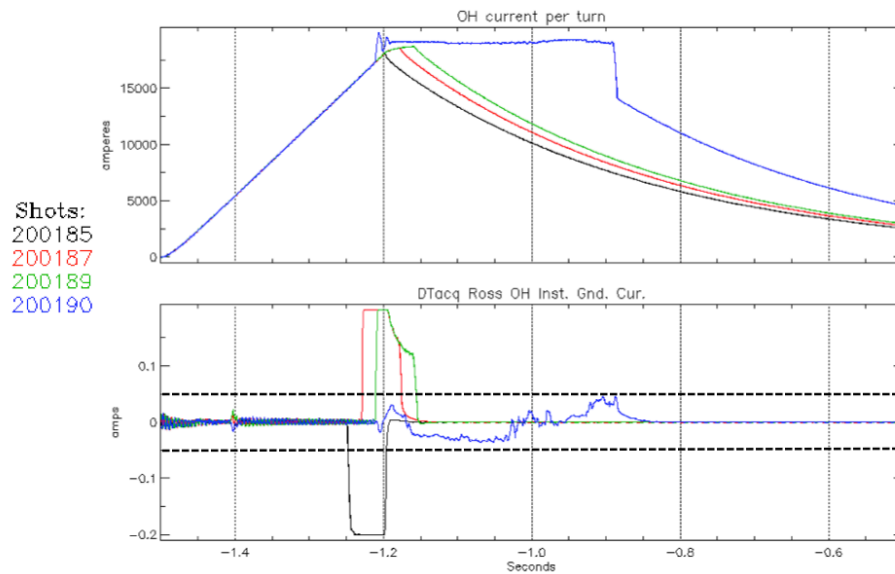
Shot 200190, however, had a quite different ground current signature, as can be seen in the expanded plot in Figure 7. The ground currents were much smaller, and thus the decision to remove the “instantaneous” ground current relays did not impact the ultimate fault (recall also that the inverse-time OH ground current relays were still present in any case).

In this case, it appears that the mobile ground braid likely interacted with two of the water feeds at the same time. In doing so, the net reference of the OH circuit was not dramatically changed, and so the ground currents were minimized. On the other hand, this interaction apparently resulted in an arc across the insulating clamp on the OH water feed. Once this happened, the Belleville stack was at high voltage with respect to the other water feeds and could easily arc to those other feeds. The net result was an electrical path from one water feed to its bracket via an arc, to the bottom of the Belleville stack, to the bracket of another water feed, and finally to the water feed by an arc. This is consistent with the observed line-to-ground voltages, and the OH current waveform can be reproduced by simple models involving an arc that shorts out $\frac{3}{4}$ of the turns of the coil. This fault then evolved to include two

Figure 7 Zoom in on the OH coil current and OH ground currents for the four attempts at the 100% test shots on 4/24/2015

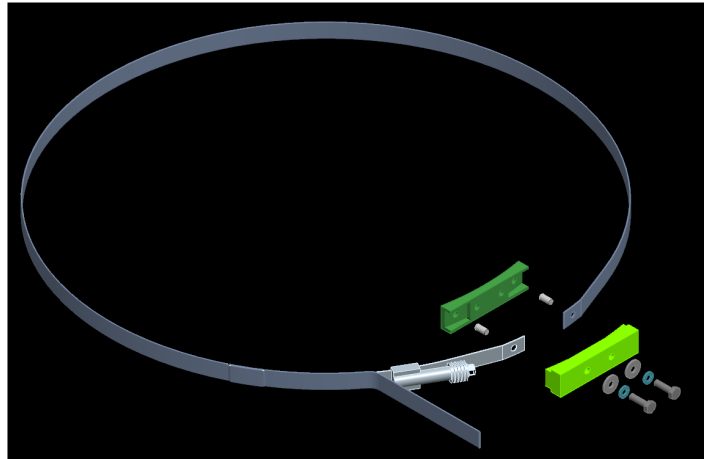
Figure 8 Redesigned OH ground clamp with G10 insulator

The OH ground plane, which is composed of low resistance paint applied to the OH coil's outer surface, shall be grounded to the inner vacuum vessel, with a single point connection, through a 10Ω resistor. The revised hose clamp employs a spring-loaded tightening system, which allows the hose clamp to maintain tension on the braid during typical OH coil thermal cycling. The hose clamp is modified to incorporate an electric break, approximately four inches in length, which prevents a current loop from forming in the clamp. The conductive braid, which is a flattened tube, will be opened and slipped over the hose clamp, ensuring that it cannot separate from the hose clamp even if the hose clamp loses spring tension. The braid will be arranged so that it cannot slide over the hose clamp's electric break, which would compromise its benefit.

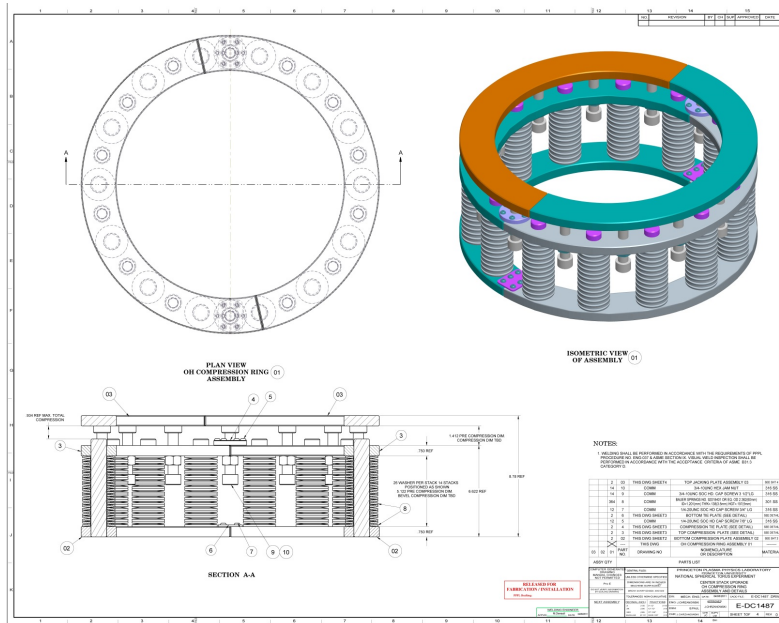
Figure 9 OH Compression Ring

The OH compression ring is an assembly of three stainless steel rings with welded posts that hold belleville spring washers and jacking screws. The compression ring assembly maintains a preload on the OH coil, keeping it seated during operations. This metallic structure is located approximately 1.5 inches above the eight OH cooling tubes, which are at high voltage potentials. To ensure proper grounding of this metallic structure, jumper cables are being installed between the mechanically bolted sections of the assembly. An AWG #6 cable will ground the assembly to the inner vacuum vessel at a single point.

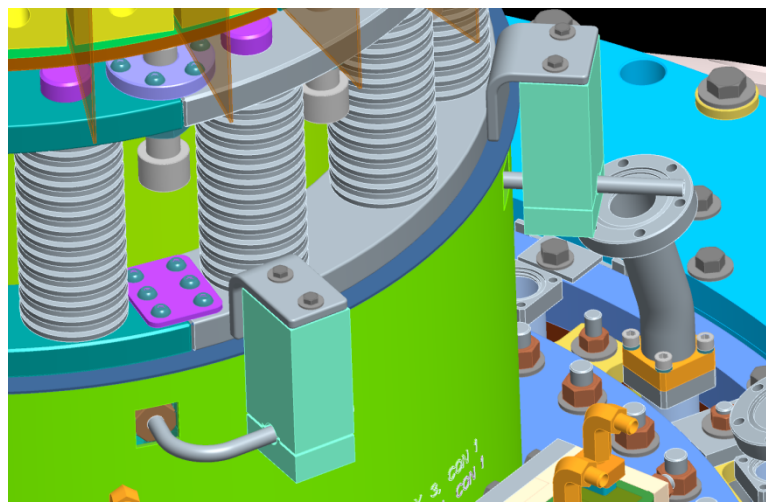
Figure 10 Redesigned OH Water tube support and insulator

The OH cooling tube support brackets provide support and strain relief for the OH cooling tubes and the OH cooling hoses. The design, shown in Figure 10, includes an “L”-shaped stainless bracket that attaches to the OH compression ring (top) and the PF-1A coil support structure (bottom). A G-10, electrically isolating block, bridges the L-shaped bracket and the cooling tube. The support bracket is being redesigned so that the metallic L-shaped component has at least one inch of air gap and/or tracking length to any electrically energized component (the cooling tubes). The design of the new bracket is based on input from an electrical engineer experienced in high voltage design, and validated with electrostatic finite element analysis. A prototype shall be built and bench hi-pot tested to 26 kV to validate the analysis. All production support pieces shall be bench hi-pot tested to 13 kV prior to installation. All installed components shall be in-situ hi-pot tested to 9 kV to validate installation.

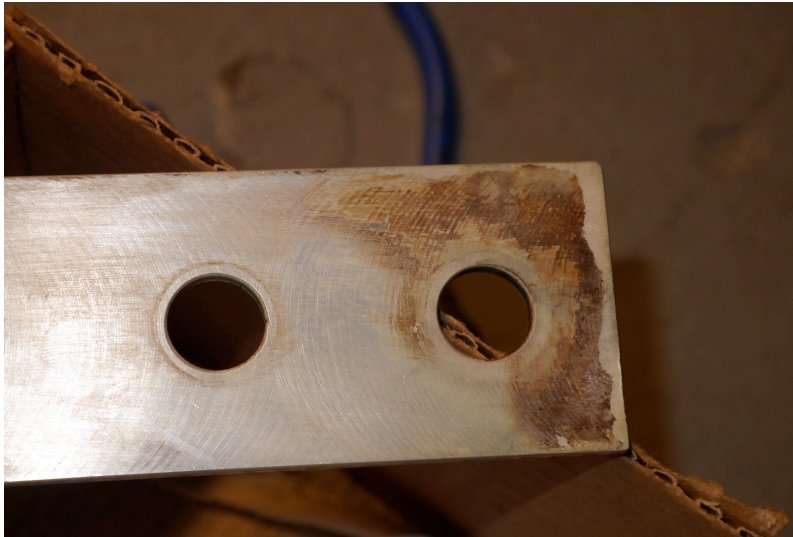
Disassembly of the electrical connections between the TF bundle and the TF Outer Legs (TFOL) revealed discoloration on the silver-plated electrical contact faces as shown in Figure 11. This discoloration was present on the electrical faces between the TF connectors and TFOL mating flags and may be due to water during the incident. Flatness and surface finish measurements of the contact are being taken. Electrical resistance measurements of the joints indicate an acceptable value (~.020 micro-ohms).

Figure 11 Example of staining found on TF connections

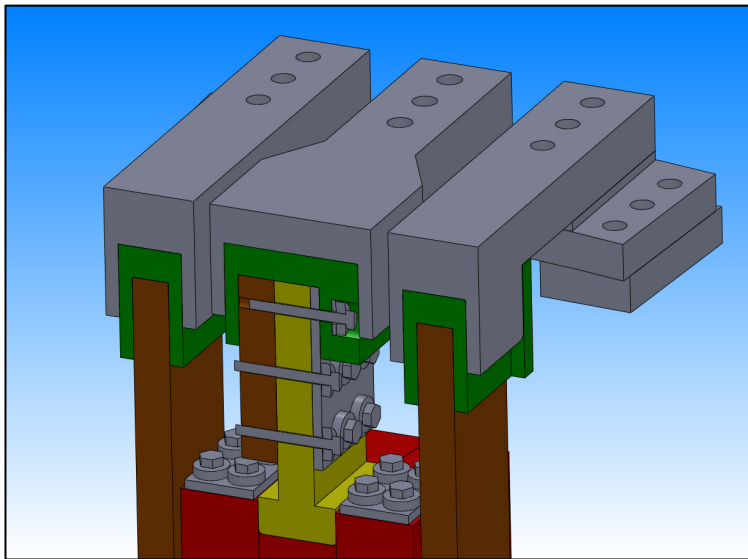
At disassembly, four of the thirty-six G-10 isolators were found to have cracks along the plane of the G-10's laminations. It is difficult to ascertain whether the cracking is due to assembly technique, excessive play (improper shimming or shifting during coil pulsing), or stack up of tolerances that caused unanticipated loads in sections of the G-10. Application of the structural filler will alleviate these conditions.

Figure 12 OTF Finger Supports cross section

The TF connector support brackets (see Figure 12) are structures that prevent the mechanical forces, induced from electromagnetic interaction between the TF flex strap and the vertical magnetic fields, from being transmitted to the TF outer leg (TFOL) flag's braze joint. At the time of initial assembly, the specified structural adhesive/gap filler was not available, and in order to meet the design intent the installation crew used shimming to eliminate gaps between the TF connector, G-10 electrical isolator and the Inconel support bracket. Inspection indicated that the shimming effort was effective. However the structural filler has become available and shall be applied during reassembly of the TF flex strap/connectors/ bracket system.

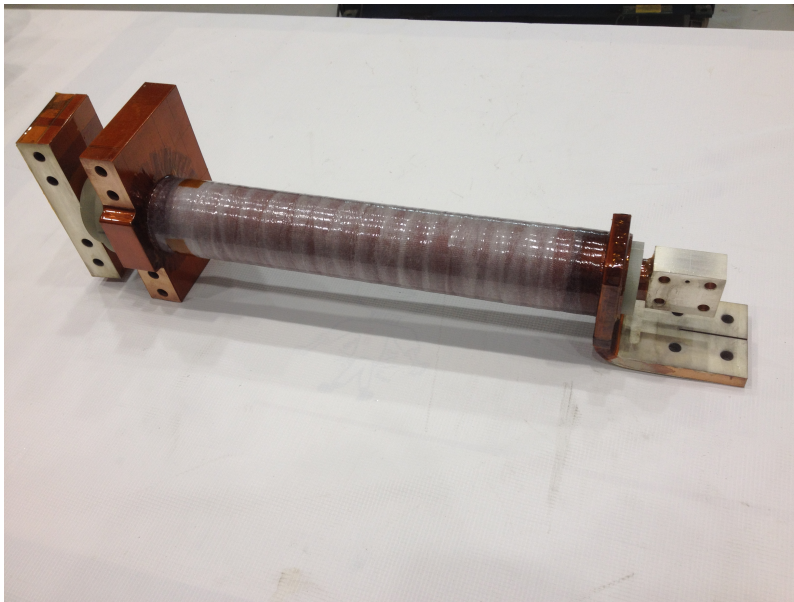
Figure 13 OH Coax connection

The OH coaxial electrical buss (see Figure 13) will be removed as part of the lower umbrella disassembly. While the coaxial bus is removed, it shall be disassembled and holes shall be drilled into the external conductor to allow injection of epoxy filler after it is reinstalled. The epoxy filler shall eliminate any deflection of the conductors which in turn minimizes loads on the OH electrical contact faces.

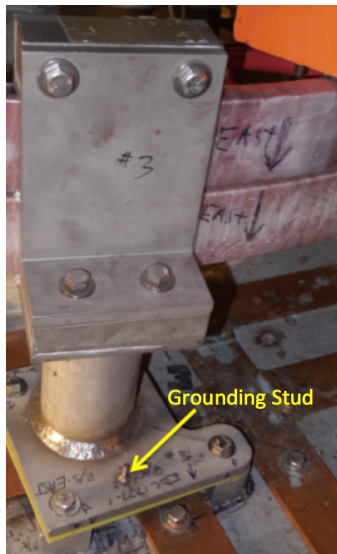
Field inspections have revealed that the brackets that support the TF, OH and CHI bus are not properly grounded. They are mechanically fastened to the NSTX test Cell concrete floor, which provides a weak electrical connection to building ground. These structures (see Figure 14) will be bonded with cables to copper plates that will reference them directly to the building steel.

Figure 14 Bussbar floor support missing grounding jumper
