NSTX Centerstack Scope

**NSTX Upgrade
Readiness For Operations Review
PPPL
December 9-11, 2014**

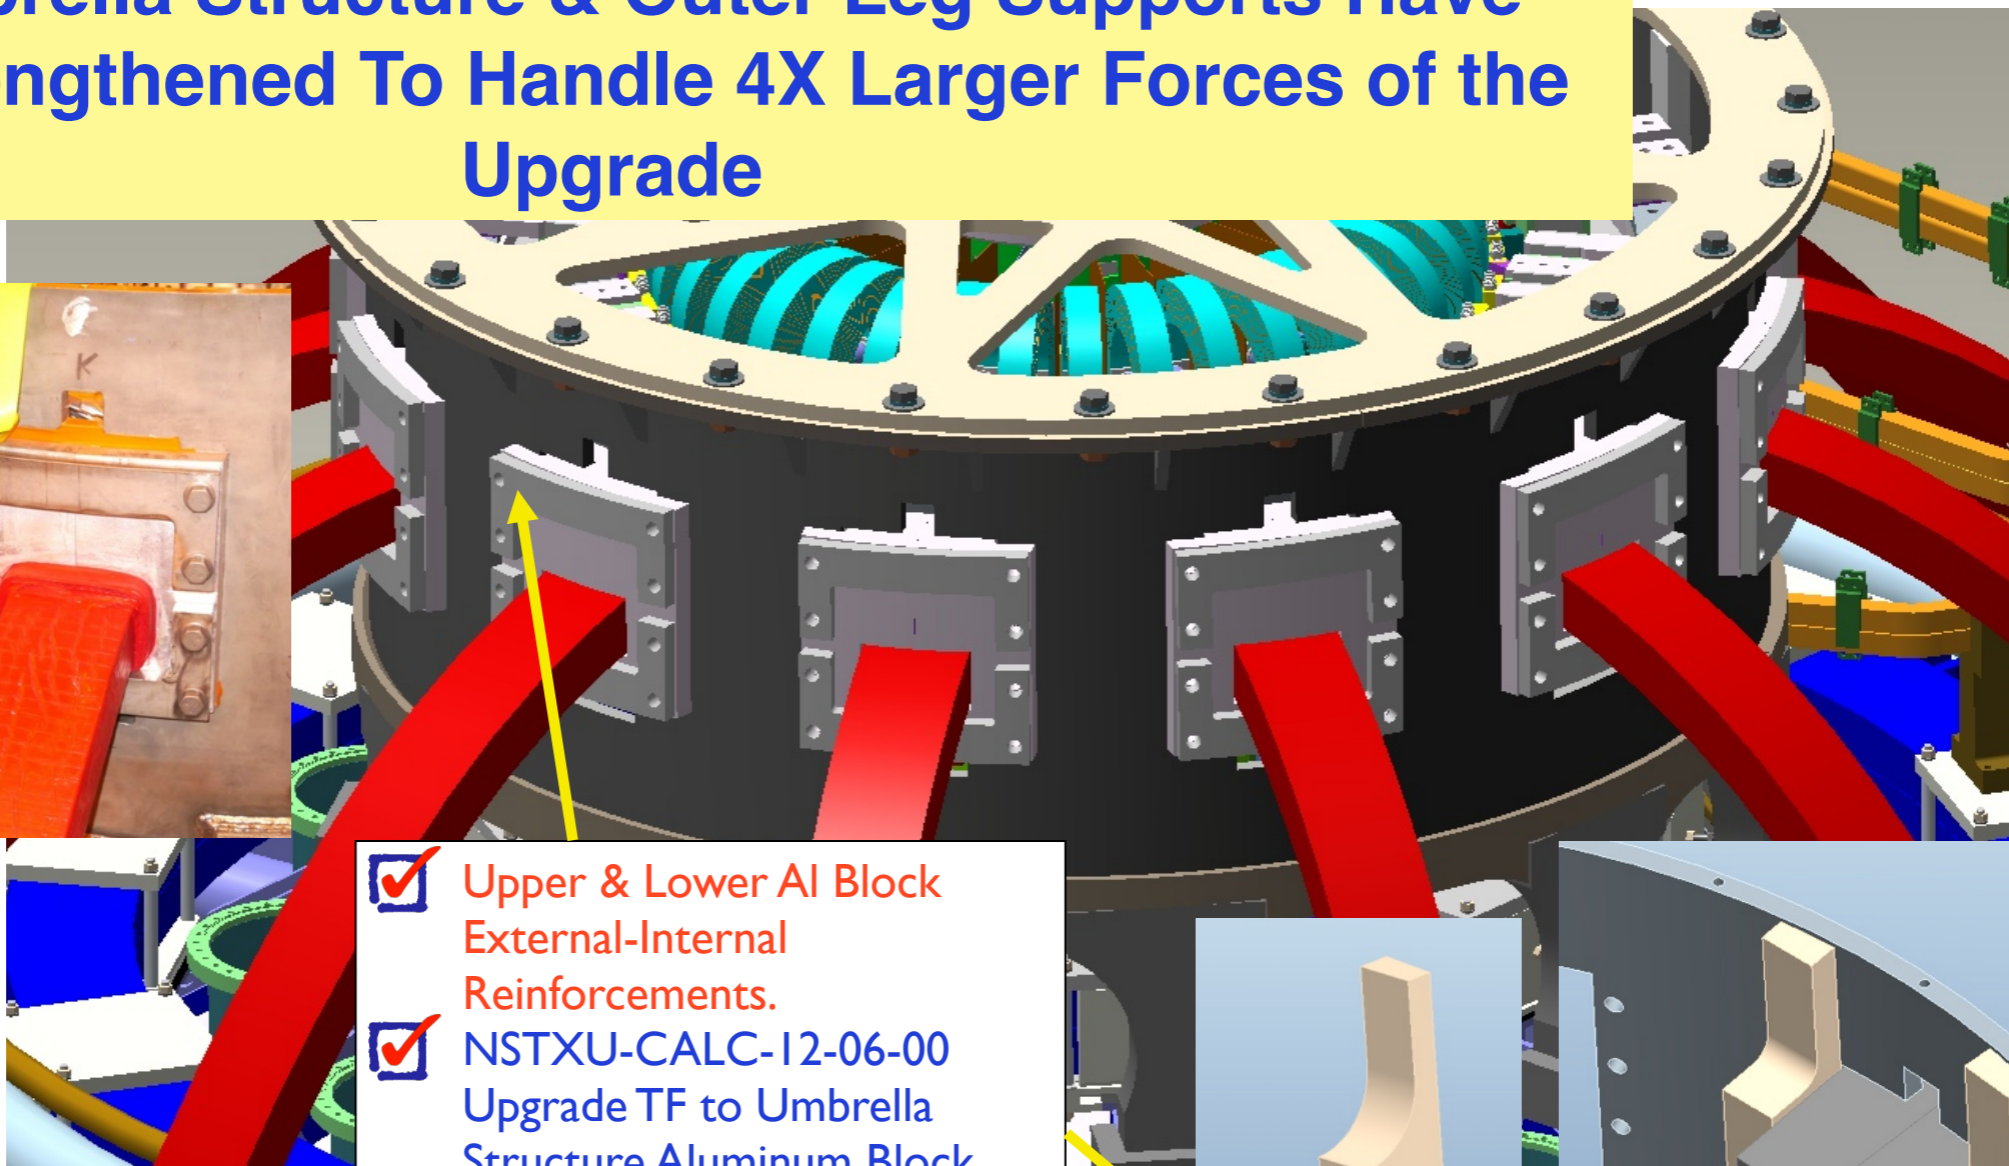
Umbrella Reinforcement

The Umbrella Structure & Outer Leg Supports Have Been Strengthened To Handle 4X Larger Forces of the Upgrade

- ✓ Upper & Lower AI Block External-Internal Reinforcements.
- ✓ NSTXU-CALC-12-06-00 Upgrade TF to Umbrella Structure Aluminum Block Connection (Titus), (Smith)
- ✓ NSTXU-CALC-132-04-00, - Analysis of TF Outer Leg, (Zhang), (Titus)

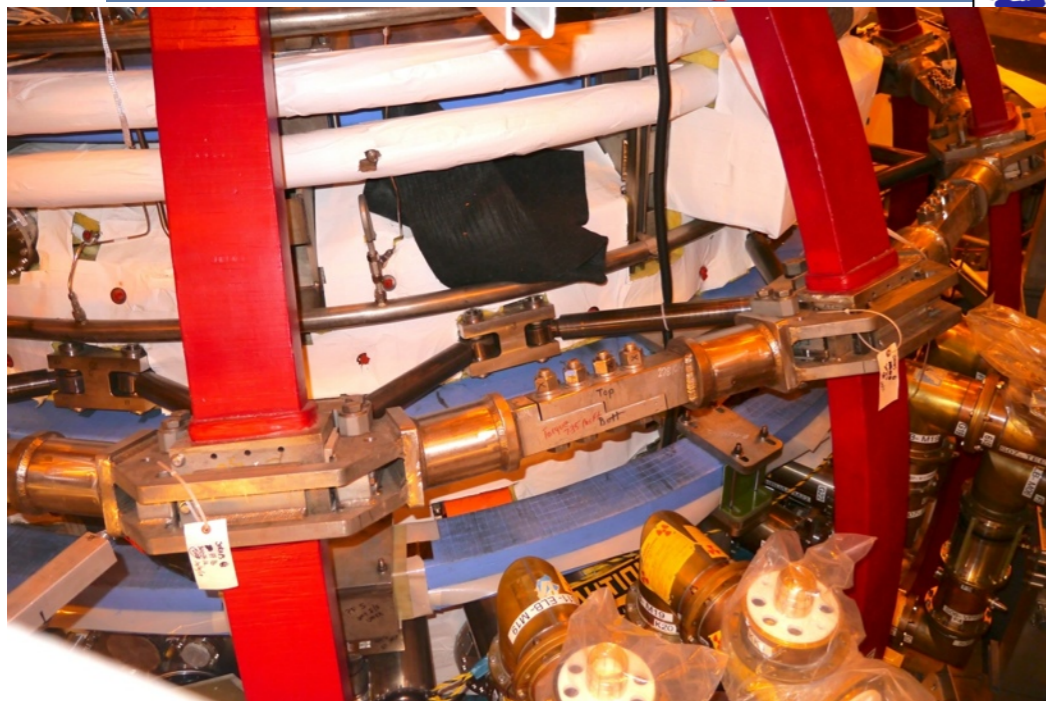
TFOL Support Ring

TFOL Support Link Assembly

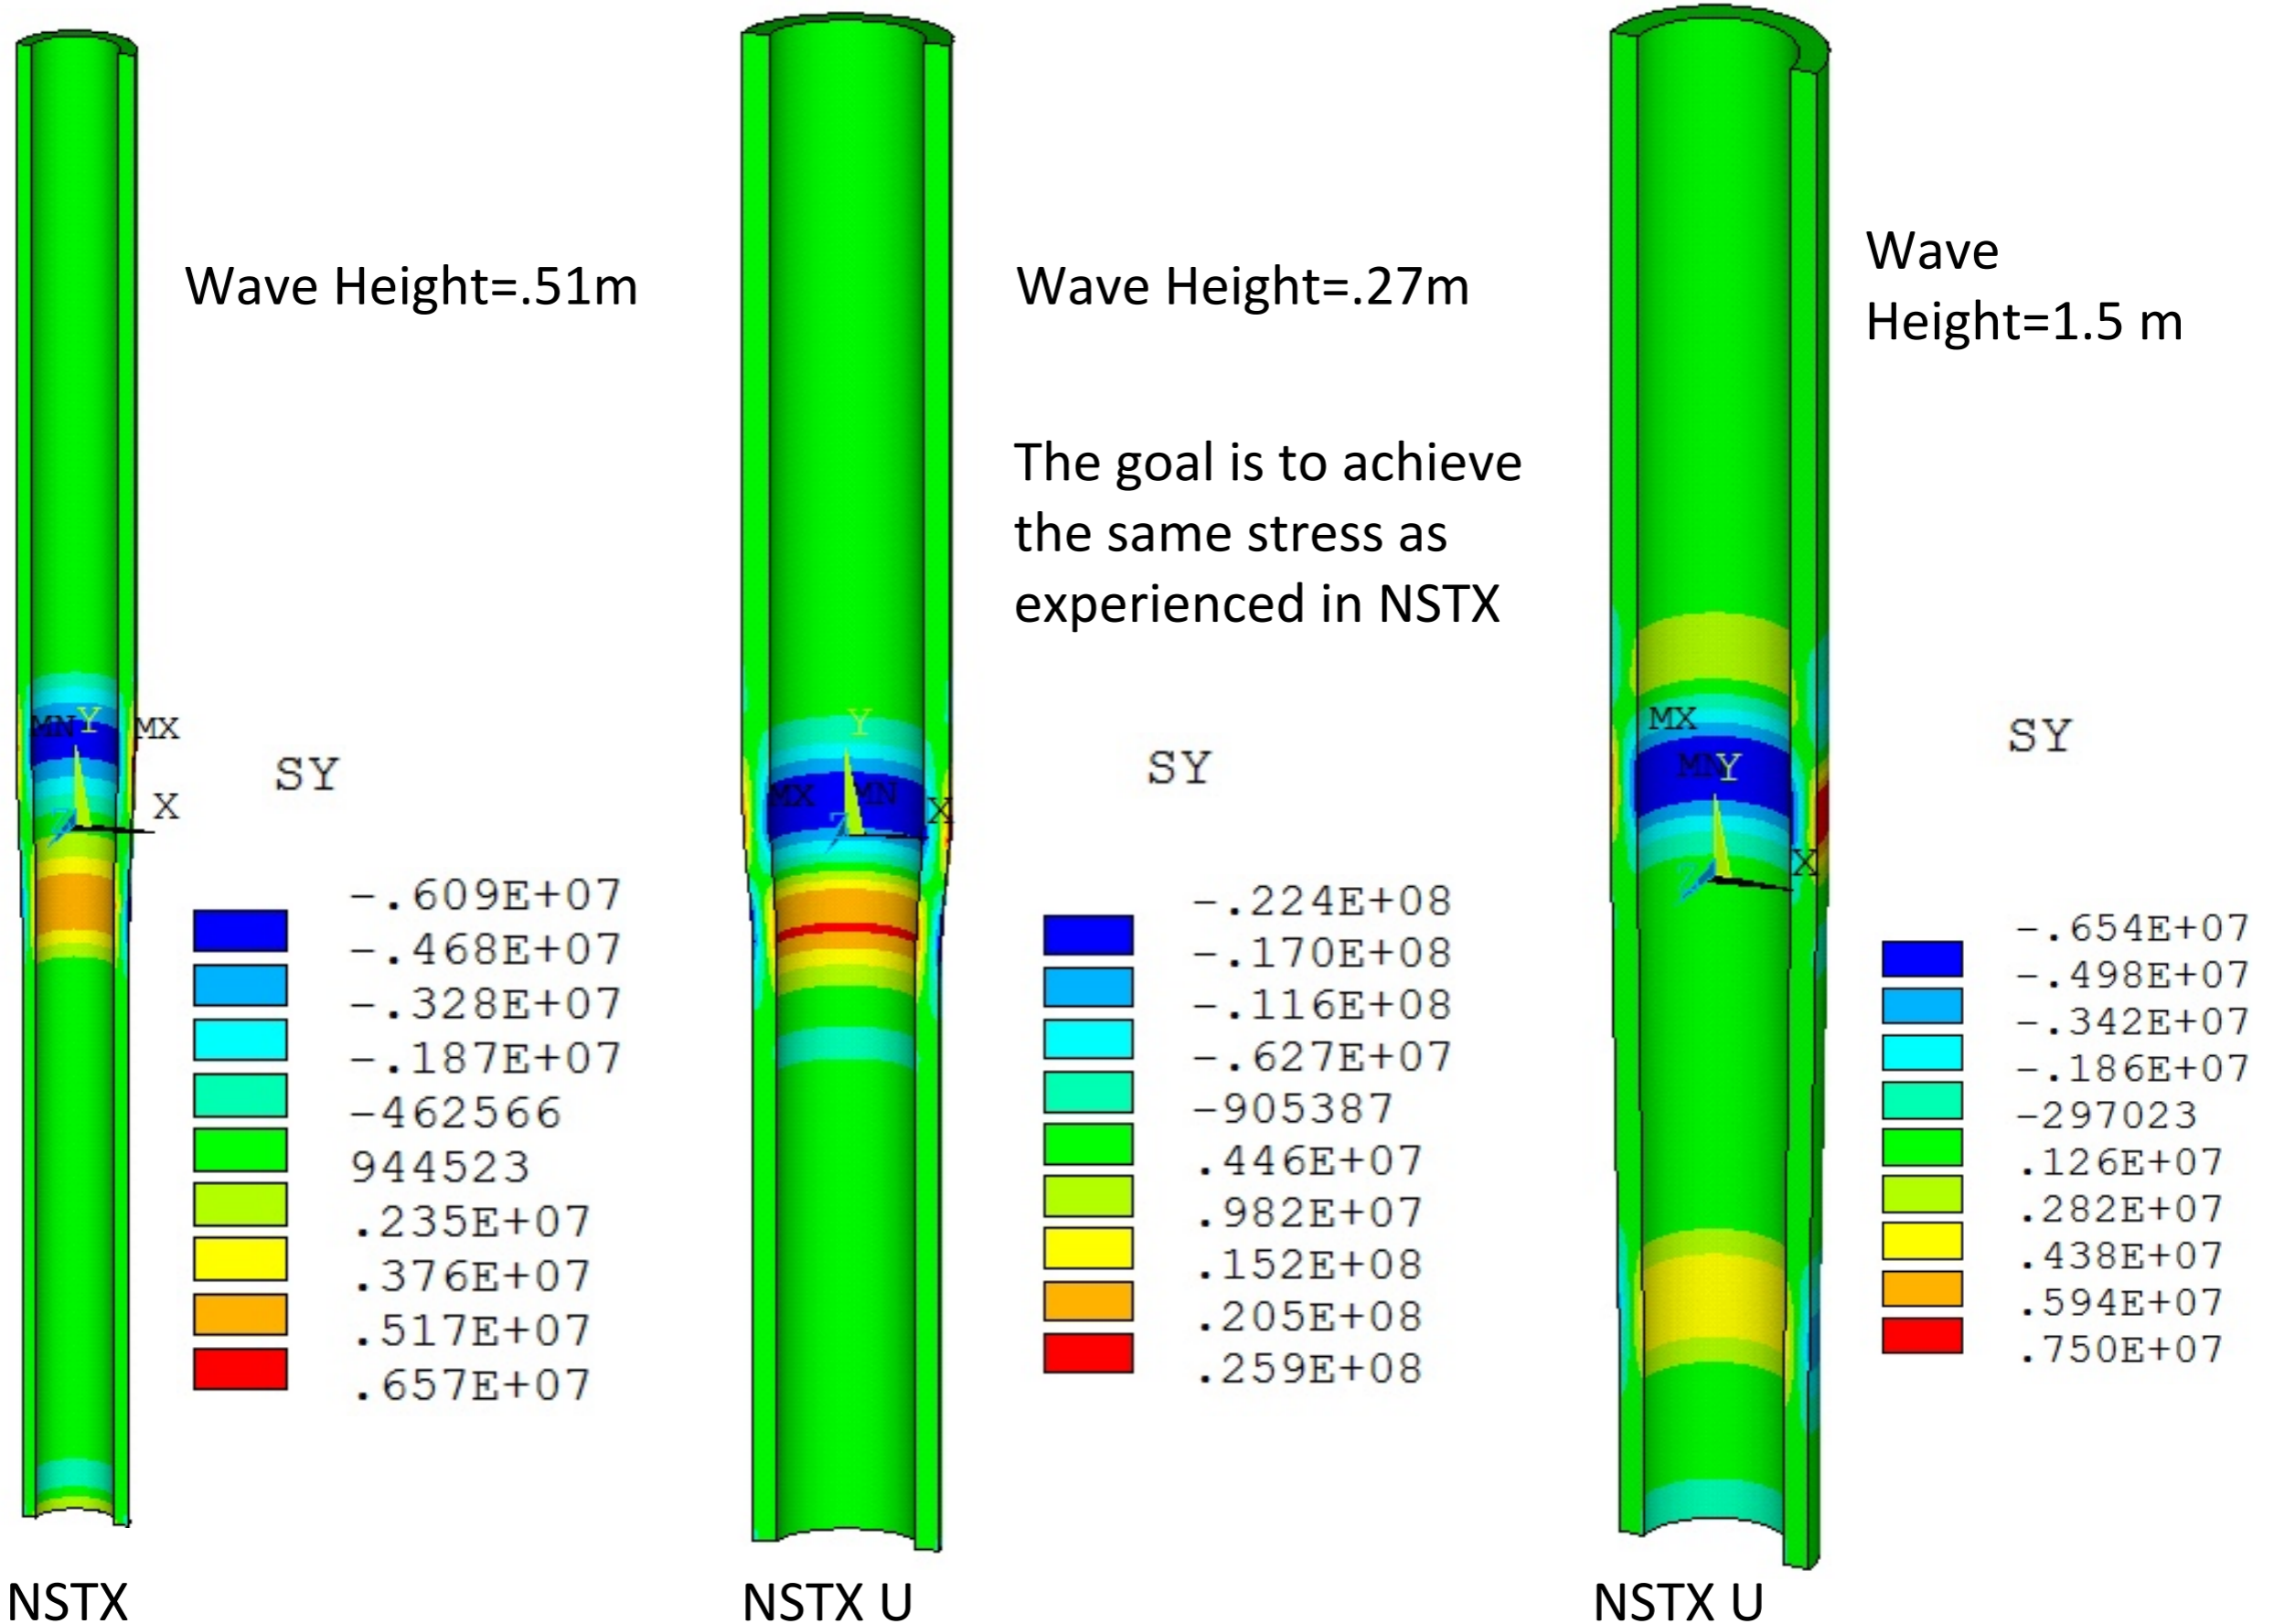
OH Cooling Wave Calculation

- The copper/glass bond may delaminate due to the stresses predicted in the analysis.
- Delamination alone would not cause the coil to fail but repeated mechanical motion during pulses may cause a short.
- Solution: A water heating system is being designed to provide a more gentle cooling cycle by starting the cooling with hot water and gradually cooling to 12c over 300s
- In addition a series of tests are being performed by the resin manufacturer to determine if the coil will delaminate and eventually fail electrically

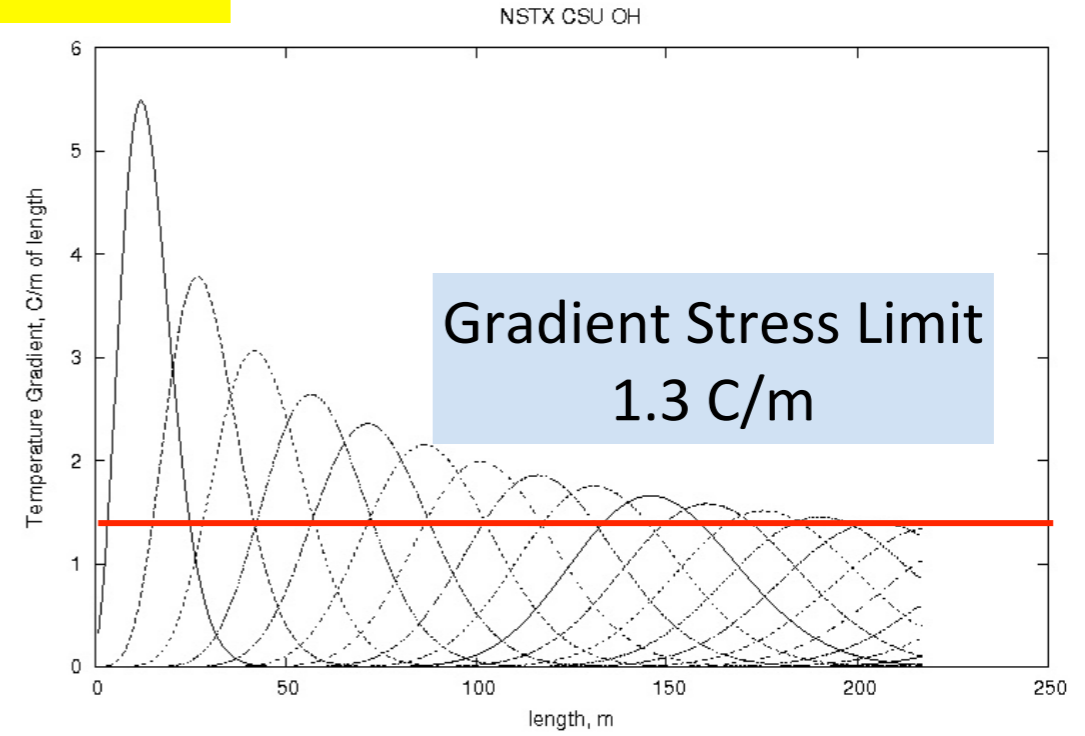
Cooling with Constant 12 C Water

OH Cooling Wave and Gradient in Conductor

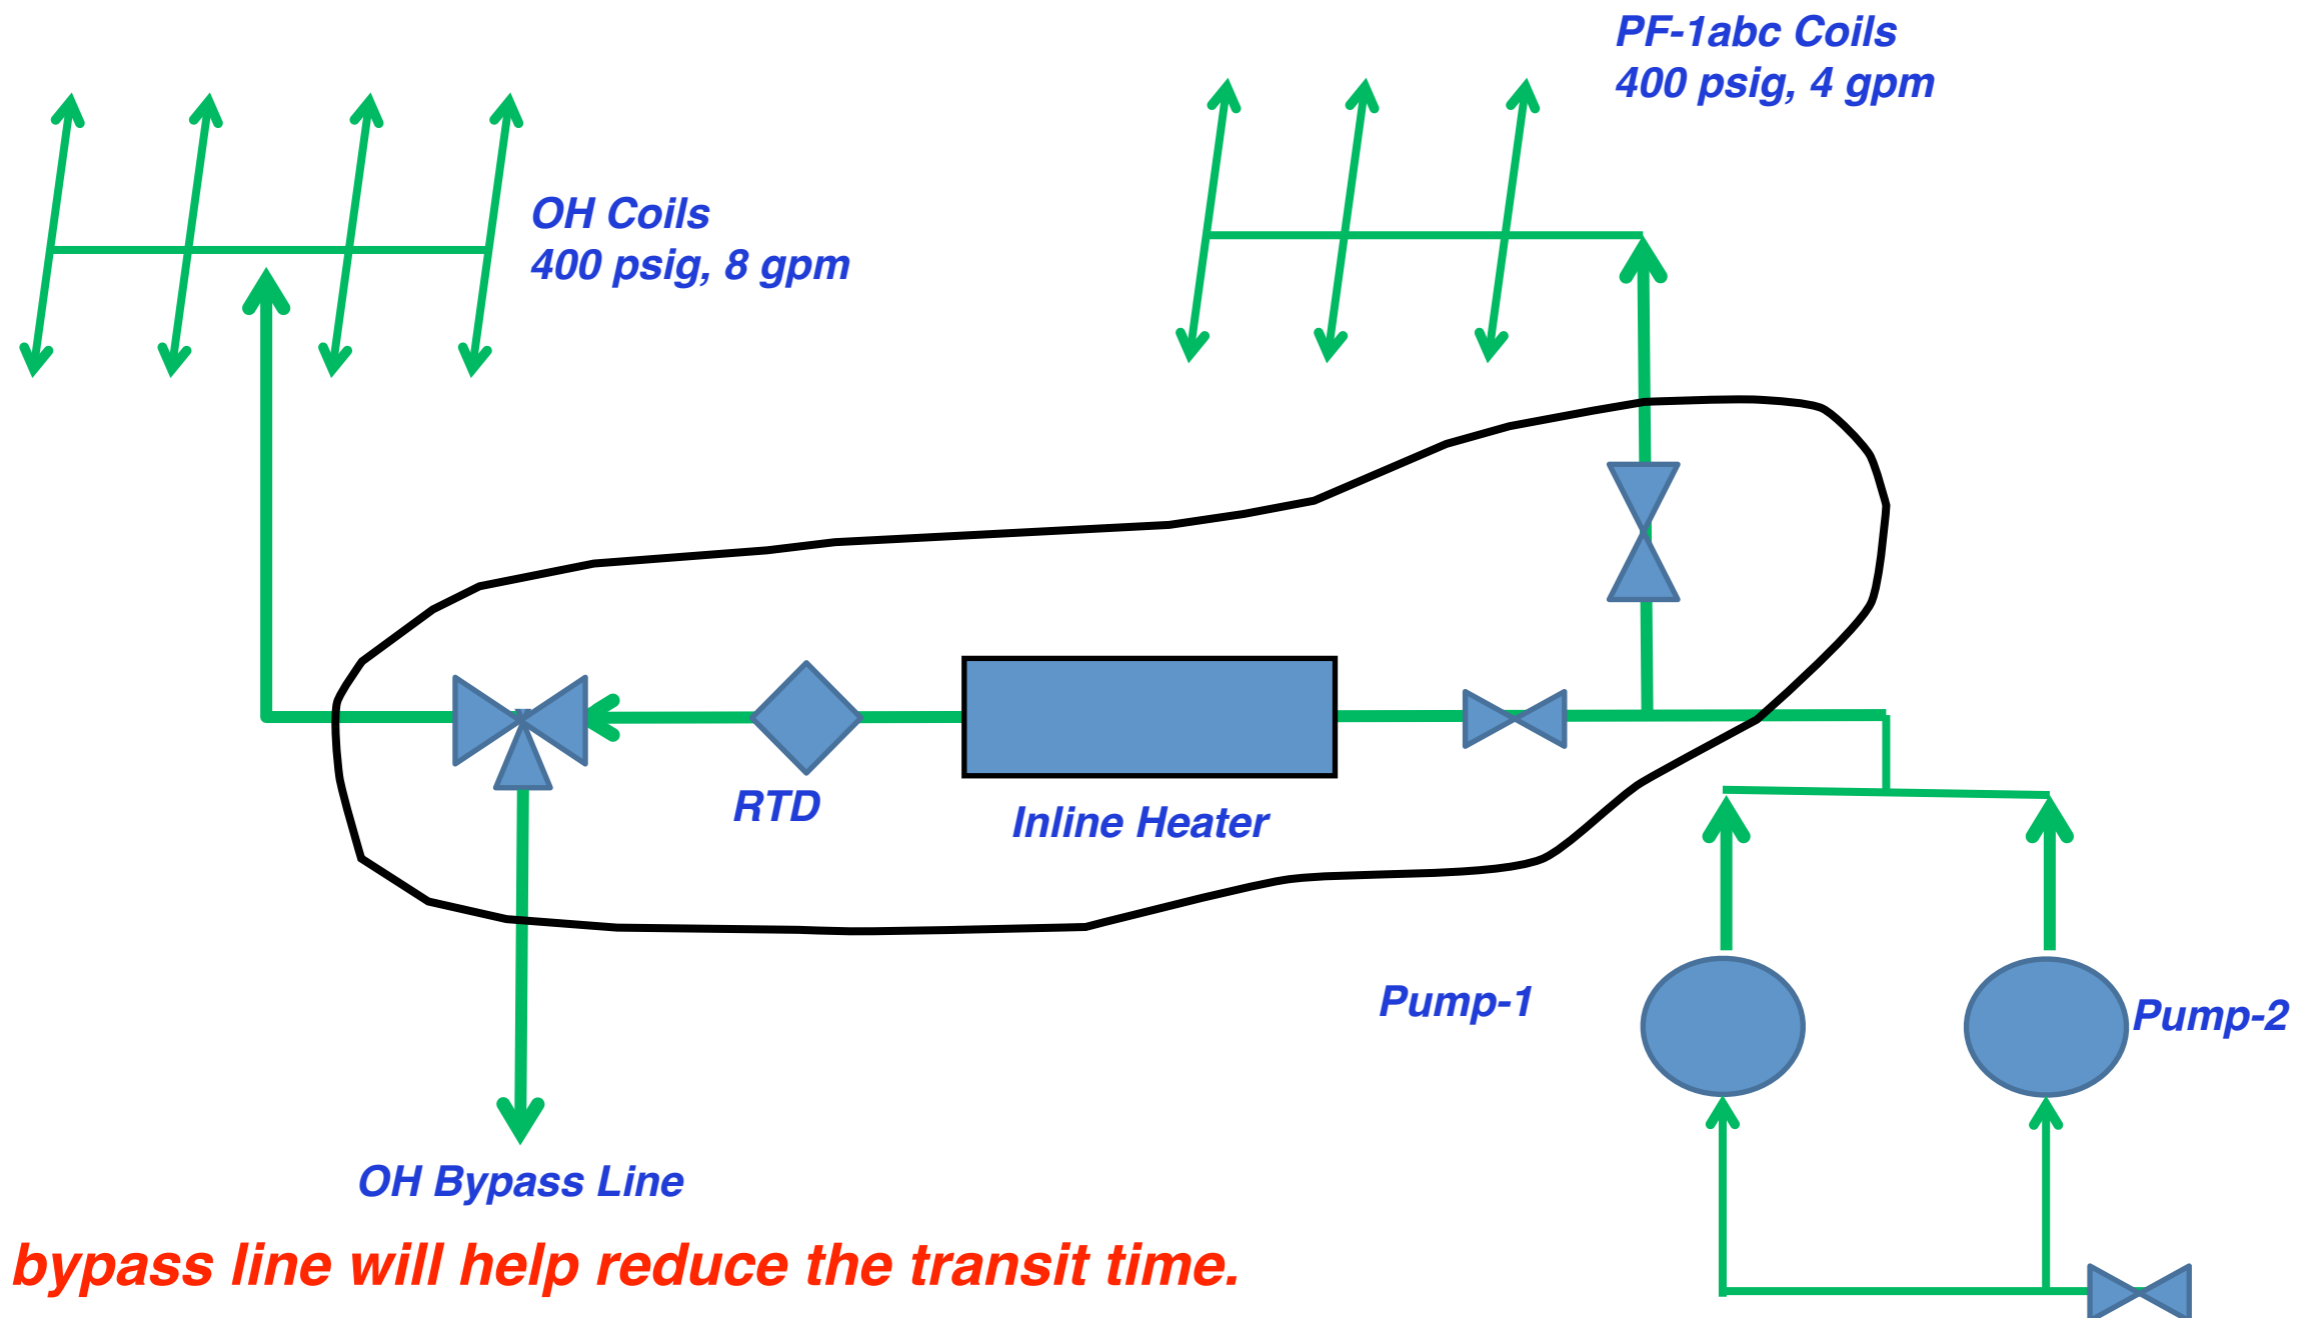
Proposed OH Water Heater Design (Atnafu)

- Inline heater on the high pressure side provides water temp matched to coil temperature after pulse
- Temperature ramps down over 5 mins to cool coil gently
- Detailed design is underway
- Installation planned to be ready for initial operations in March.

- **The bypass line will help reduce the transit time.**

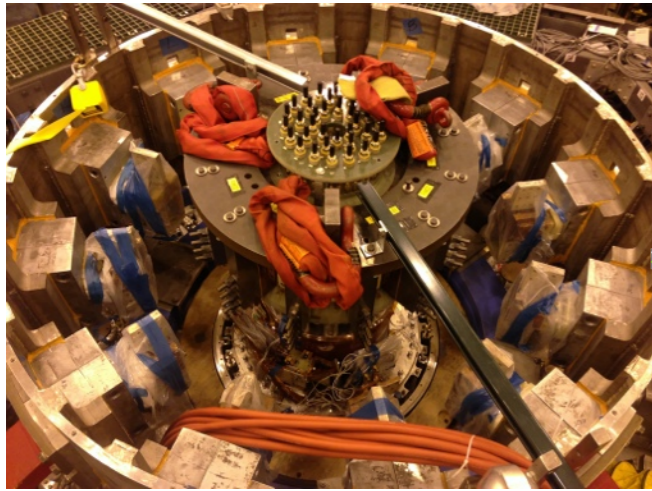
Assembly & Installation of CS Completed

Installed the completed Center Stack Assembly into the Vacuum Vessel (October 2014)
