# *OH Coil Cooling Tube Arc Failure New Designs and Re-commissioning*

**2015/05/28**

# Scope of this Presentation

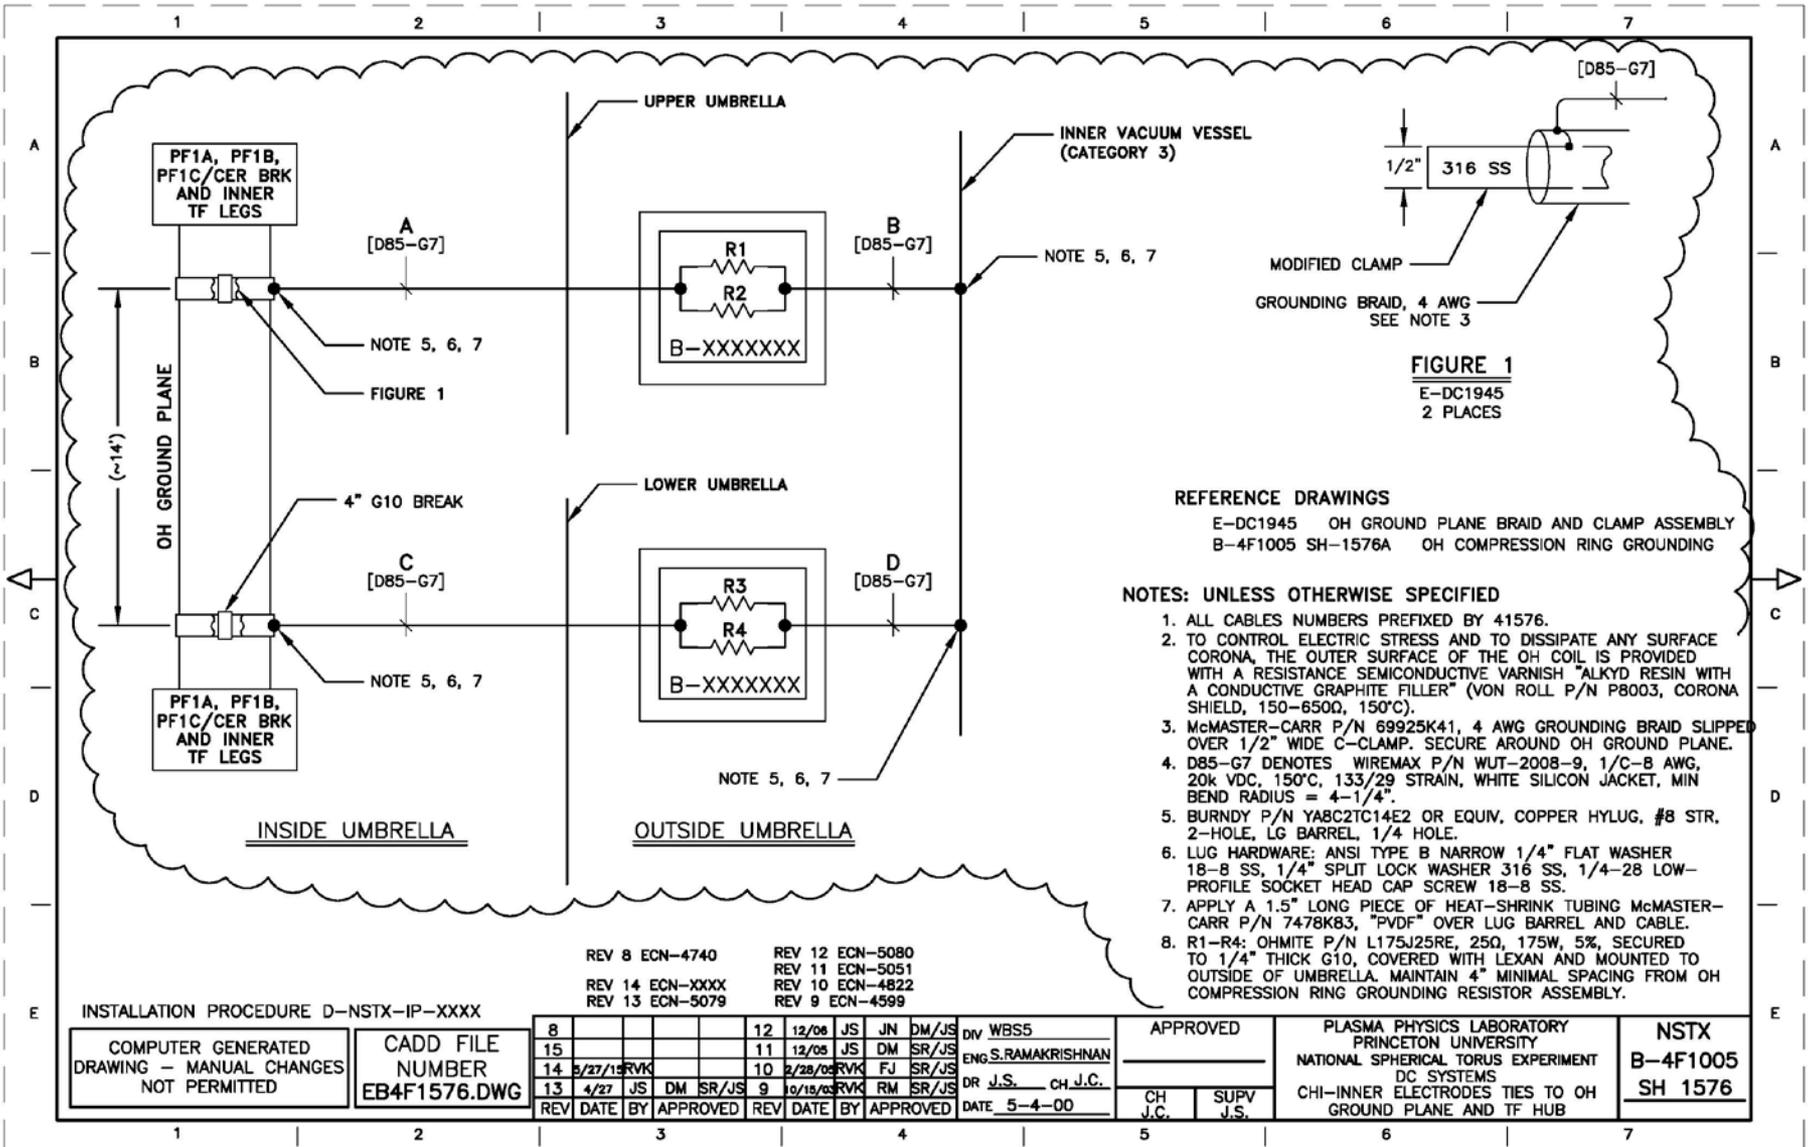
# Item 1 - OH Ground Plane Grounding - Schematic

- The OH ground plane grounding scheme has been re-envisioned with the following design criteria:
  - Provide grounding points at both ends of the ground plane.
  - **NO CONTINUOUS LOOPS**
  - At the top end, use a modified version of the design that worked for NSTX.
  - At the bottom end a new concept is being developed.
  - Both ends will be grounded to a single point (through resistors) to the inner vacuum vessel.

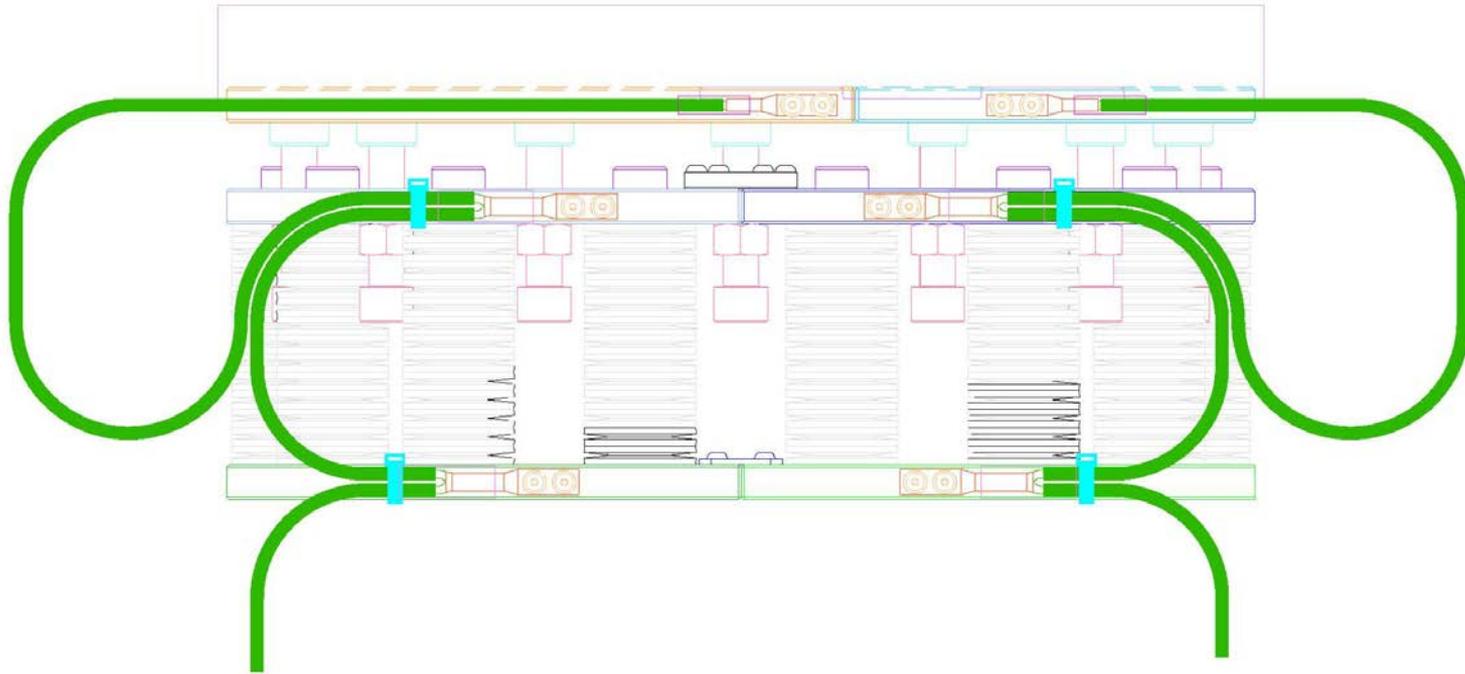
# Item 2 - OH Compression Ring Grounding Cabling

- OH compression ring is an assembly of split rings with welded posts that hold belleville spring washers.
  - We will install jumper cables to ensure that all the ring segments are grounded.
- A single point grounding cable will be bonded (through resistors) to the inner vacuum vessel.
- Grounding scheme must be coordinated with installation of OH cooling tube isolating supports. **All these items must be carefully field fit.**
- Drawings ready for review/approval
- Peer review planned for next week
- Procedure being developed.

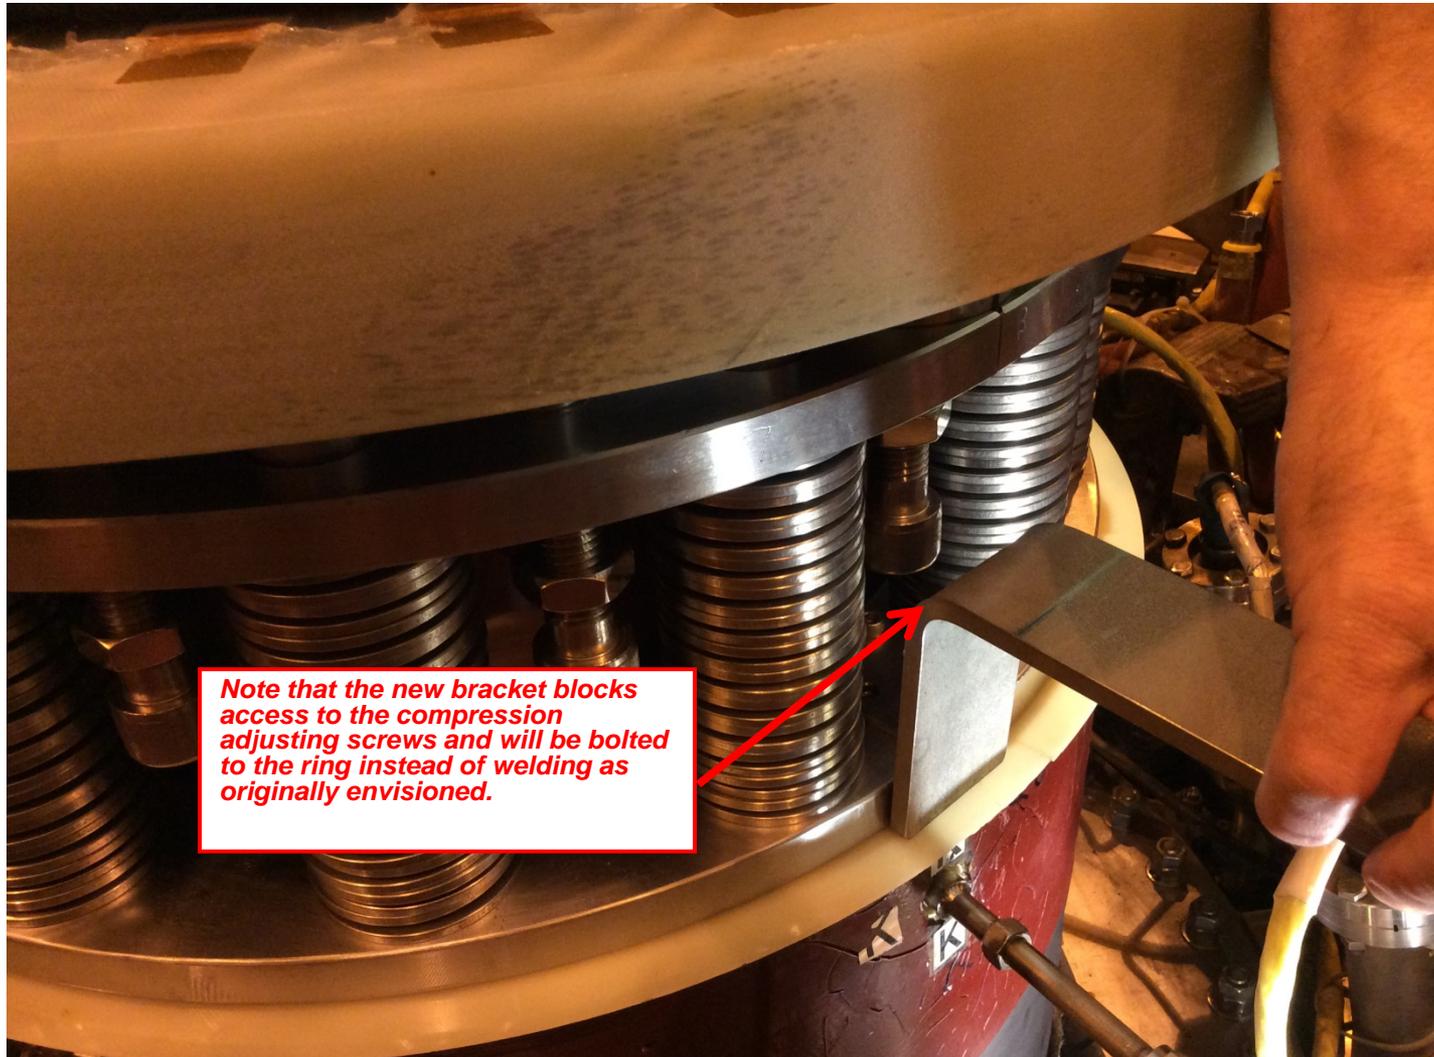
## *Field Fitting to the OH Compression Ring Assembly is a necessary an Iterative Process*
