NSTX-U Startup Arc Fault Technical Explanation

M. Williams (AD Engineering and Infrastructure)
Stefan Gerhardt (NSTX-U Research Operations)
NSTX-U Engineering Team

OH Arc Fault External Review
May 28, 2014

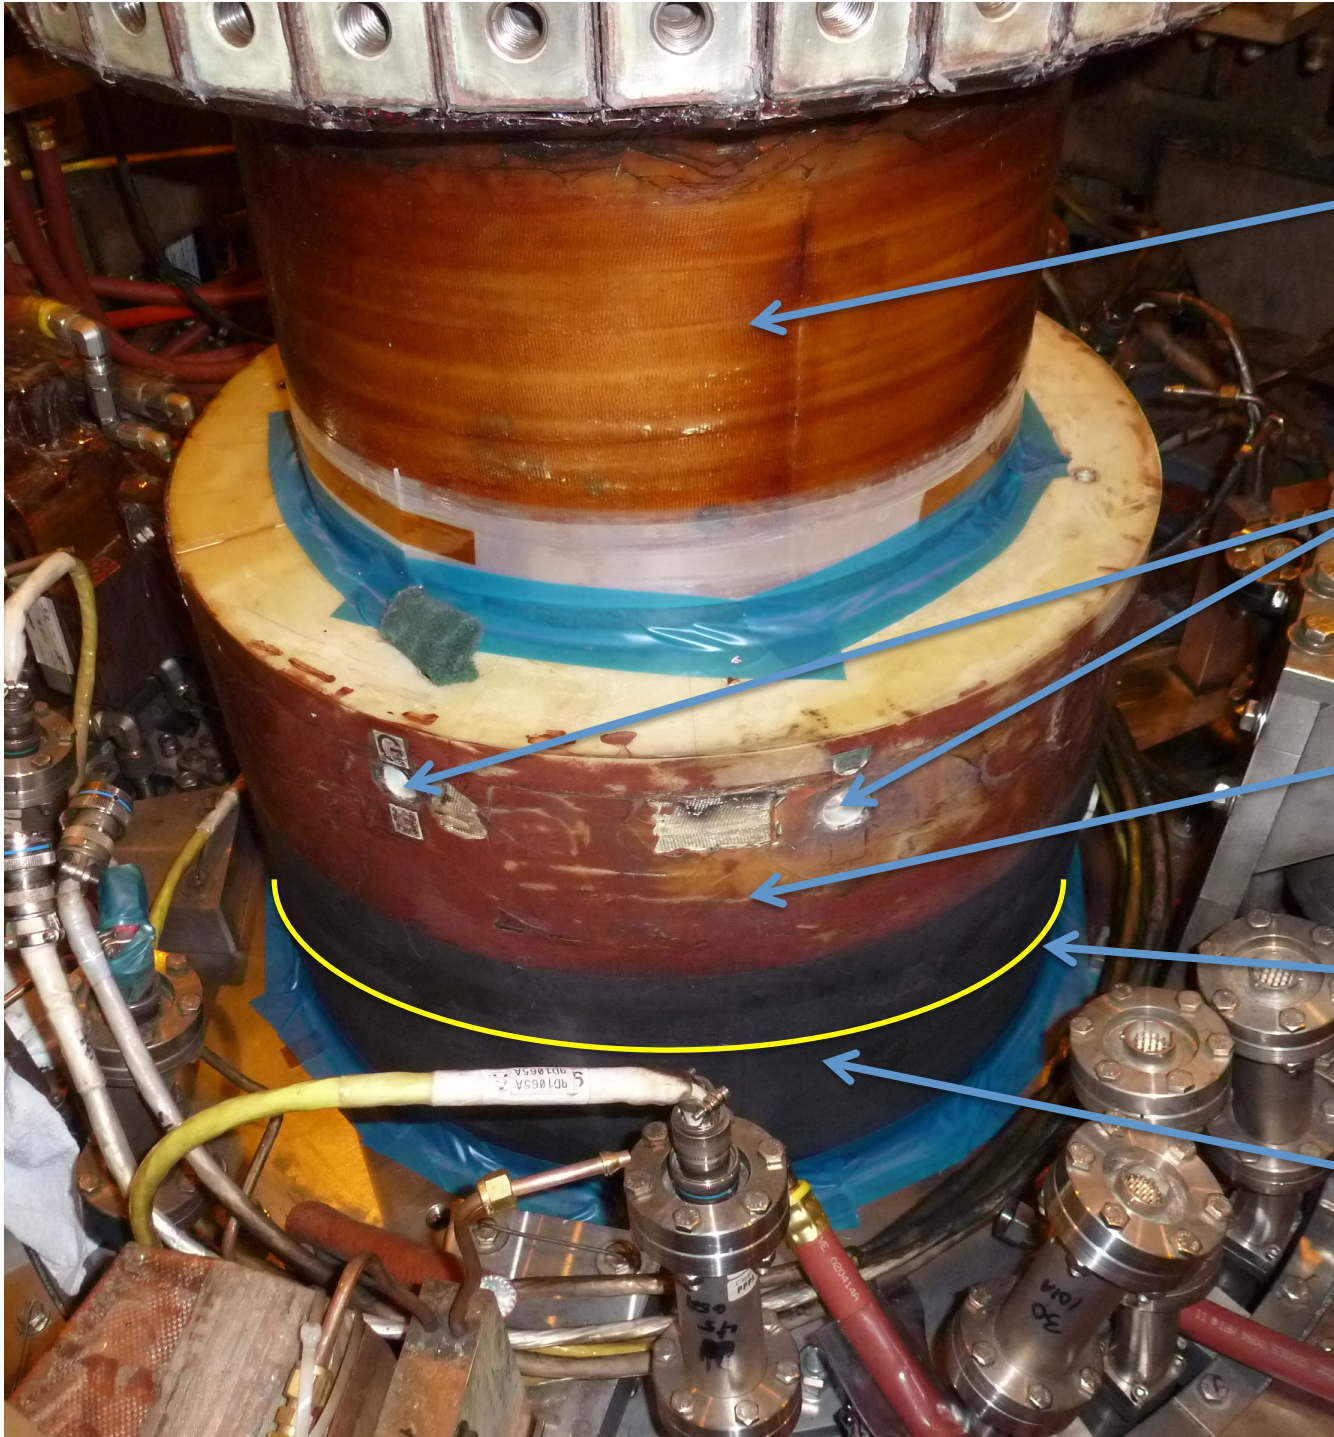
Schematic of Installation
on 4/24/2015

TF bundle (OH Preload Assembly removed)

OH cooling water channels

OH coil

Path of Ground Braid (Schematically)

OH ground plane (black conductive paint)

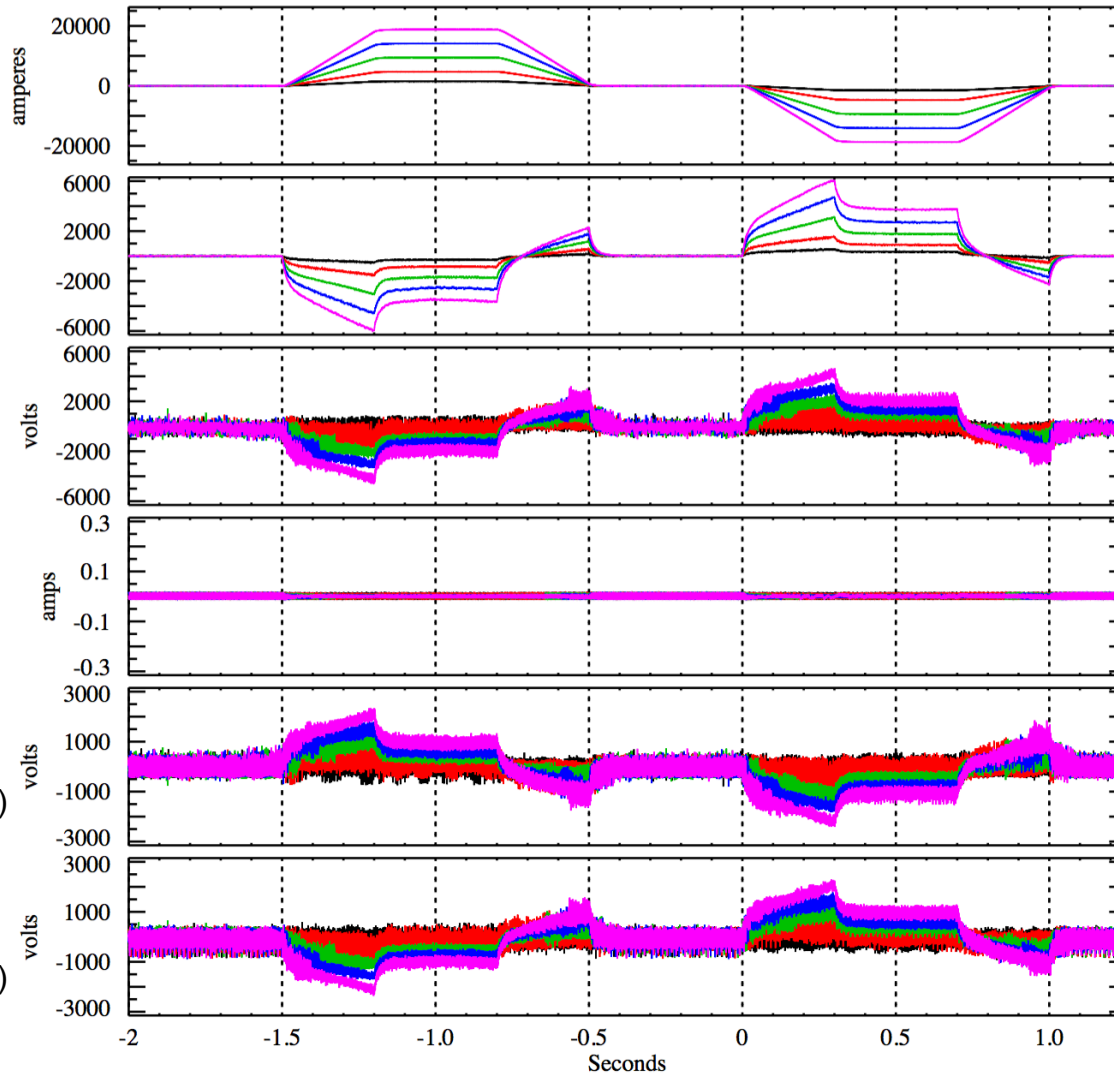
Sequence of Events Leading Up to Fault ISTP Was Completed Without Issue

Shots:
200151
200152
200153
200154
200157

- Up to 100% shot $\rightarrow I_{TF} = -65 \text{ kA}$, $-21 \text{ kA} \leq I_{OH} \leq 21 \text{ kA}$

Note: Operations team was not routinely inspecting the ground current and line voltages during any of the shots; critical trends were discovered after forensic analysis.

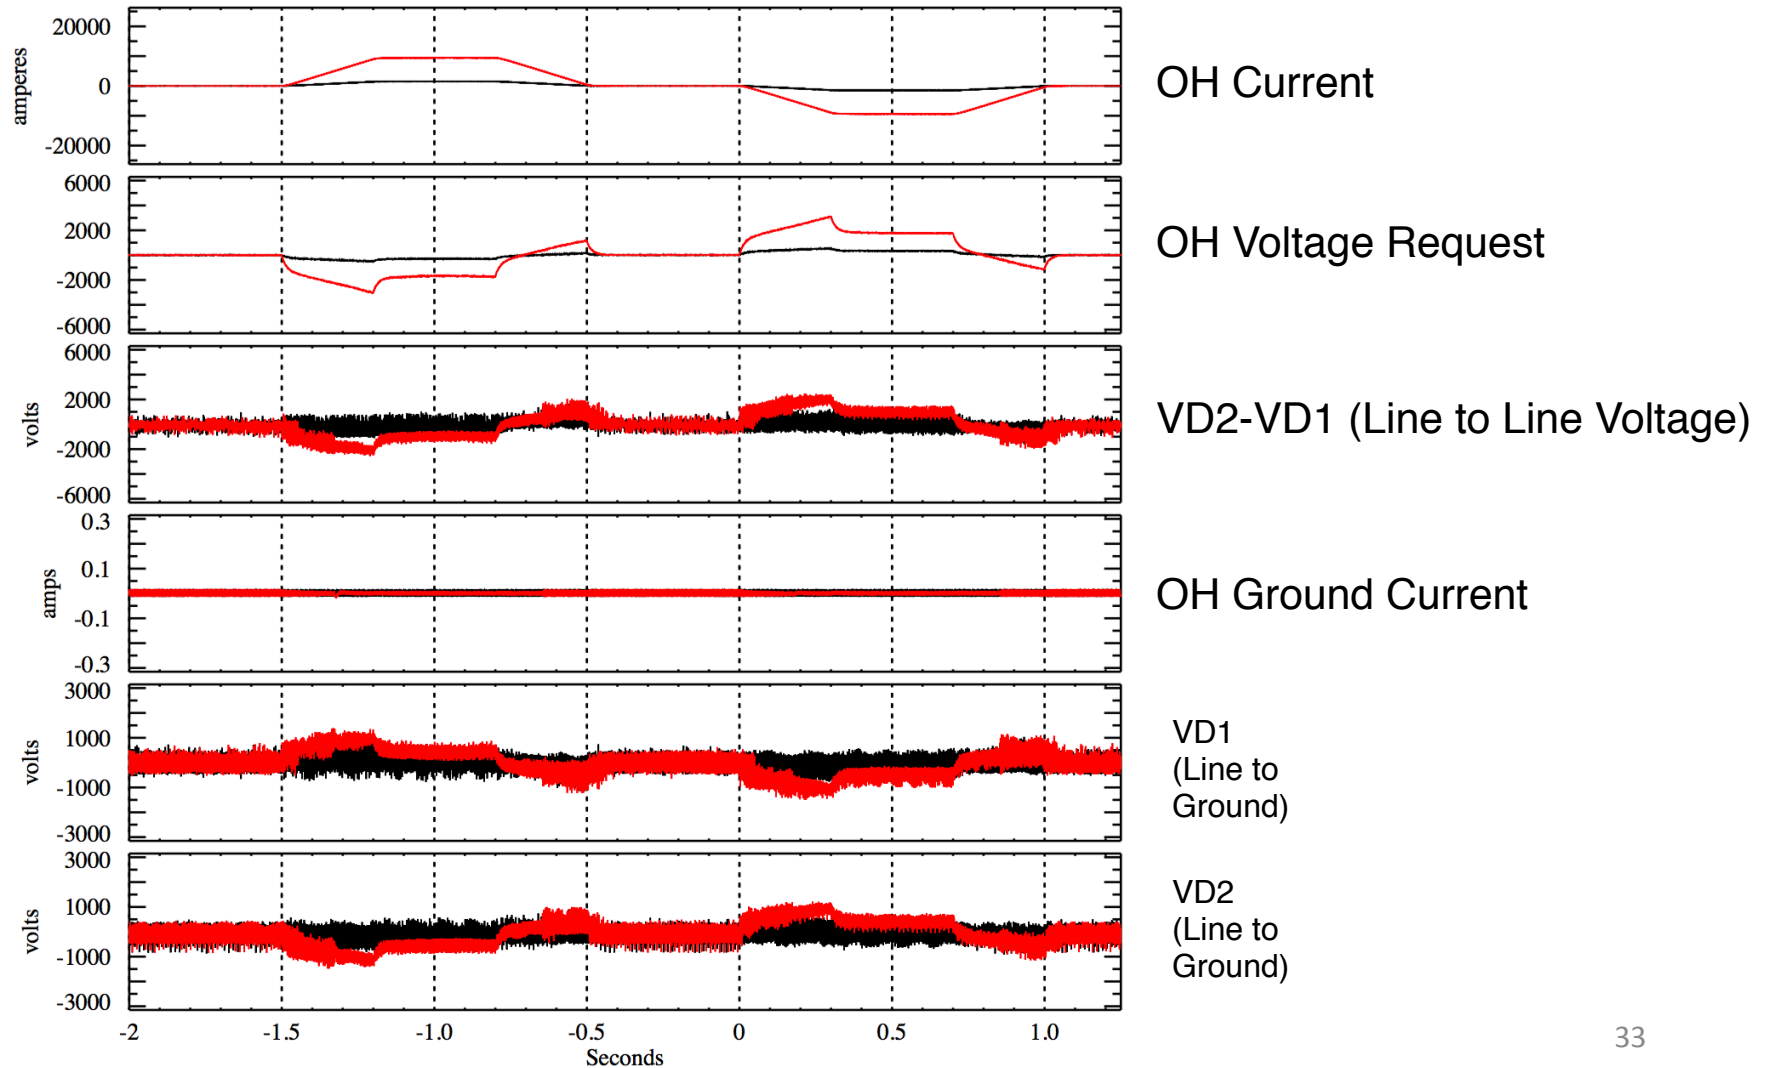
Sequence of Events Leading Up to Fault 8% and 50% shots on 4/24/2015 Were Fine

Shots:
200183
200184

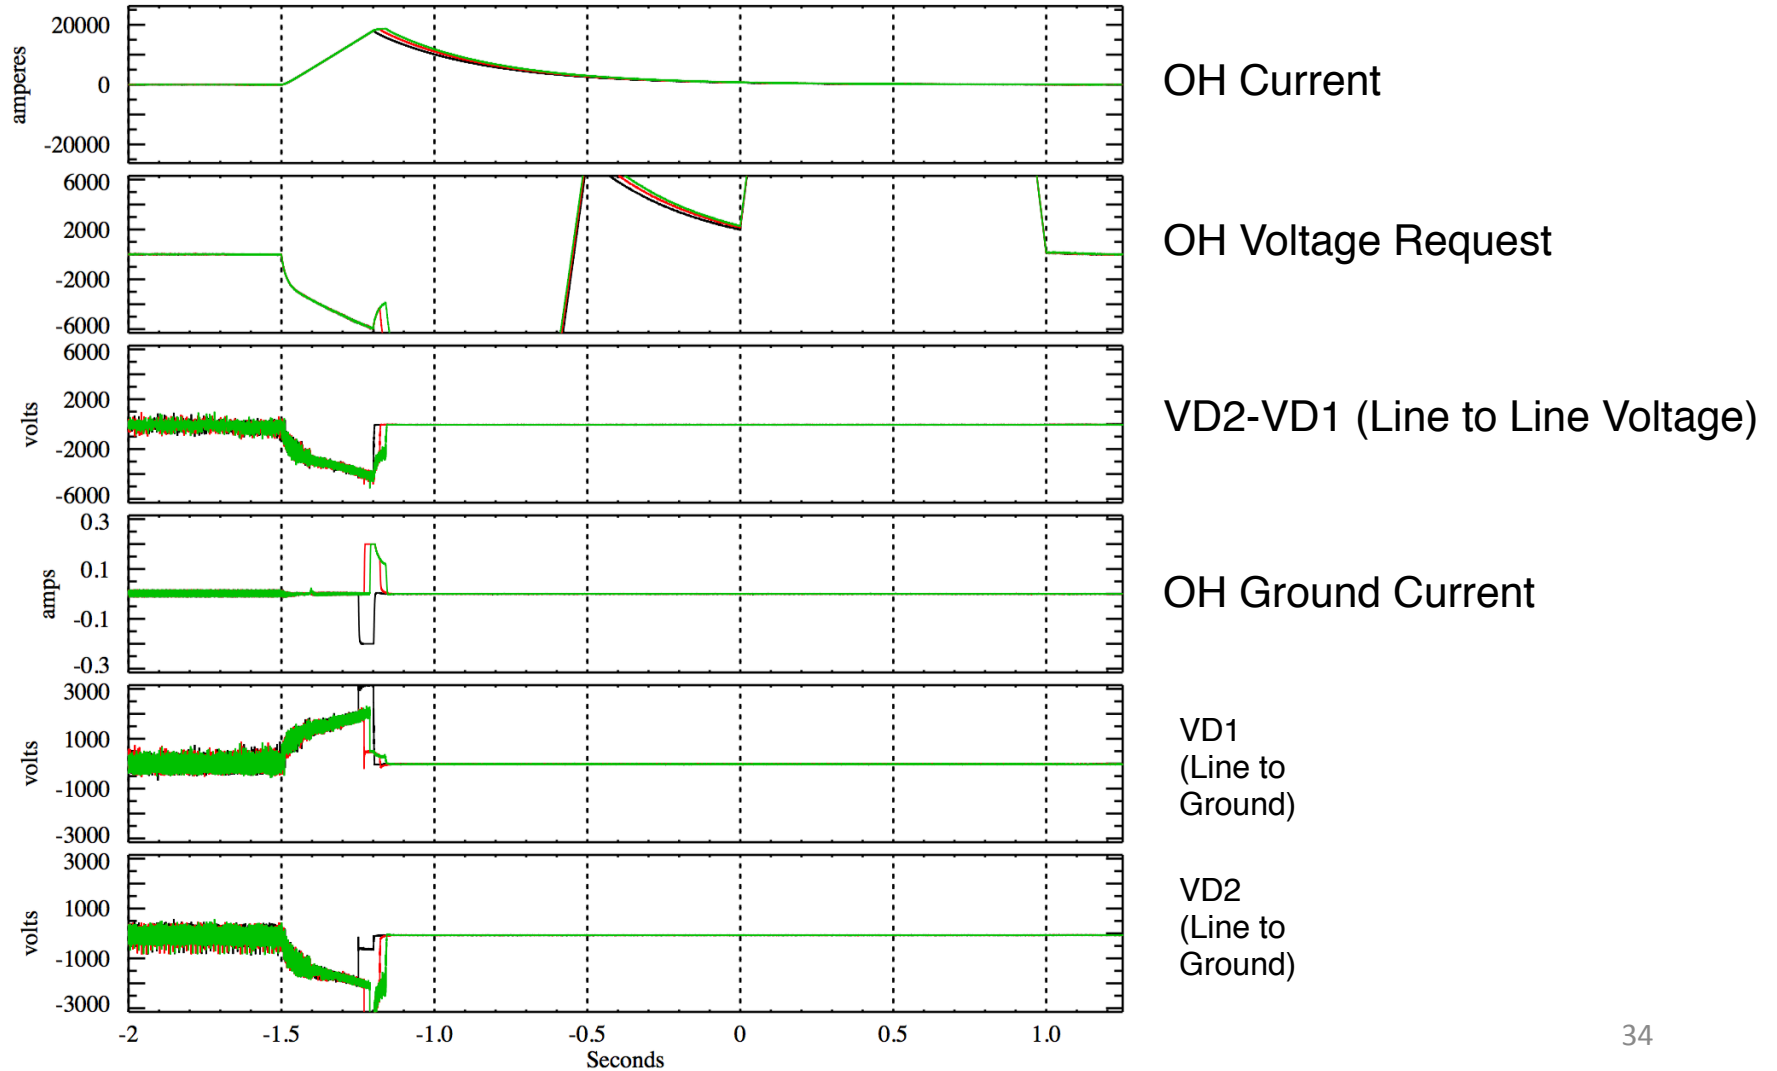
Sequence of Events Leading Up to Fault

Struggled in Attempts to Recreated Previous 100% Test Shot (II)

Shots:
200185
200187
200189

Zoom Out View

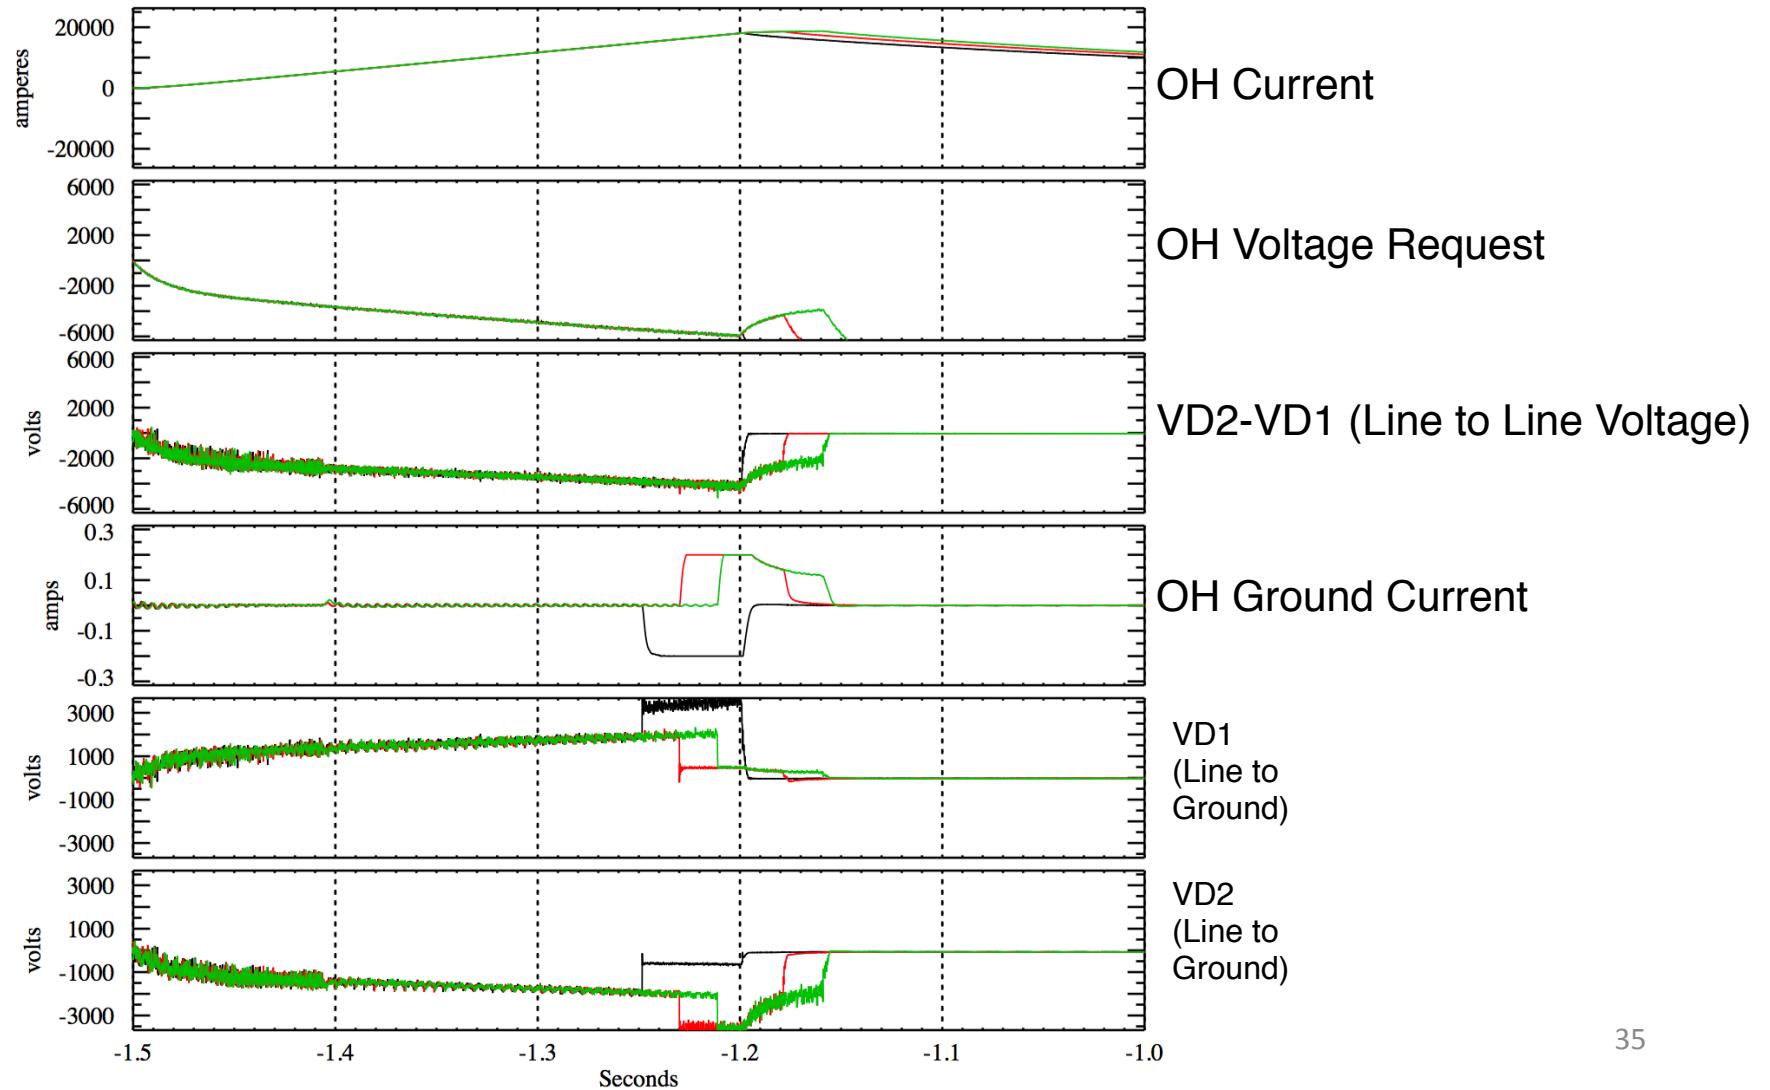
Sequence of Events Leading Up to Fault

Next Shot Had The Damaging Fault

Shots:

200185

200187

200189

200190

Zoom Out Plot of Four Shots on 4/24/2015

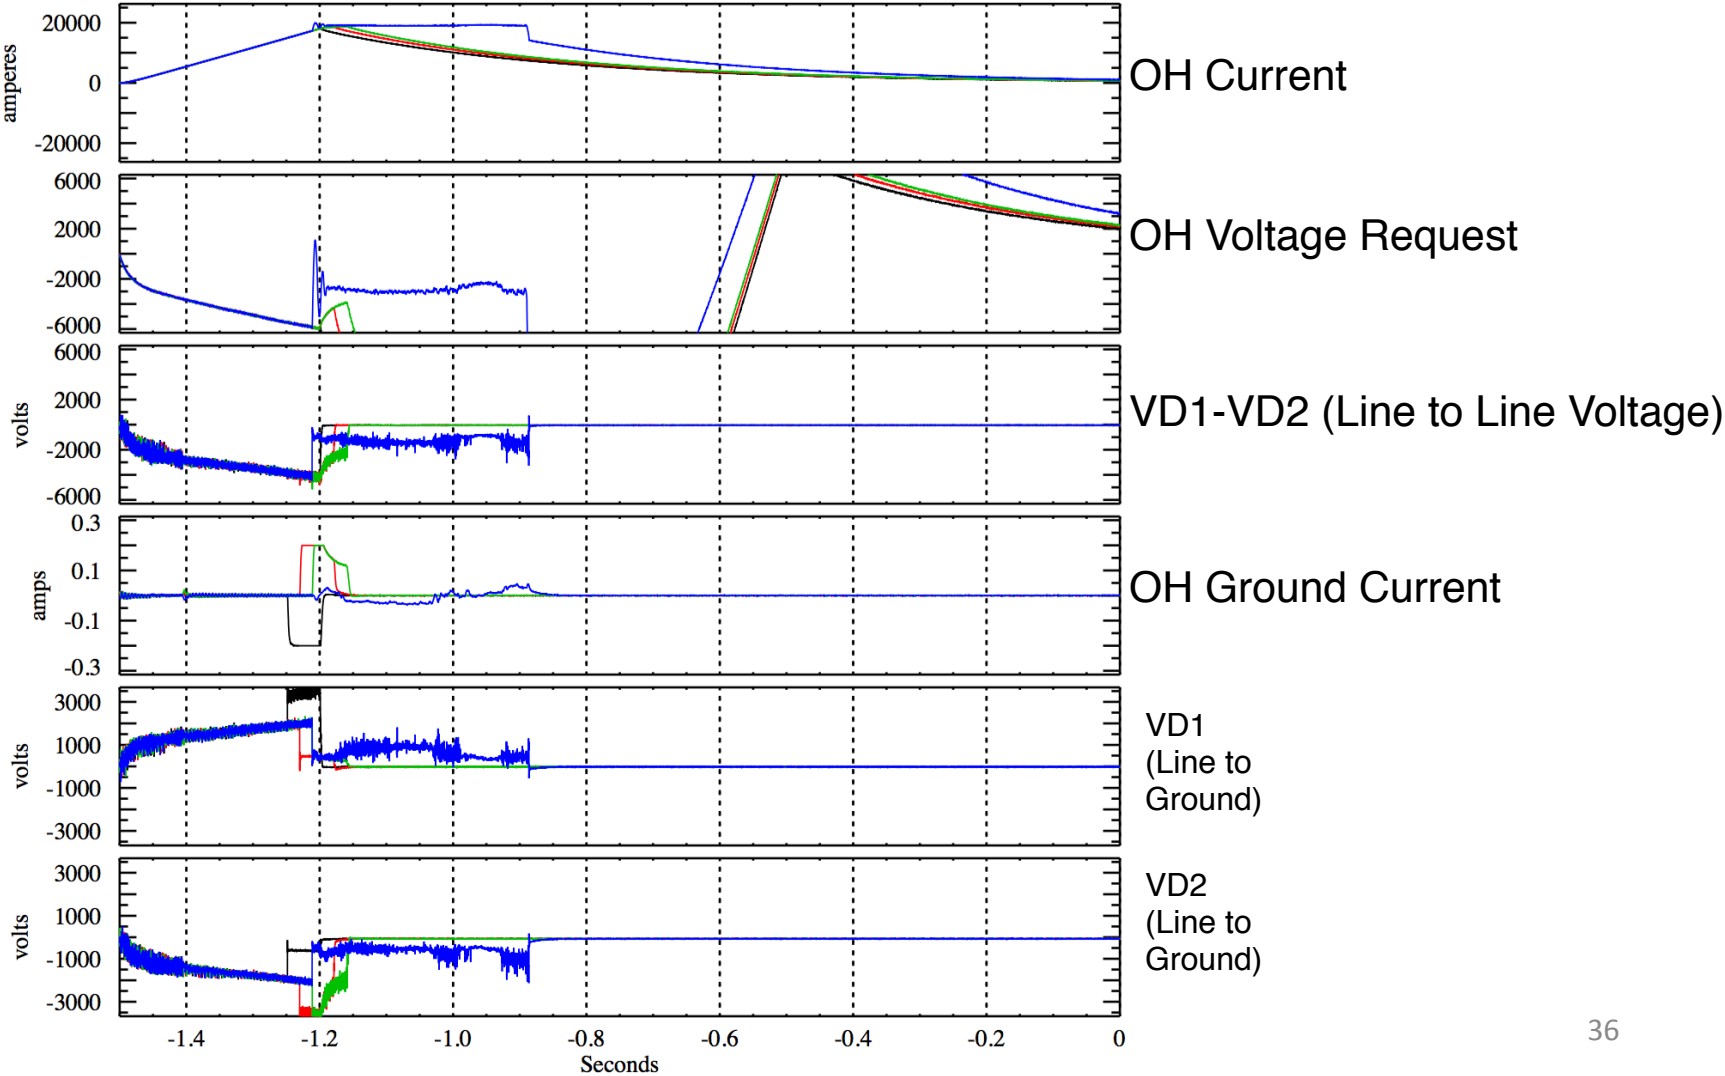
Sequence of Events Leading Up to Fault

Next Shot Had The Damaging Fault (Zoom In)

Shots:
200157
200187
200190

Zoom in on good 100% from 4/21, trip shot from 4/24, and fault from 4/24

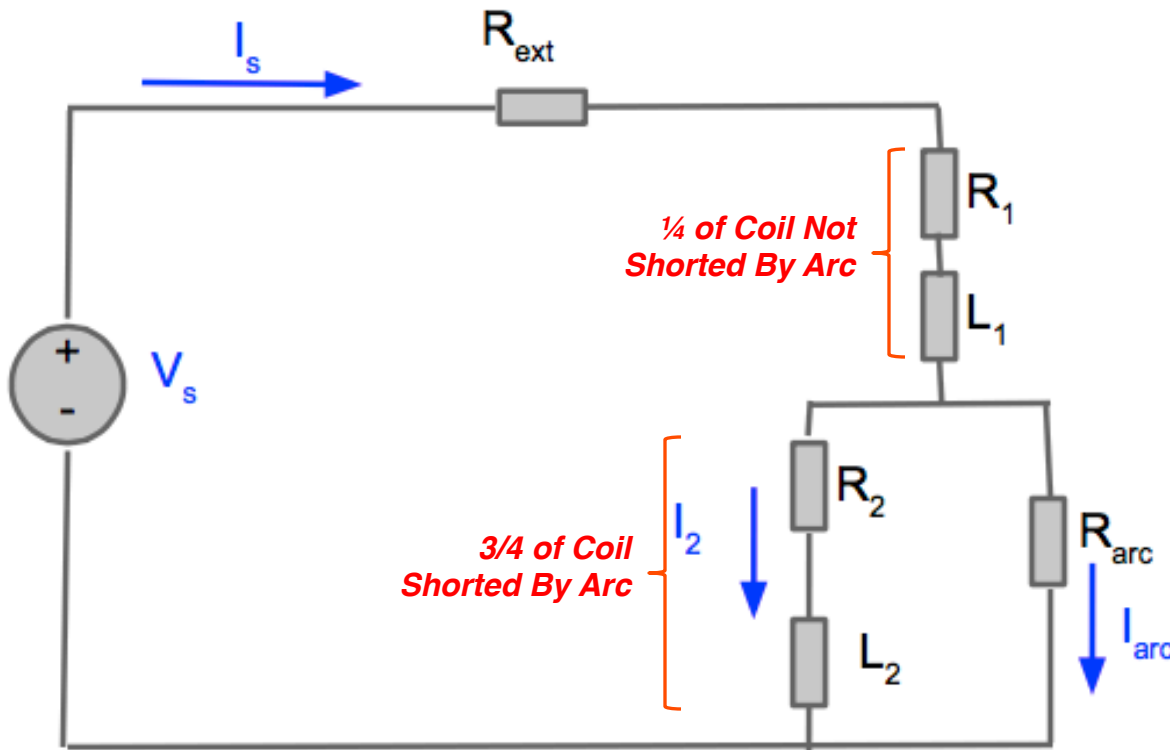
This Hypothesis For the Arc Is Corroborated by Simple Modeling

Assumptions of the Model

$$R_1 + R_2 = R_{coil}$$

Allow a time dependent R_{arc} .

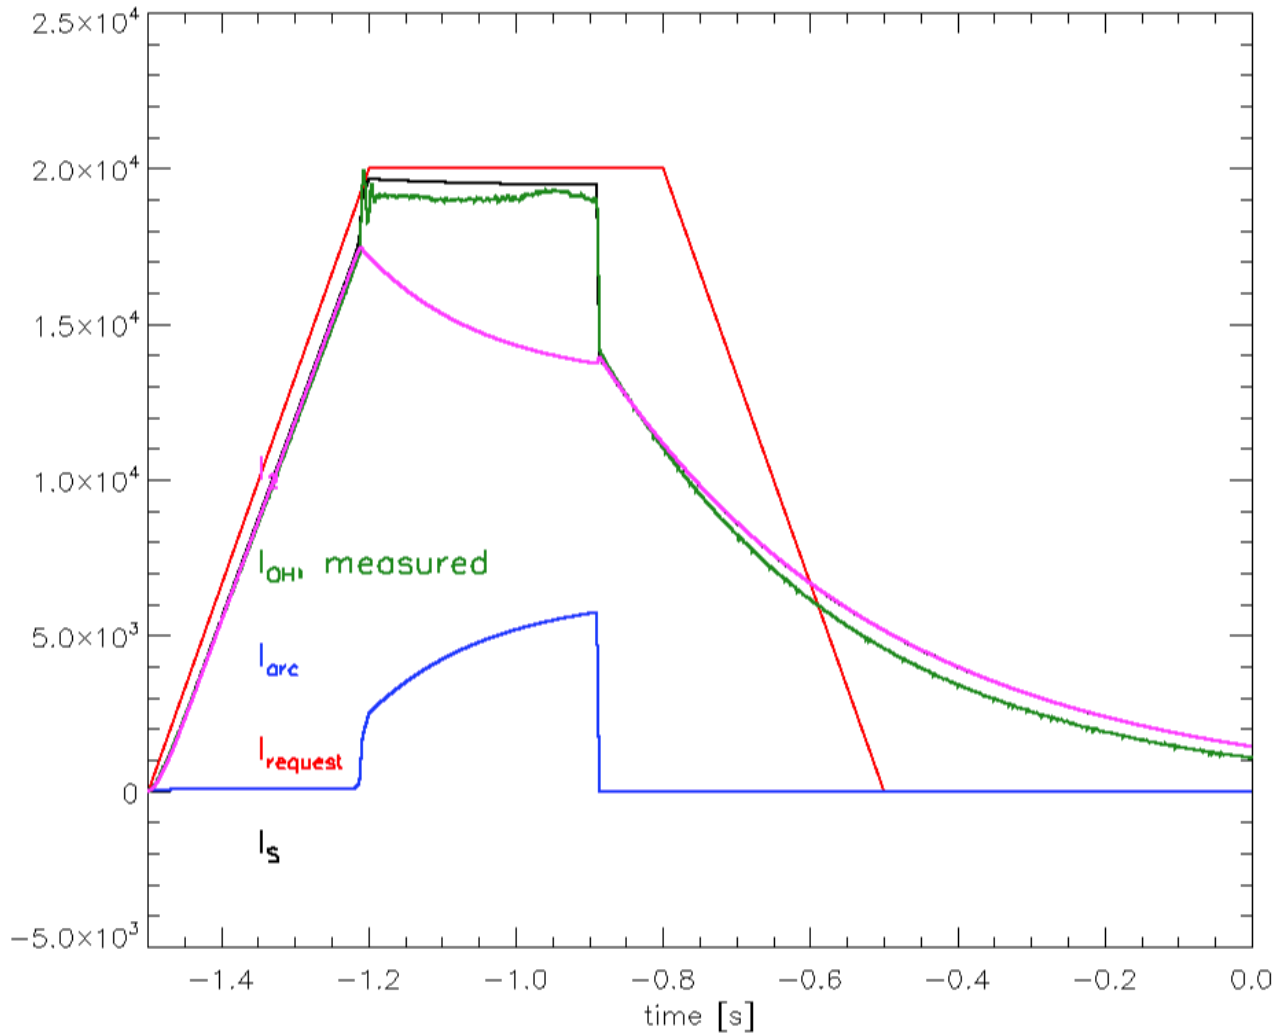
With “Reasonable” Models For the Arc Resistance, Can Match the Supply Waveform: Full View

Model of Current in Part of Coil Shorted by Arc

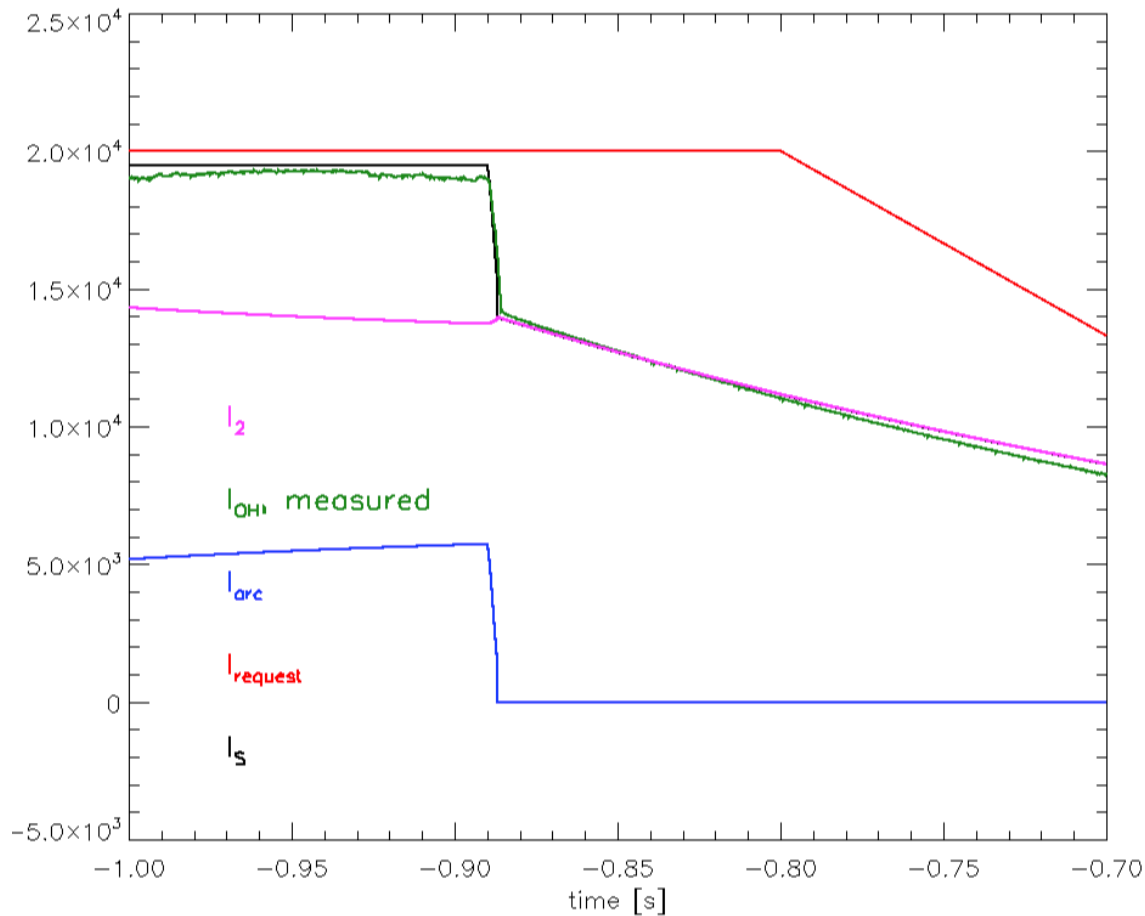
With “Reasonable” Models For the Arc Resistance, Can Match the Supply Waveform: Zoom In
