Extent of condition reference materials

Meeting with engineers to determine their concerns for extent of condition 5/19/2015

EXTENT OF CONDITIONS

NSTX-U OH Fault Extent of Condition Review

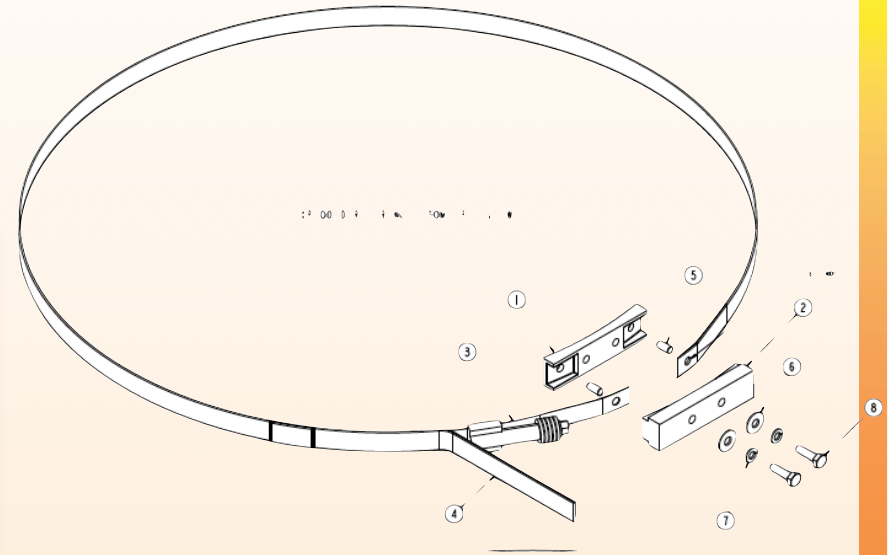
- Following included in white paper
 - Grounding Clamp - NEW design (Raftopoulos)
 - Grounding of OH Preload Assy
 - Design to solve underway (Raftopoulos)
 - OH Water tube insulator/ supports - New Design passed electrical tests (Atnafu)
 - Grounding conductors missing on floor mounts to busswork (Atnafu)

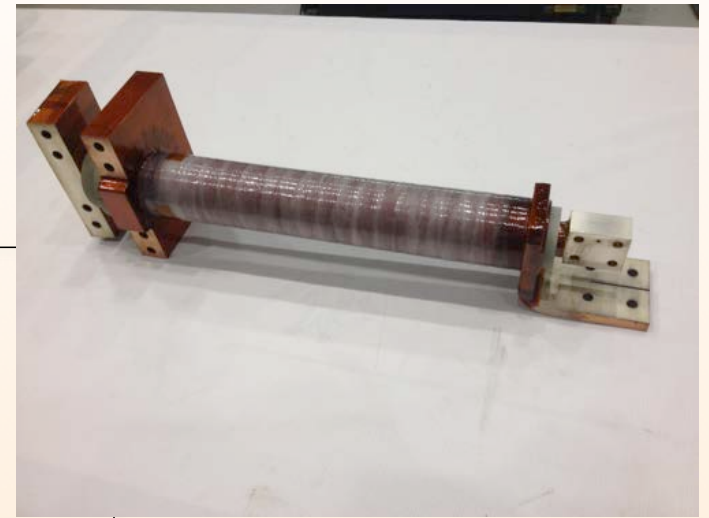
- OH Coaxial Bus (Atnafu)
 - Design change to eliminate epoxy potting of the
 - Concern regarding bending in center conductor
 - Plan to inject epoxy after installation to fill gap between G10 and copper

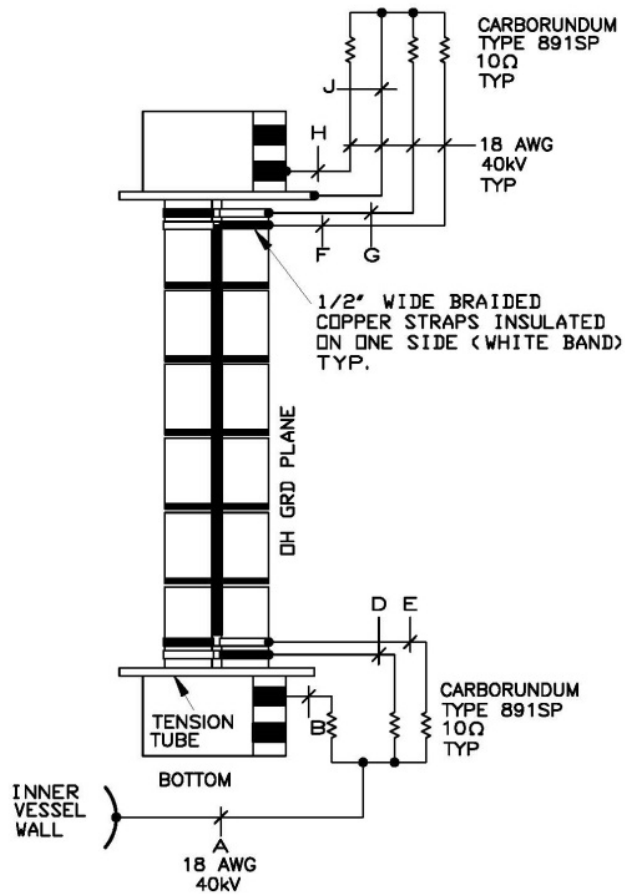
OH GROUND PLANE PRE-UPGRADE DEPICTION

- Pre-Upgrade
 - Braid was provided around (without forming a loop).
 - This was connected to Inner vessel via 10 ohm resistors
 - After the first OH ground problem in 2001 the design was reviewed and a new design was recommended – see Charlie Neumeyer's memo.

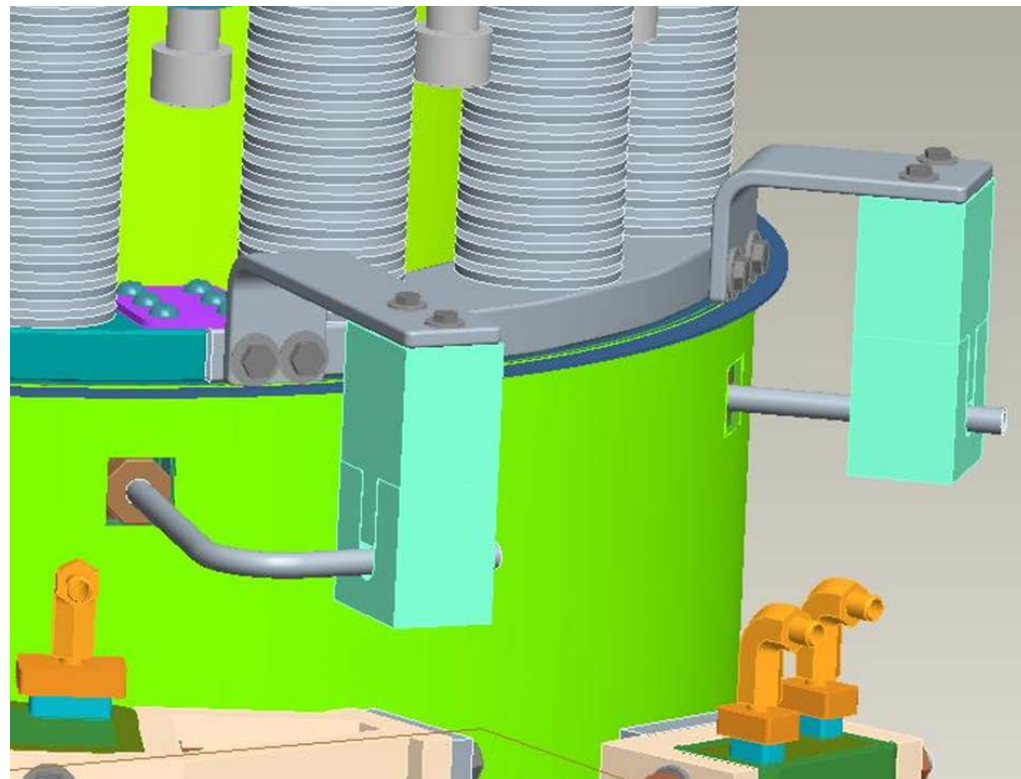
- Four of the eight Upper OH Coil Fittings were burned during the recent incident related to the OH Grounding Cable.
- The clamps which was holding the fittings were also damaged.
- The SS Braided hoses were intact.

- Inspections and leak tests proved that no damage occurred to the OH Coils
- Hydrostatic test was performed and the coils passed the test
- New clamps are being designed
- The new clamps will replace all existing ones

- The New clamp drawing #E-DC1943
- Sample clamps were fabricated and passed 26 KV hi-pot test

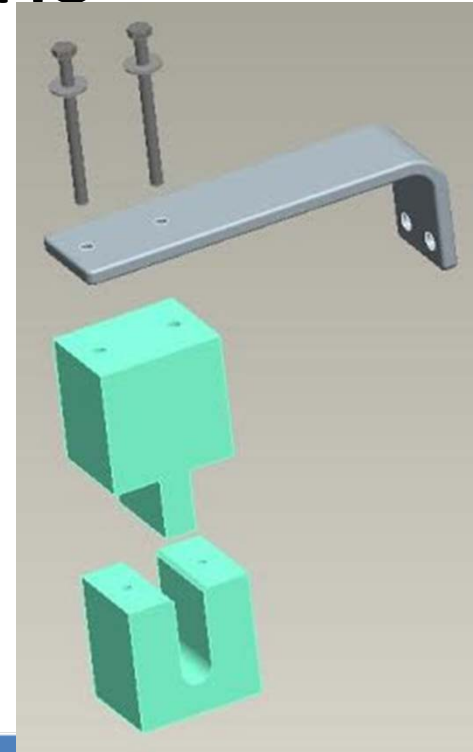
New OH Clamps Hi-Pot Test Result

Hi-Pot Voltage (KV)	0	5	9	17	26
Duration (Min.)	1	1	3	5	5
Measured Current (μ A)	0	0	0	0	14
Calculated Resistance (G Ω)	∞	∞	∞	∞	1.86

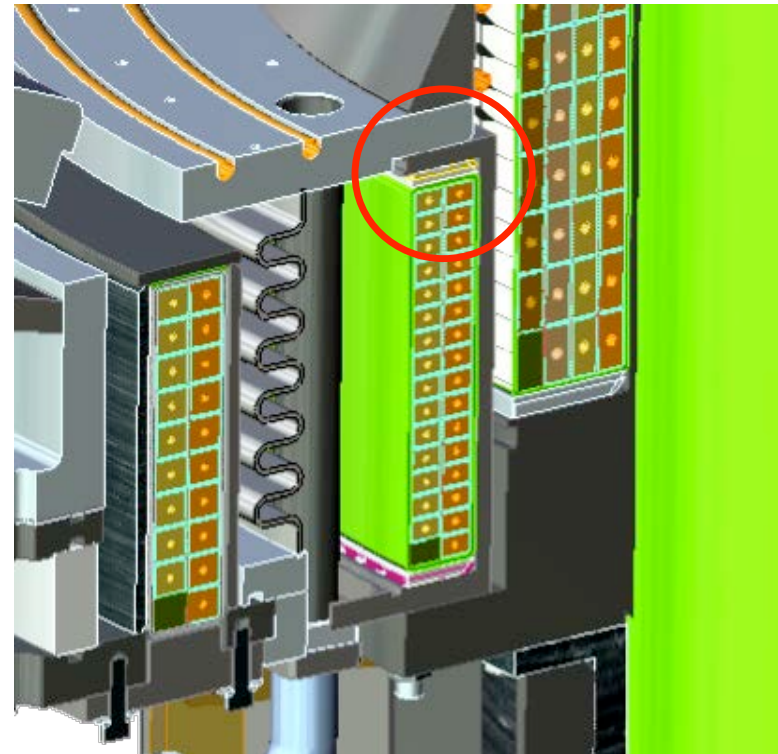
- The temperature to which the Inboard Divertor can reach during Bakeout of NSTX CS may be limited by heat loss to the PF1b coil which is welded to the CS Casing
- G10 Insulation in PF1b is at risk
- Everywhere else (OH, PF1a) the CS is insulated from the CS Casing with MicroTherm to reduce heat loss
- PF1b is part of the load path that supports the CS Casing and is in direct contact with the flange on which the Horizontal Inboard Divertor Tile is mounted
- There is also concern over the shear strength of the weld when subject to the large temperature differences
- Tile is in good thermal contact with the flange with Grafoil to limit ratcheting with consecutive pulses

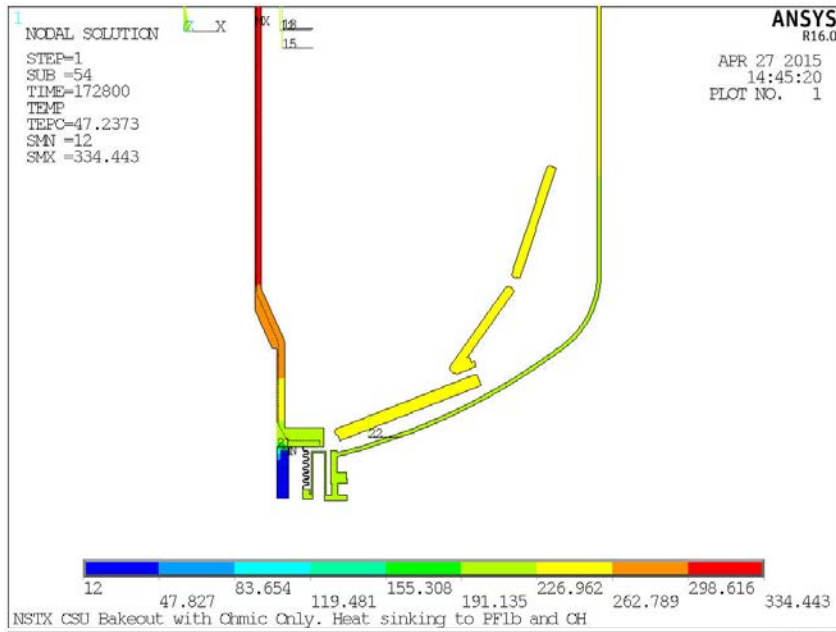
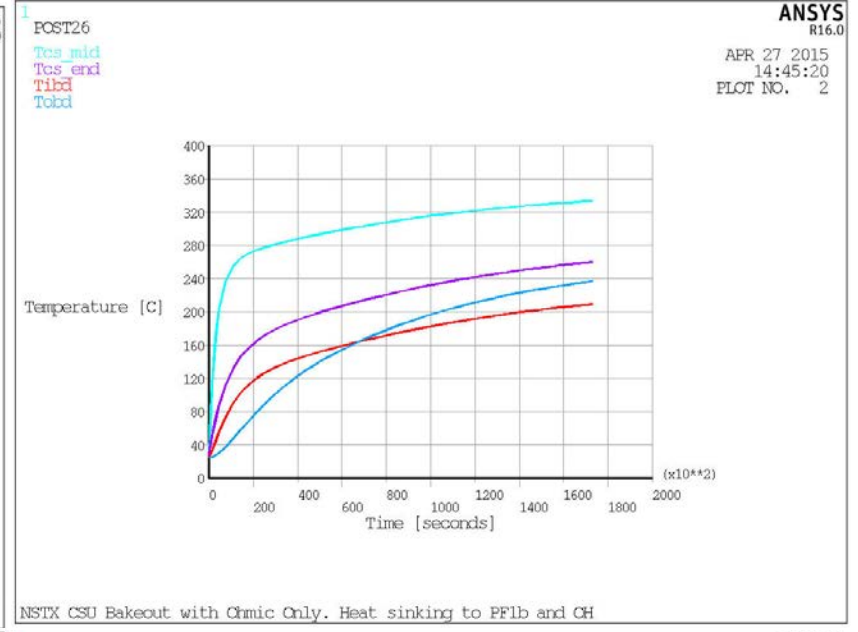
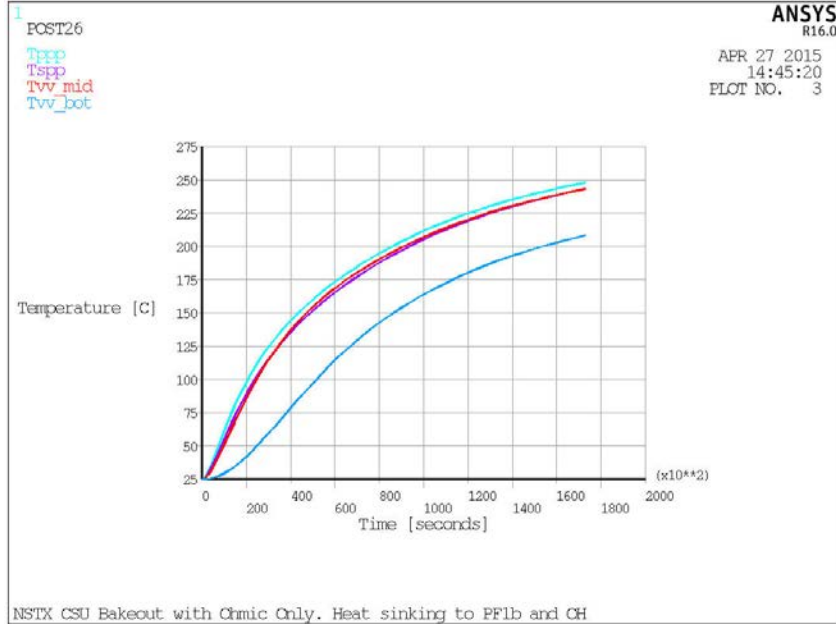
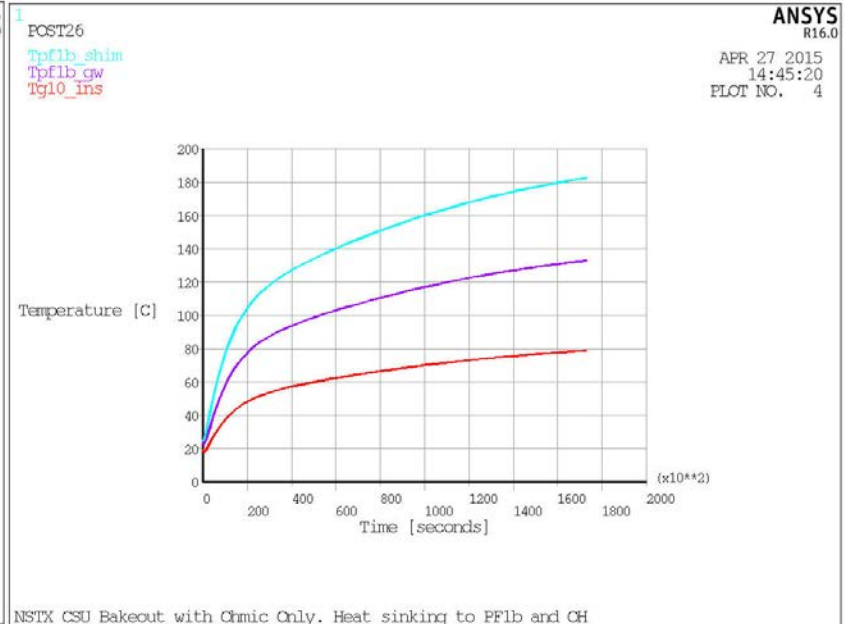
CS casing ohmically heated 8 kA without any cooling in IBD, OBD, PPP, SPP or VV

Only heat leak to OH and PF1b (VV perfectly insulation)

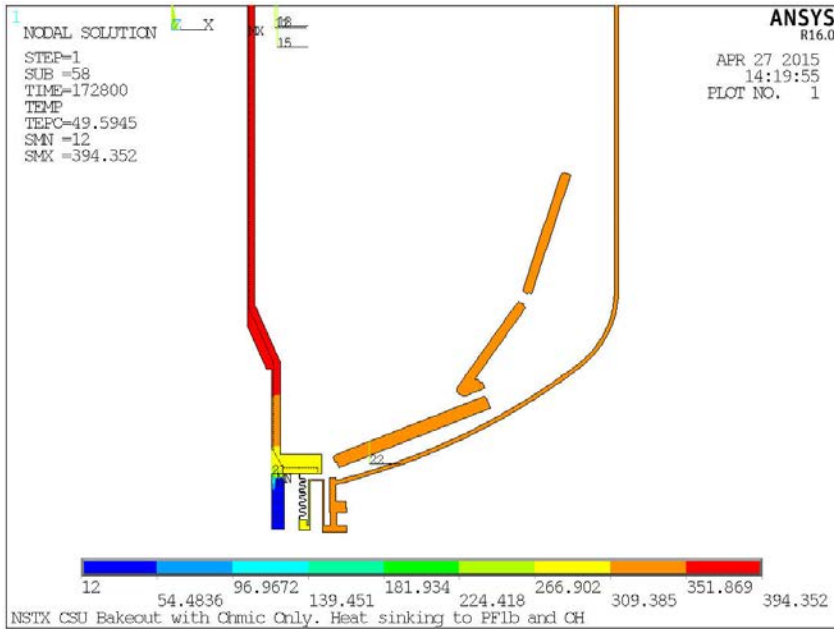
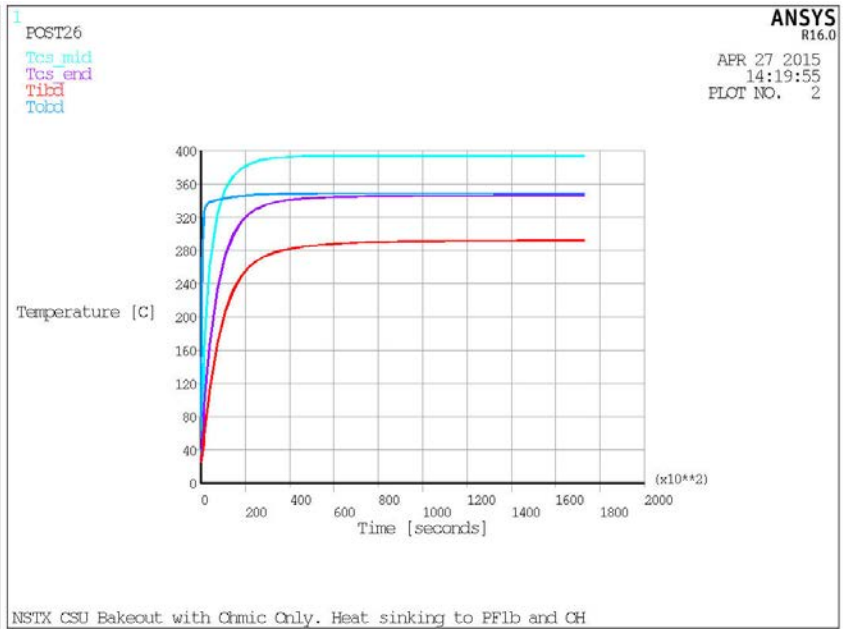
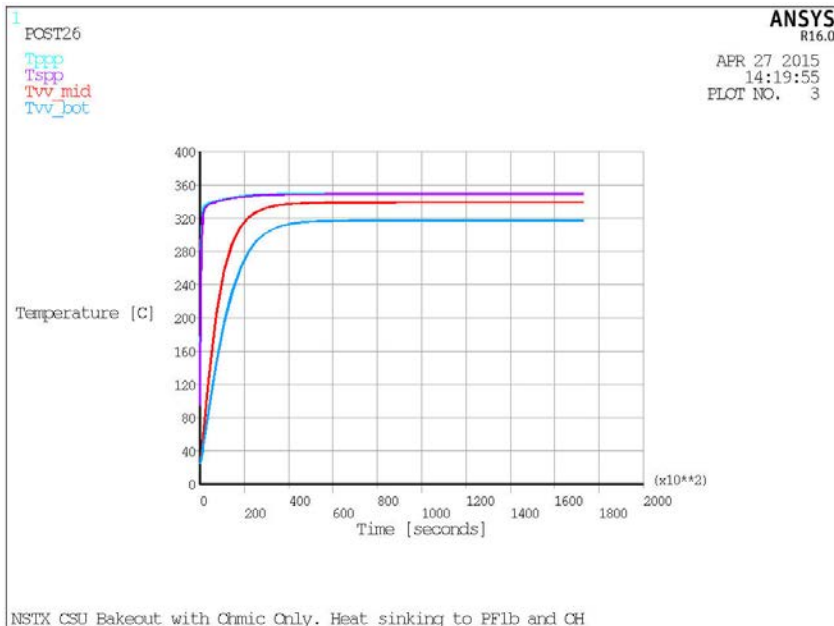
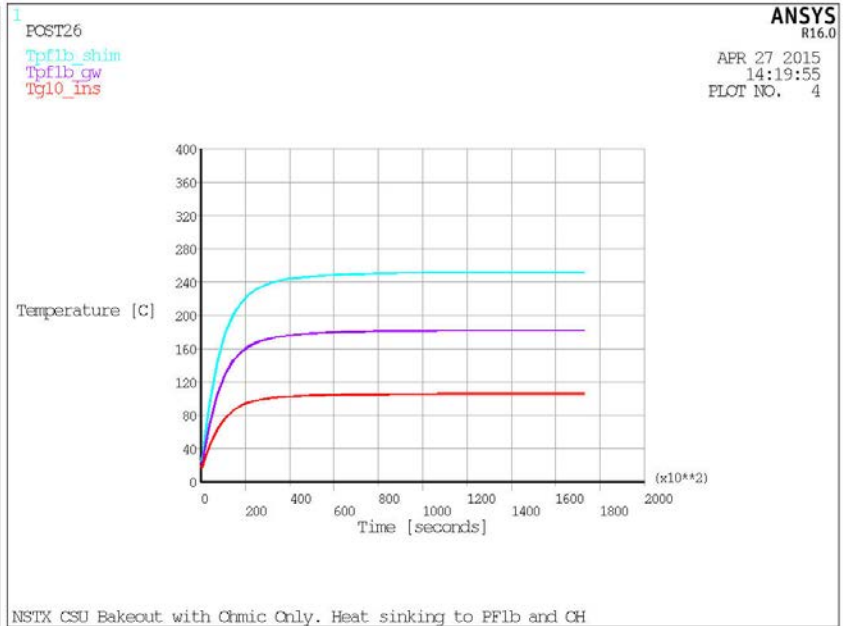
Add PPP, SPP & OBD (ie normal He system turned on)

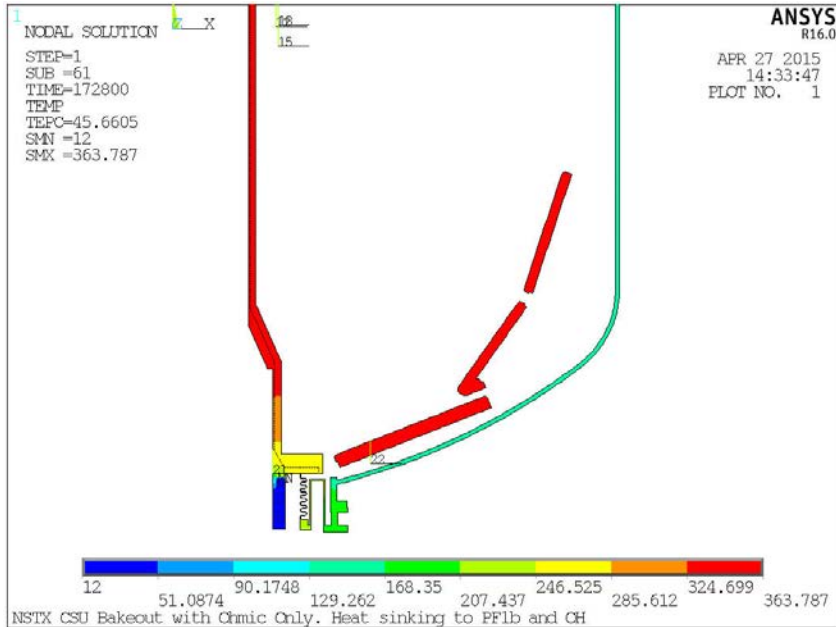
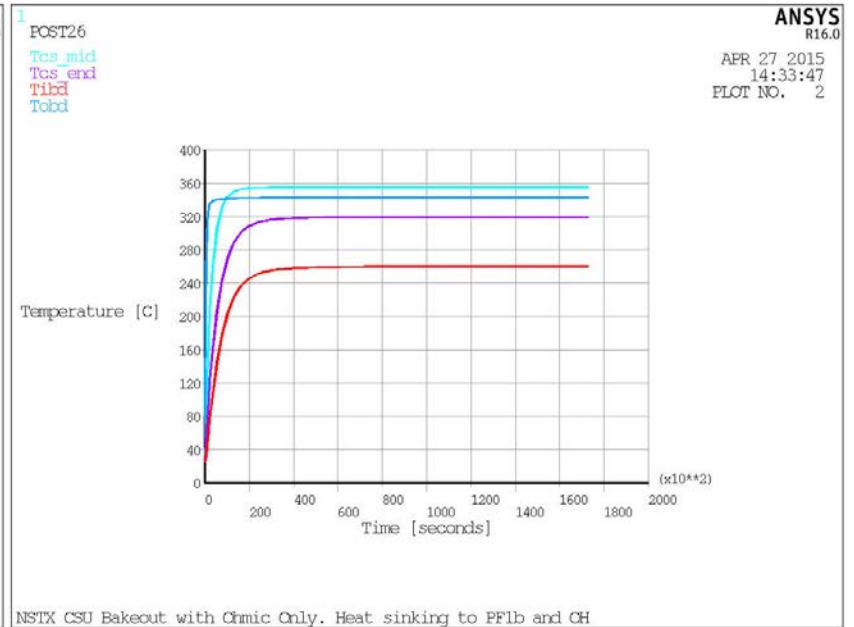
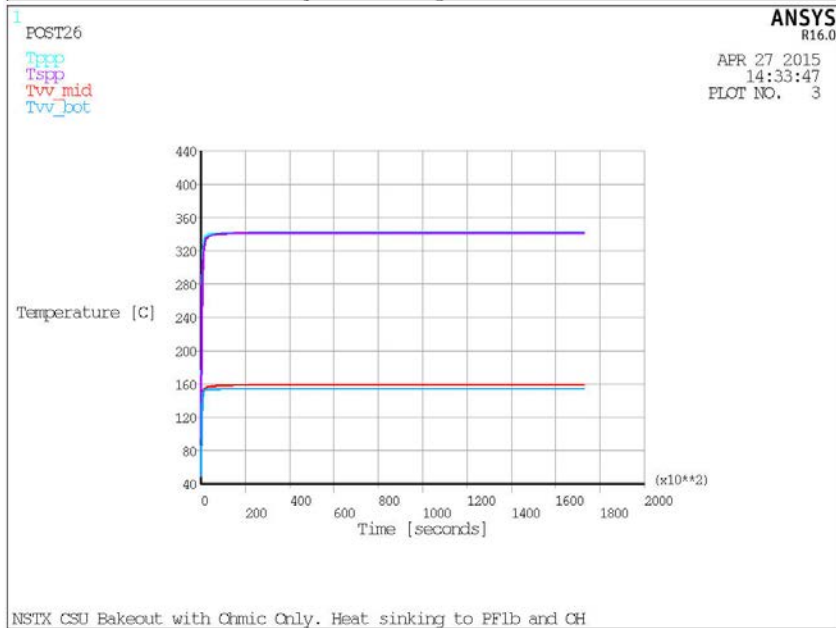
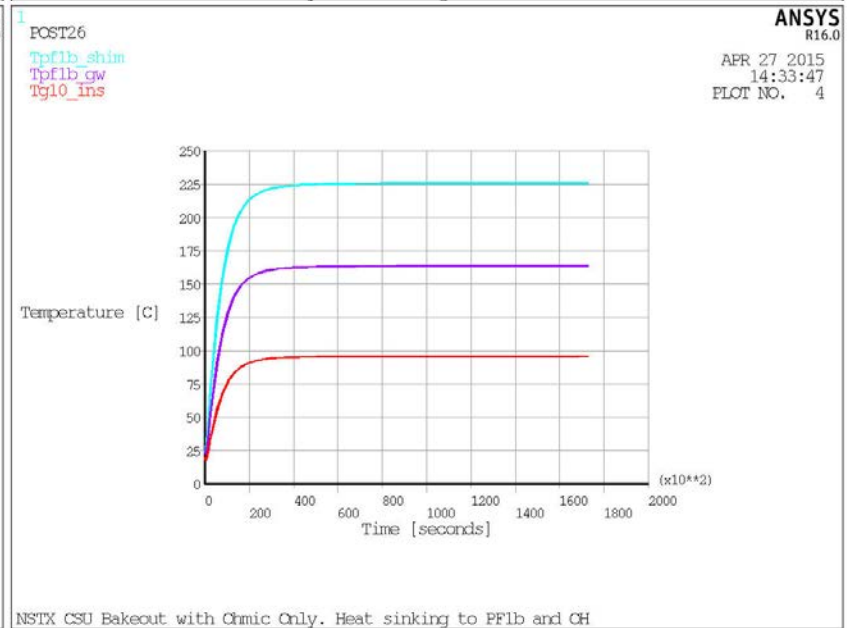
VV Cooling/Heating at 150 C

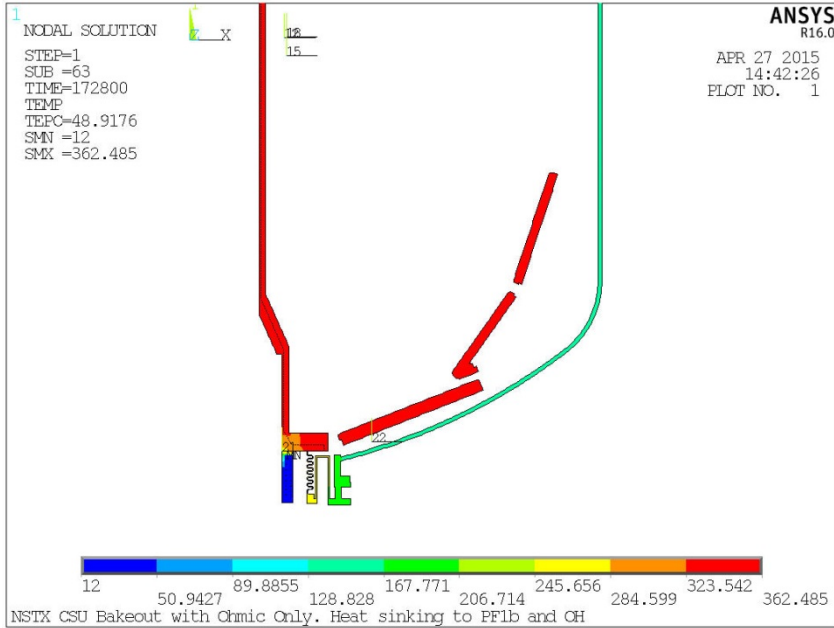
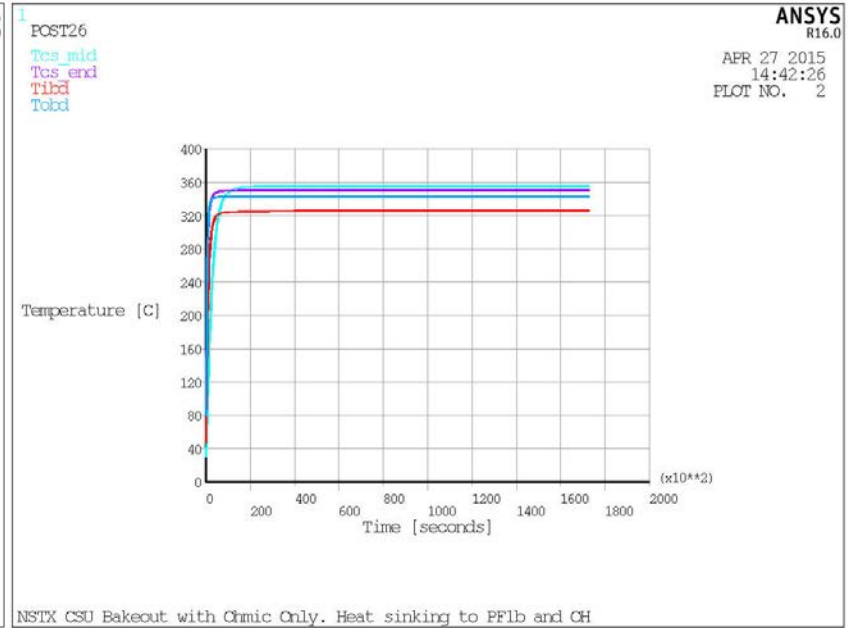
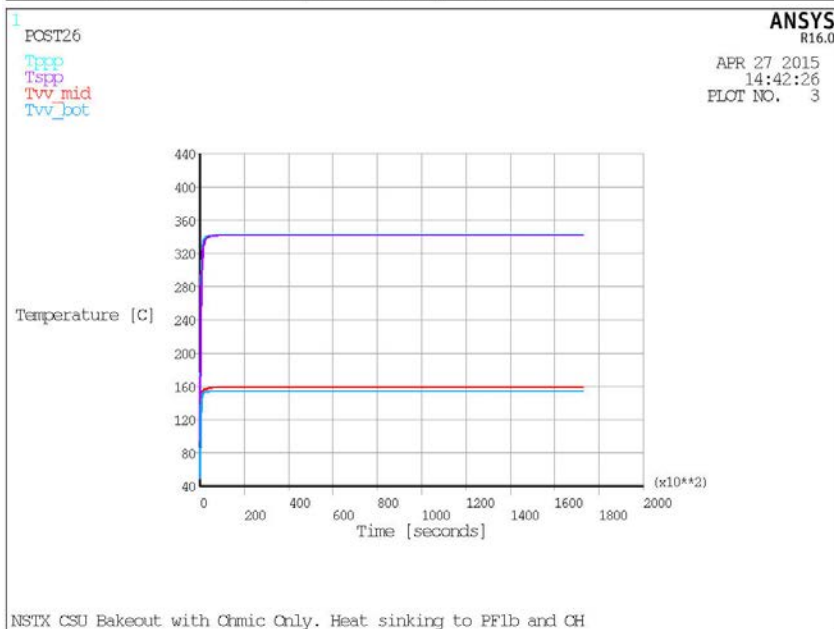
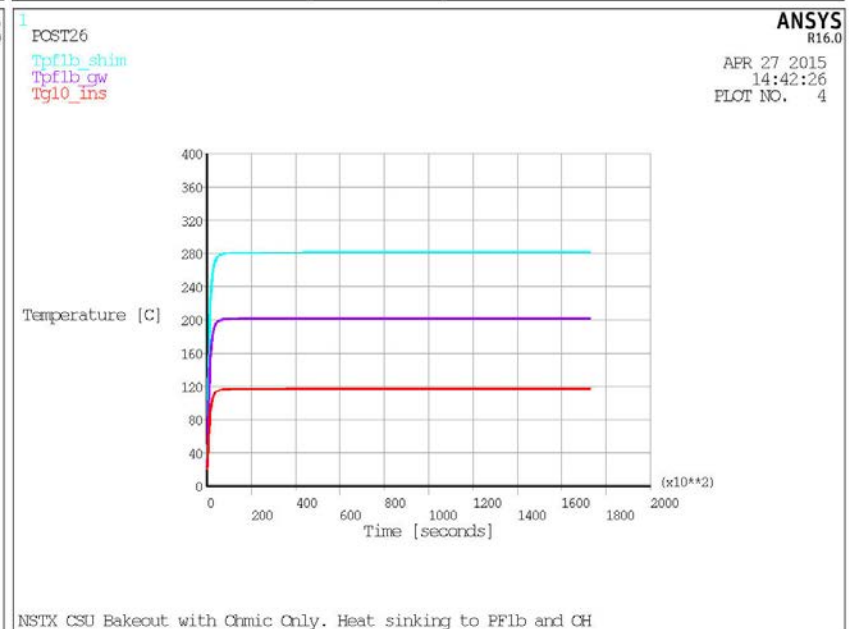
Add IBD He at 350C

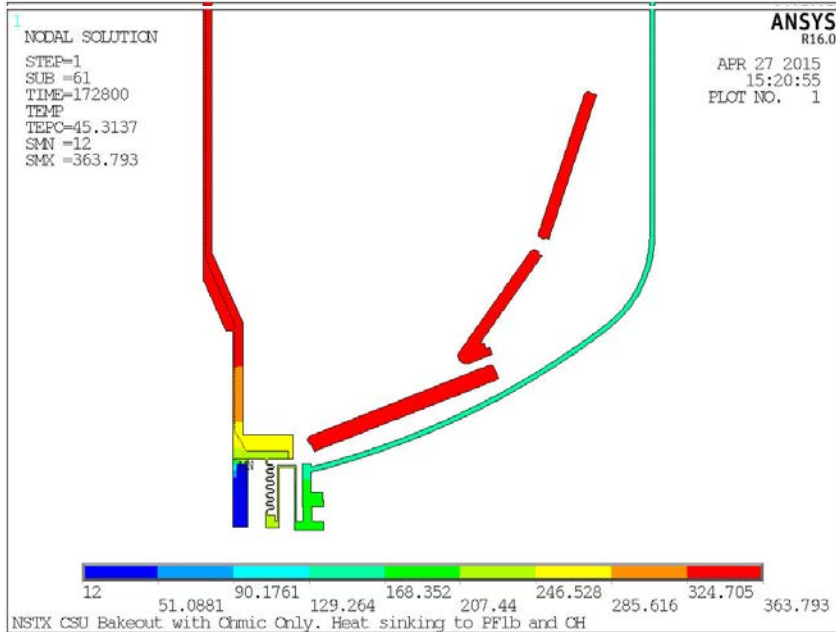
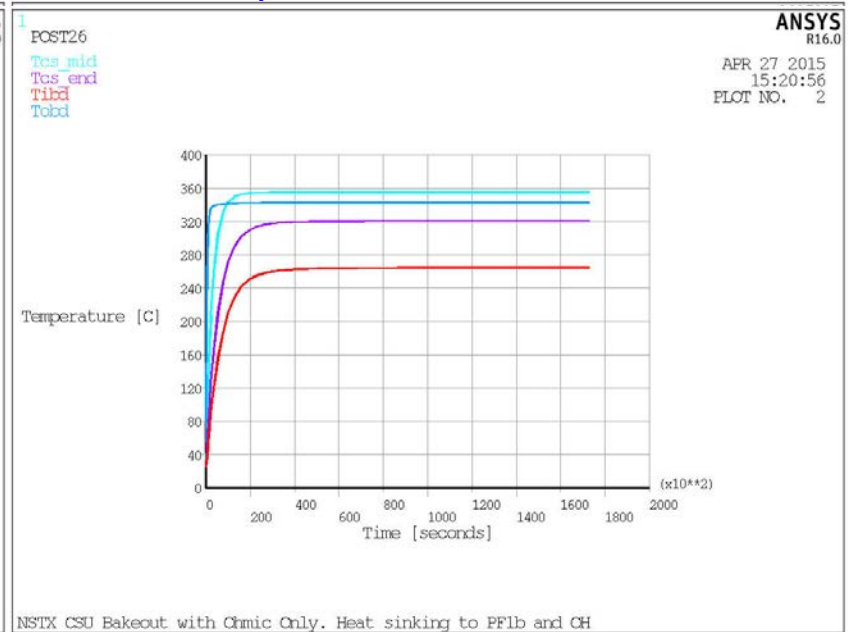
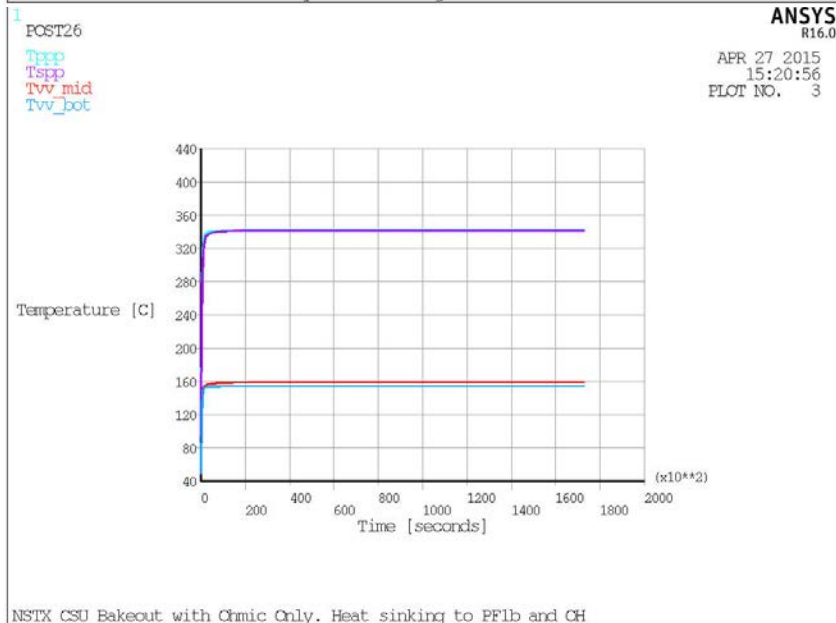
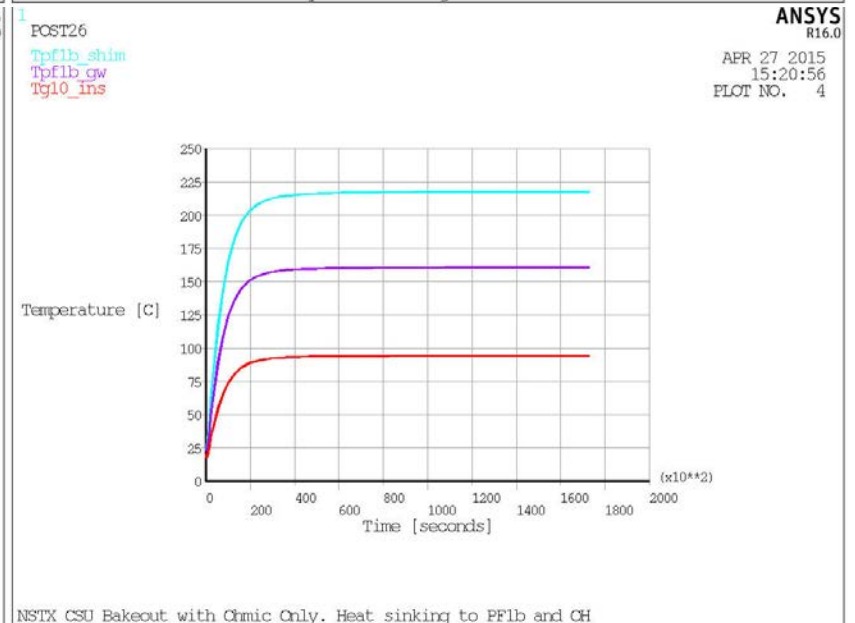
Remove IBD He at 350C and remove conduction path at IBD to let tile float thermally

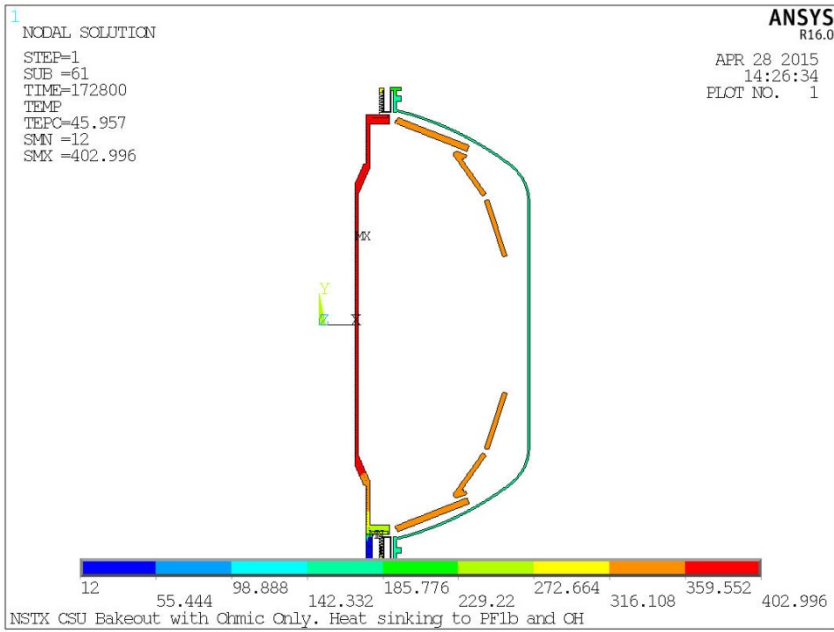
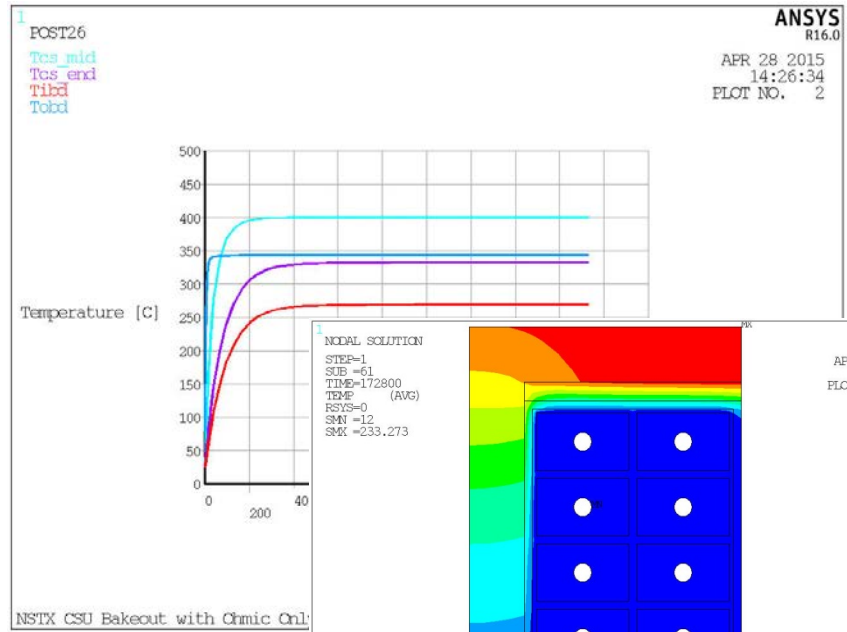
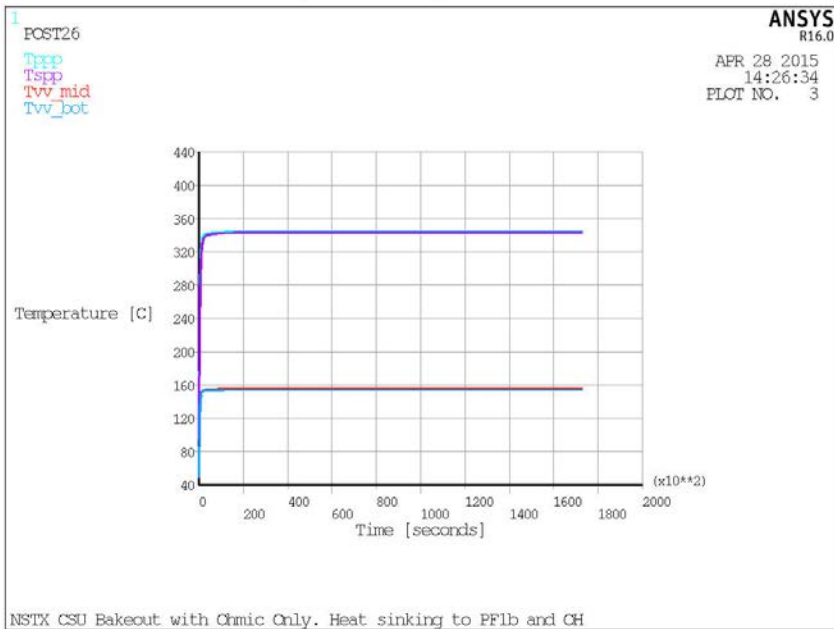
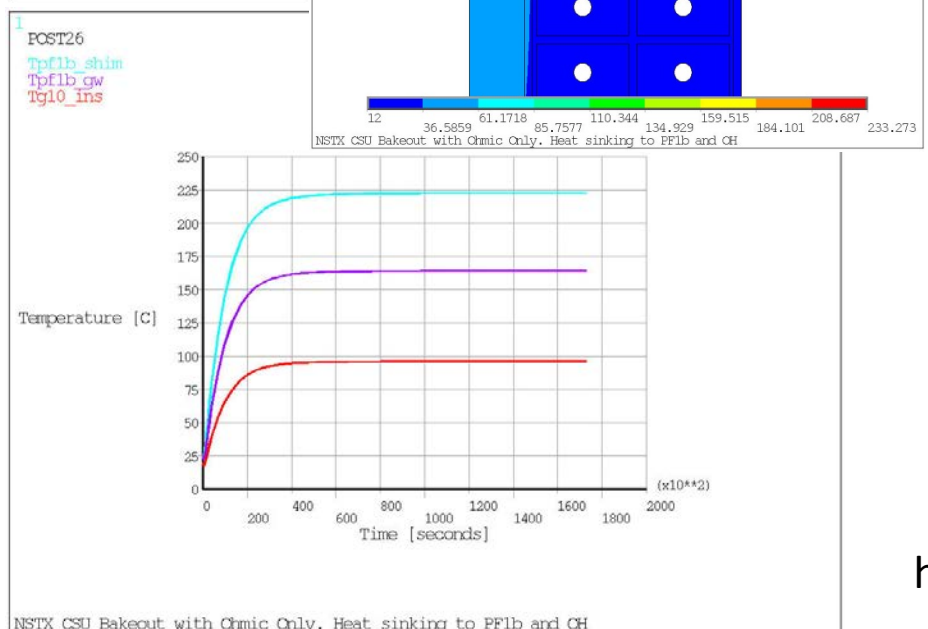
For IBDhs Tile Only - No Conduction or Radiation to flange

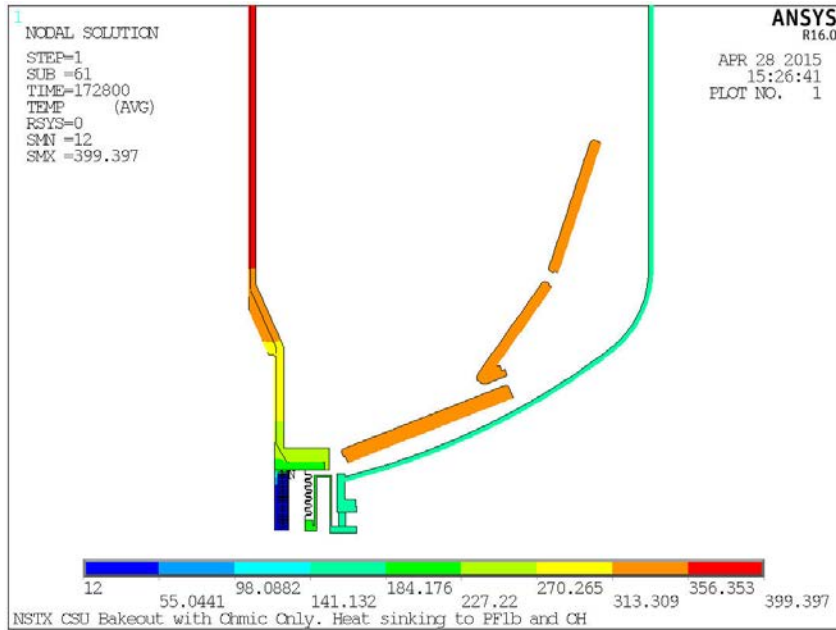
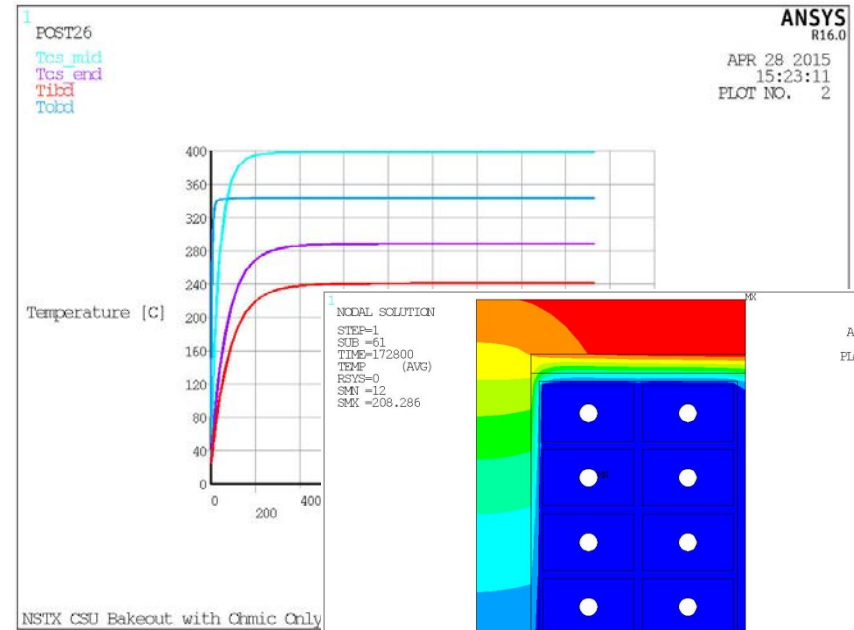
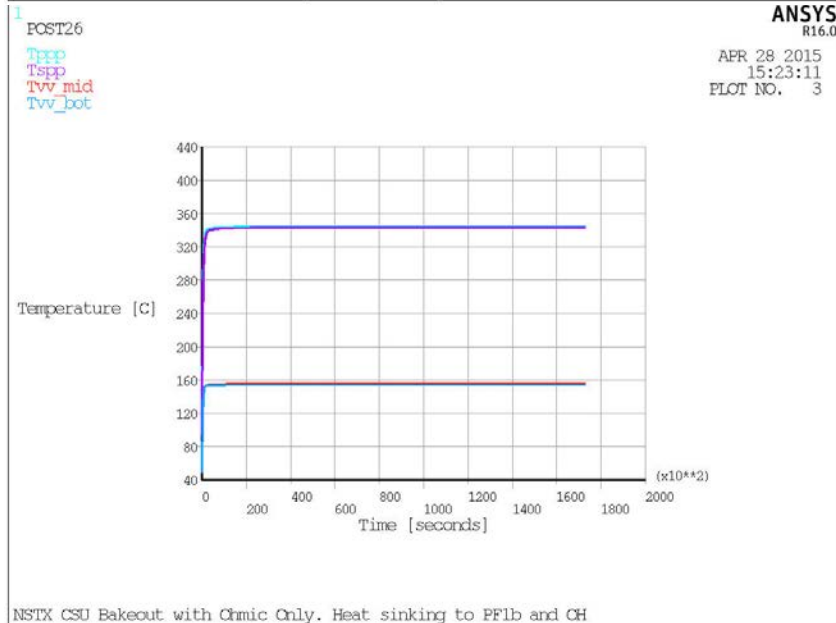
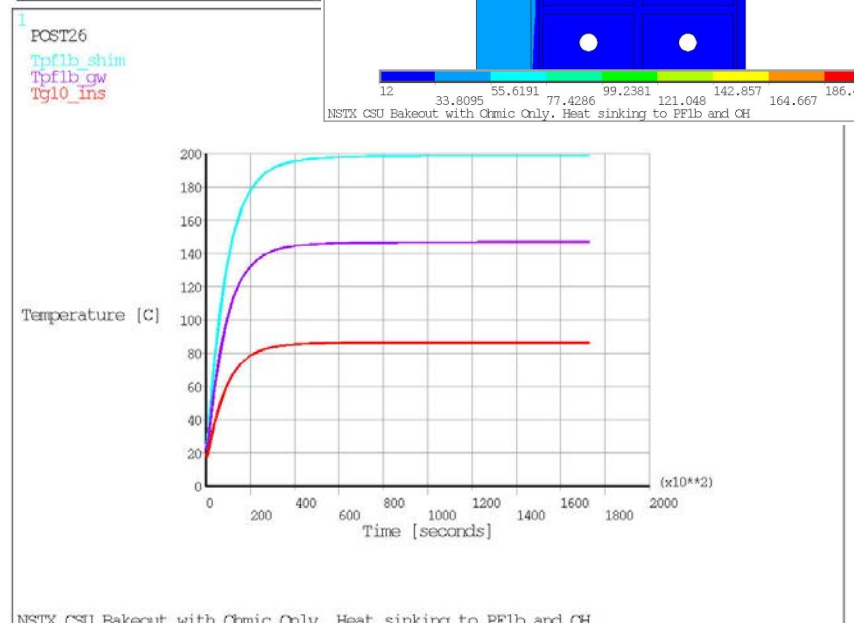
Add leakage to pf1a at 40C, h=6.3w/m²

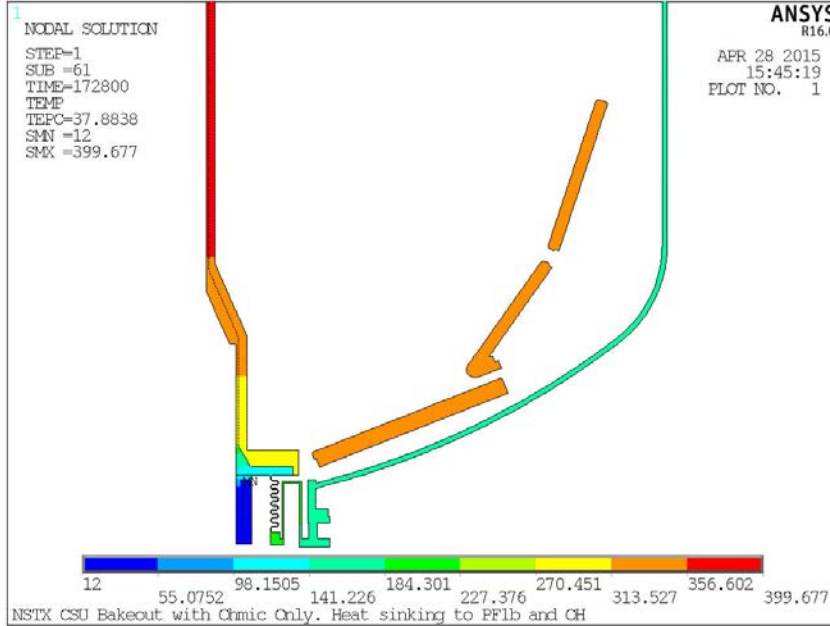
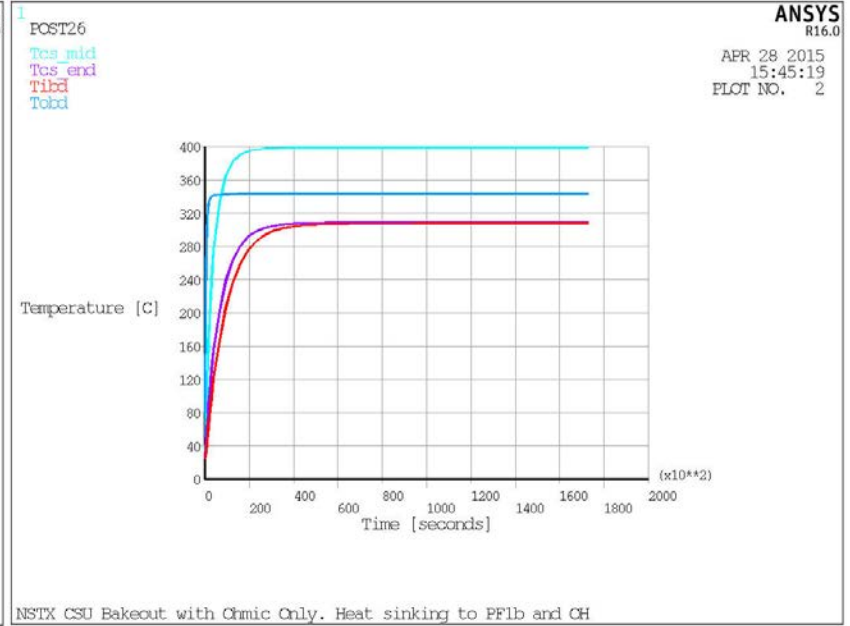
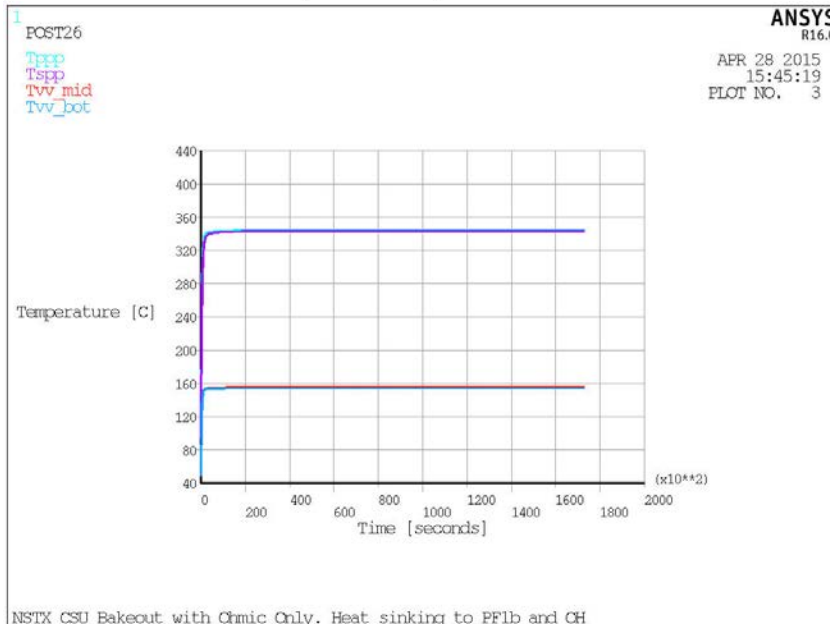
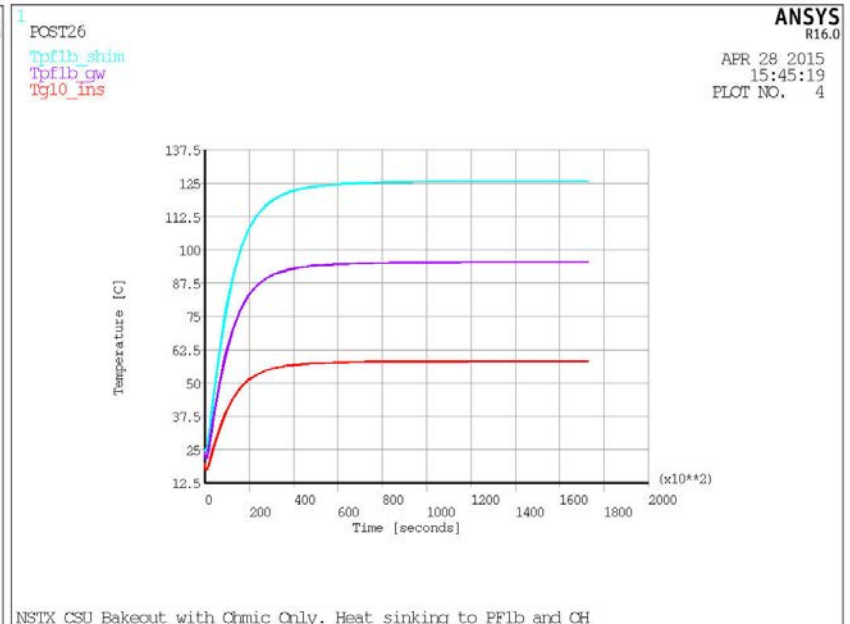
Conduction between IBDhs and IBDvs removed

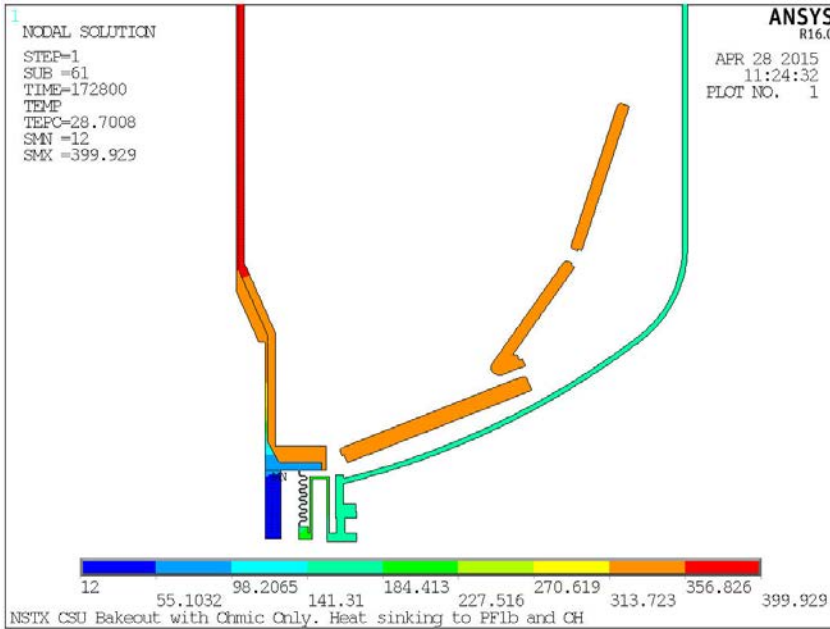
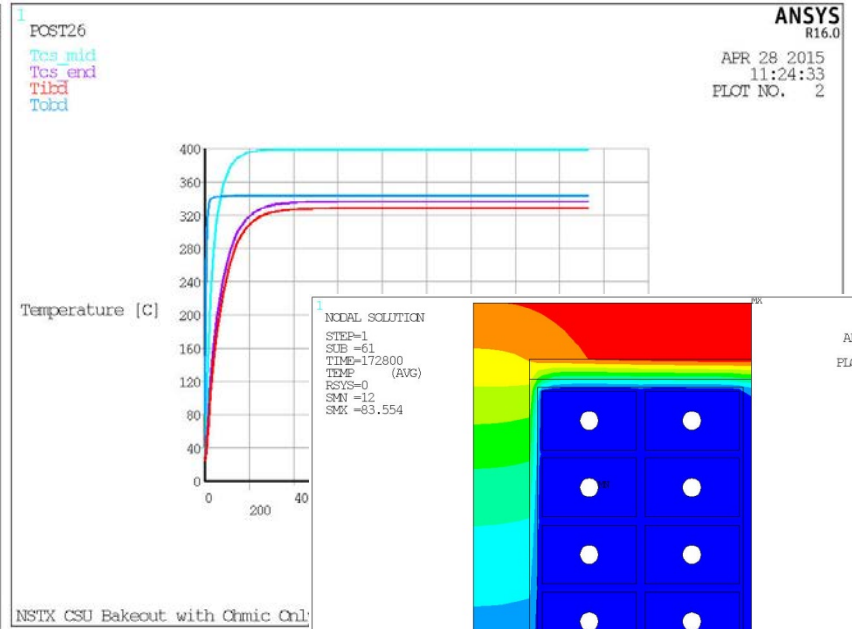
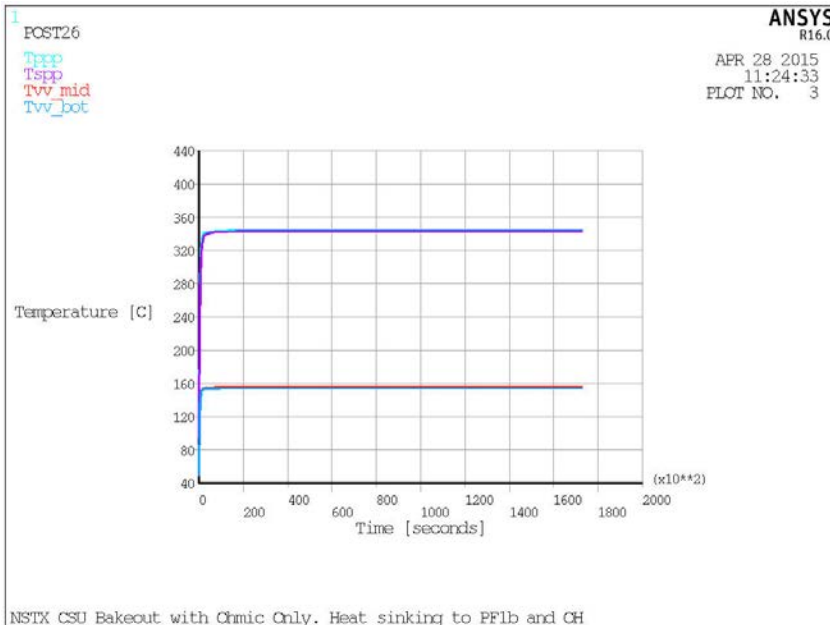
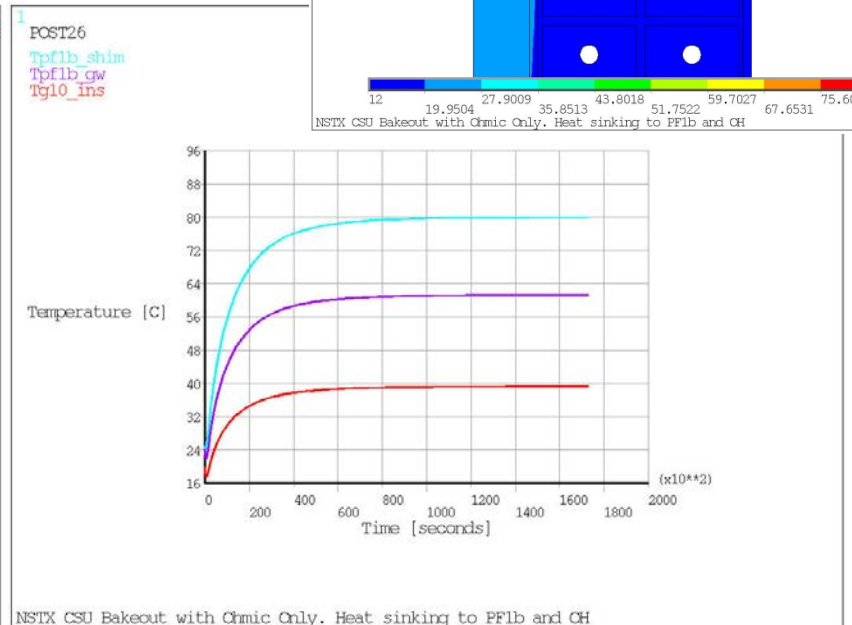
IBDhs & IBDvs Tiles No Conduction or radiation to flange (leakage to pf1a at 40C)
