Extent of condition reference materials

Meeting with engineers to determine their concerns for extent of condition 5/19/2015

EXTENT OF CONDITIONS

NSTX-U OH Fault Extent of Condition Review

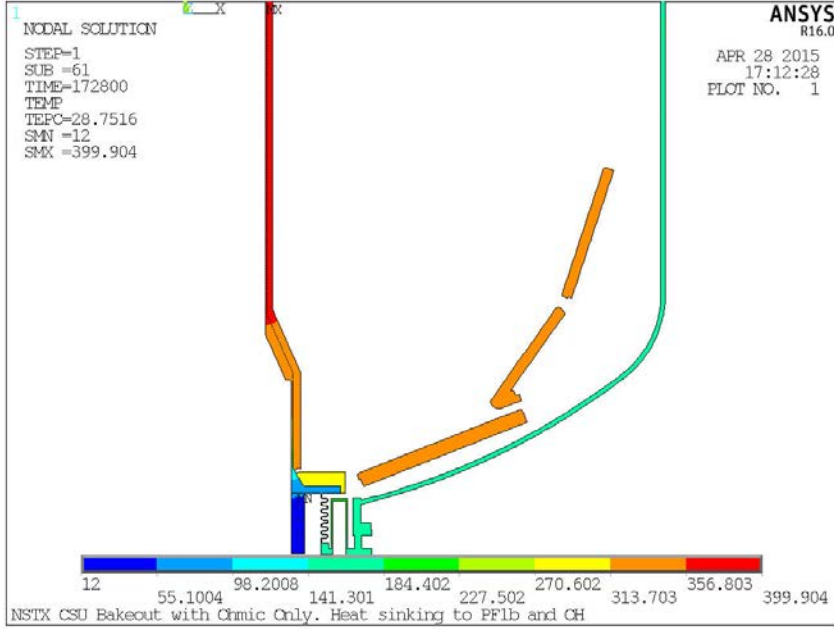
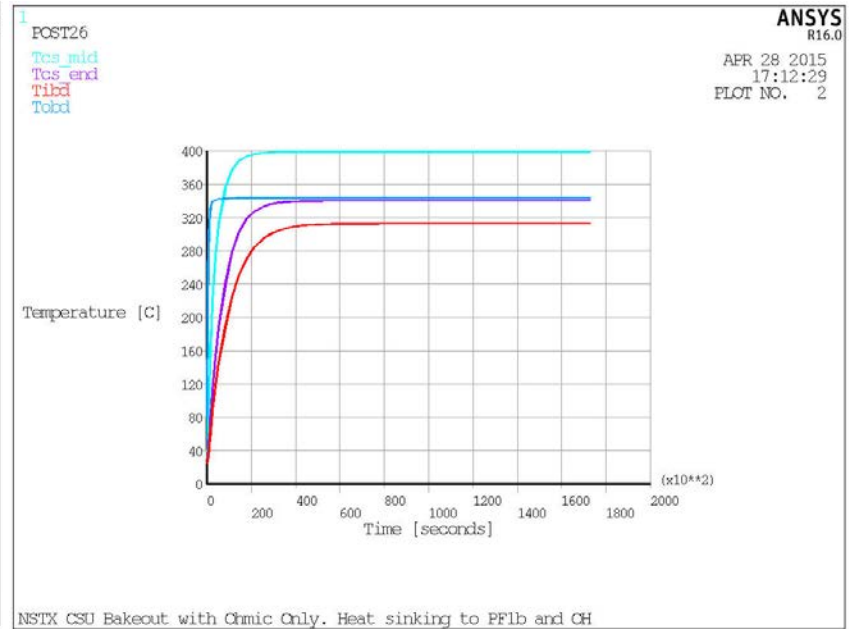
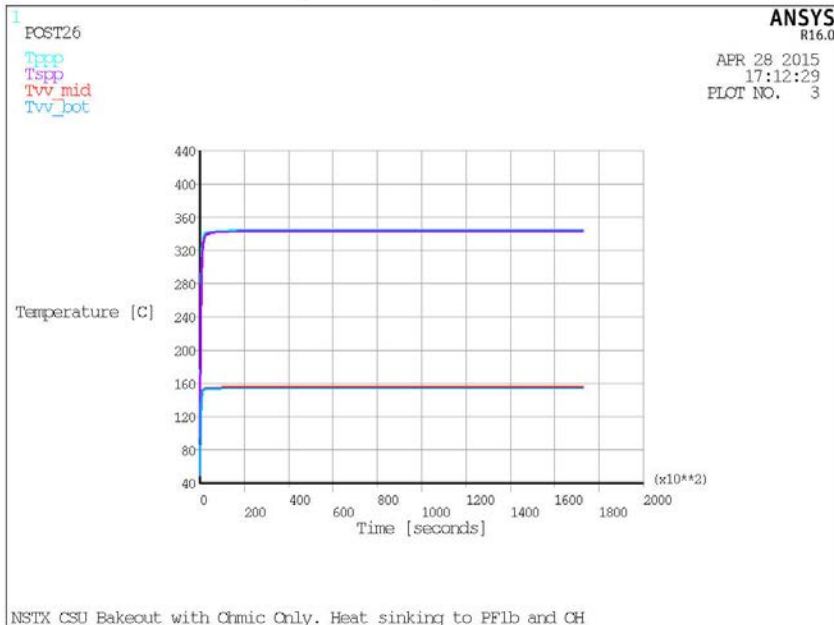
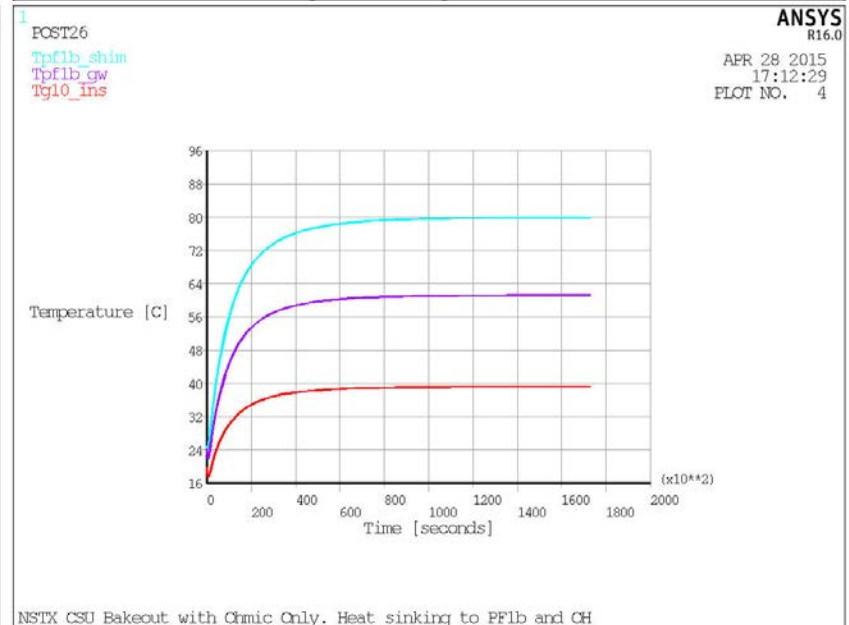
Conduction between IBDhs and IBDvs removed

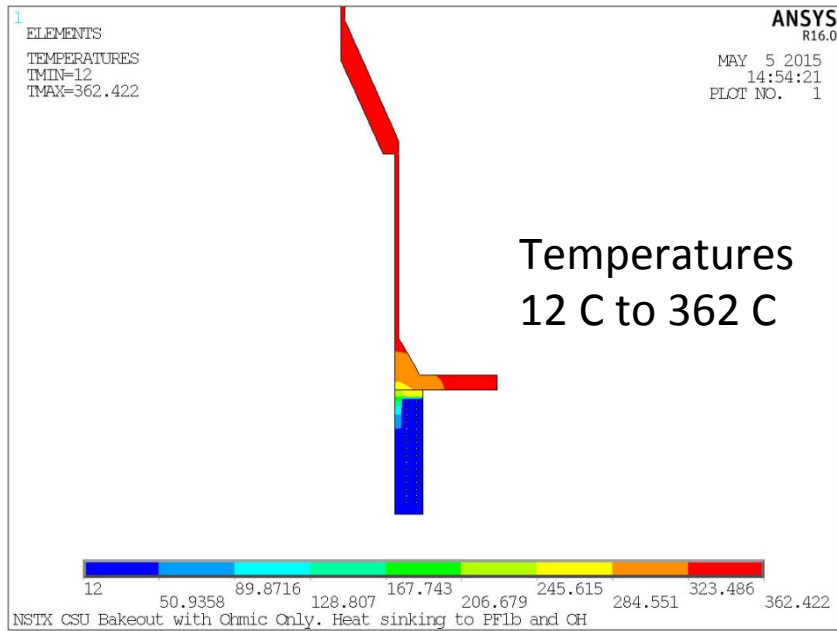
Shear At Weld from Thermal Growth

Weld Shear from Thermal Growth	
Radius	0.381 m
Weld Depth	0.003175 m
Weld Fraction	0.5
Weld Area	0.0038 m ²
Radial Force, 360deg	1.75 MN
Shear	460.49 MPa

460 MPa is taken as a limit on weld shear stress bases on (limited) testing

All options meet this limit except last (next slides)

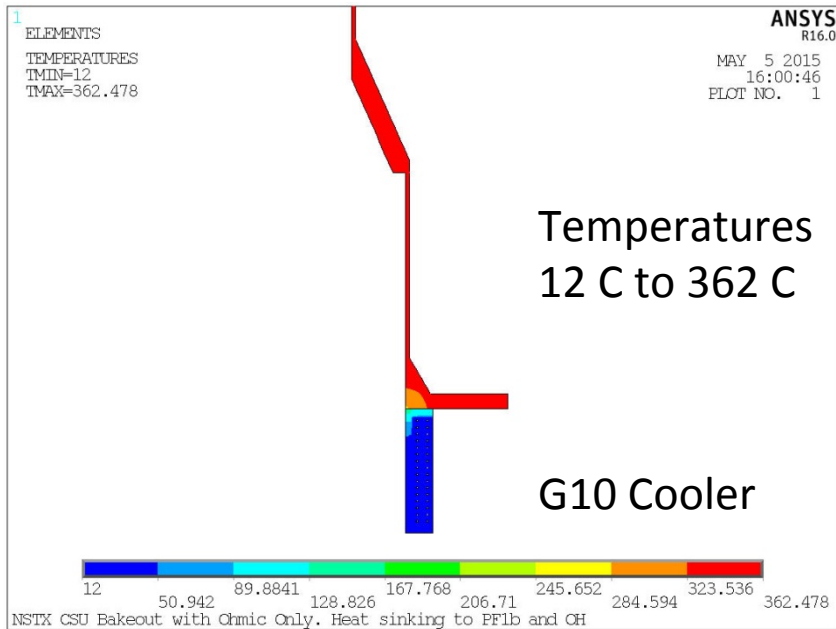
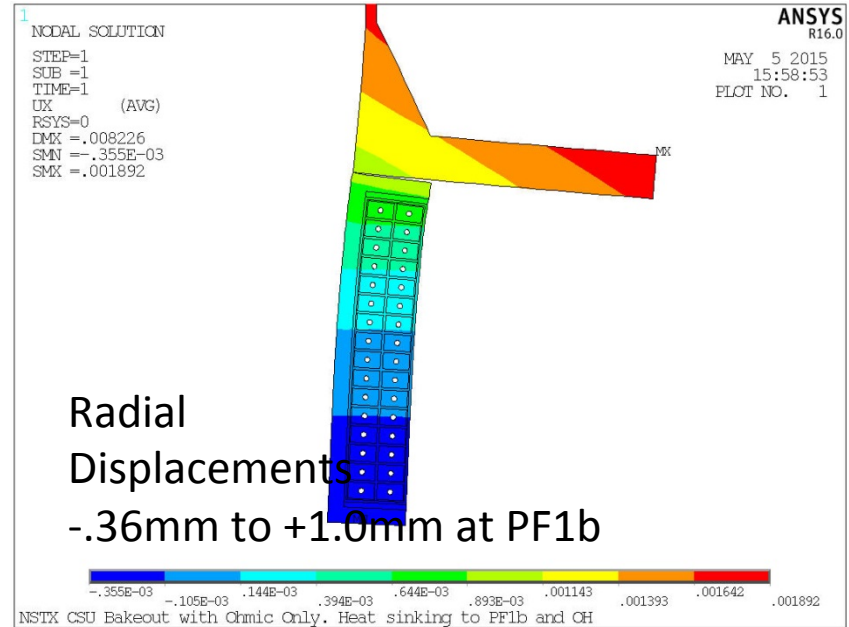
Shear At Weld from Thermal Growth

Weld Shear from Thermal Growth	
Radius	0.381 m
Weld Depth	0.003175 m
Weld Fraction	0.5
Weld Area	0.0038 m ²
Radial Force, 360deg	2.75 MN
Shear	723.63 MPa

Assuming separation of PF1b from Flange (near 0 conductance) produces a larger temperature gradient and higher shear stress
